SERVICE BULLETIN

Classification: AT18-009C	Reference: NTB18-077C	Date: June 22, 2021
------------------------------	--------------------------	------------------------

MIL ON WITH DTC P0776, P1715 AND MAY HAVE HESITATION AND/OR LACK OF POWER

APPLIED VEHICLES: 2017-2018 Sentra Turbo (B17)

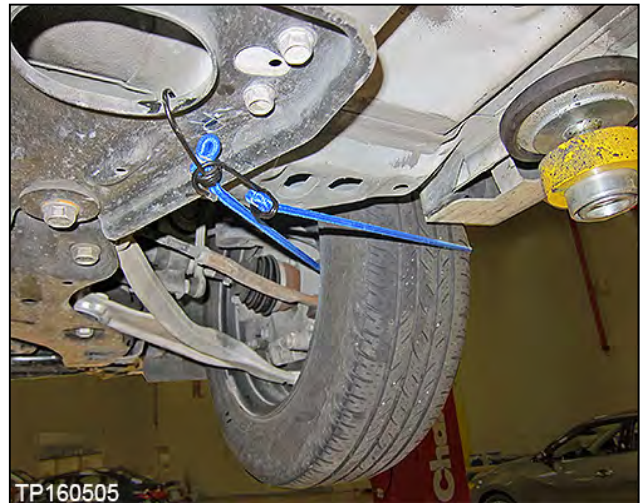
Figure 2

5. Mark the front left tire with a suitable marking.

- This will assure all 360° of the belt is inspected.

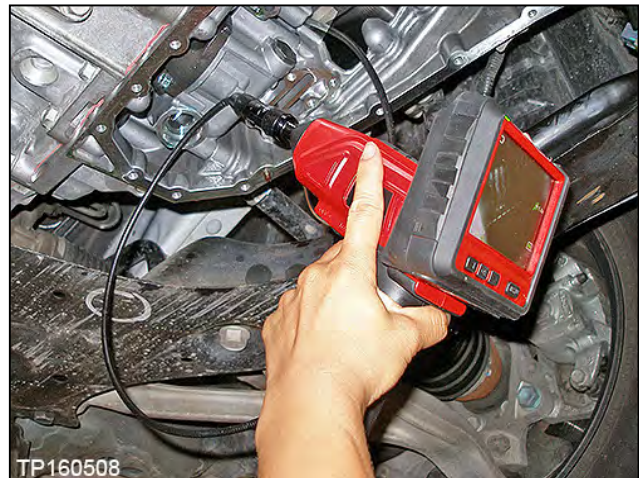
Figure 5

- b. Slowly and carefully turn the front left tire one full turn in the forward rotation to view all of the belt.

- Holding the borescope with one hand allows for turning the tire with the other hand (see Figure 5).

CAUTION: If the tire is rotated in the rearward rotation, the camera lens may get caught between the belt and pulley.

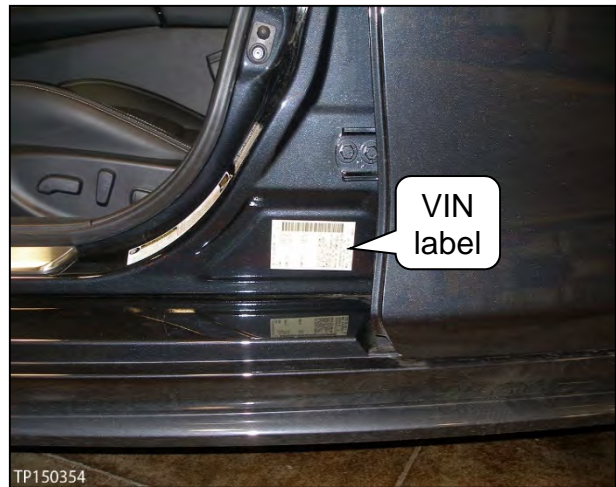
Figure 7

- f. If CVT replacement is required based on the inspection results from 6b and 6d, use borescope J-51951 to record a continuous video, 15 seconds or less, of the most severe evidence of belt slip and the VIN on the F.M.V.S.S. certification label (VIN label). See Figure 7.

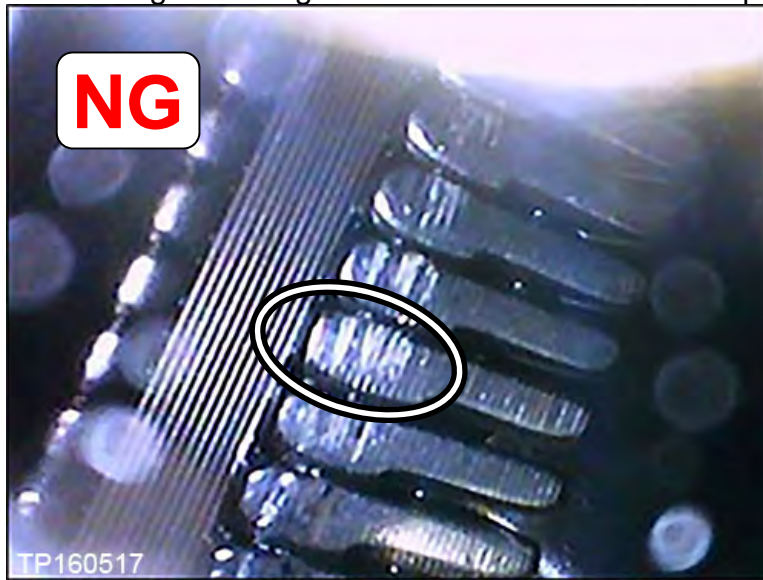
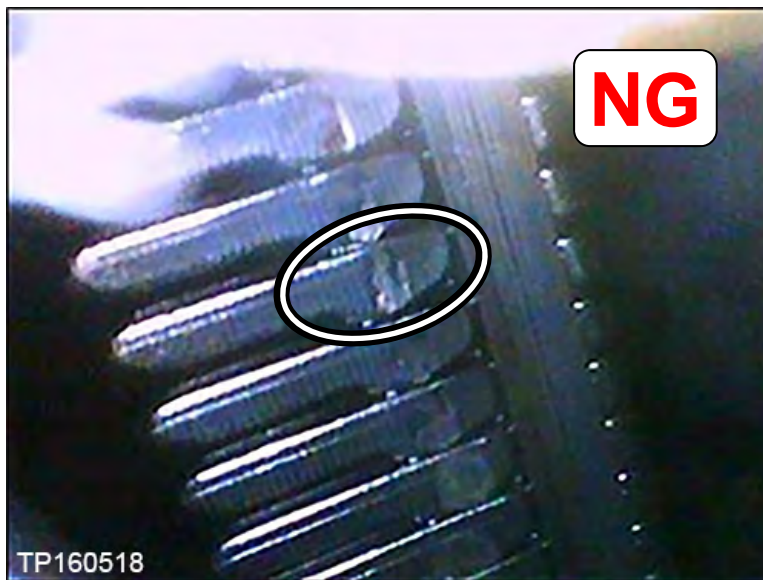
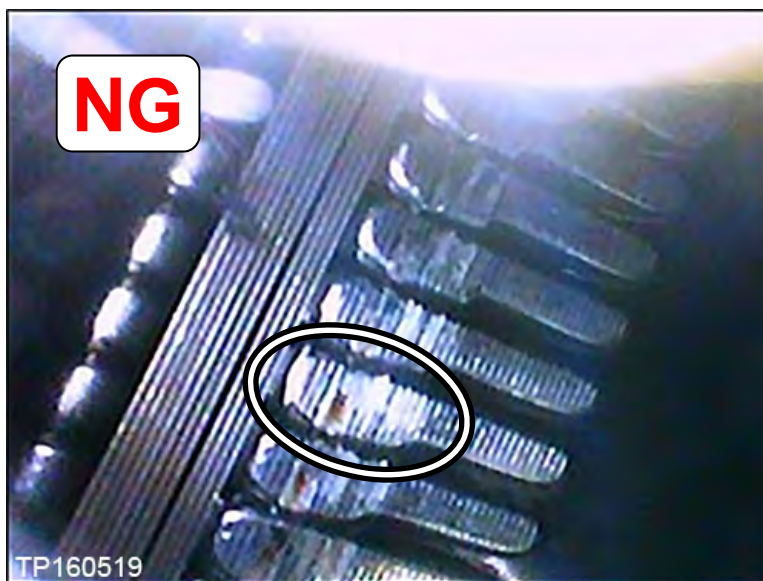
Pictures in Figure 15-Figure 17 were taken with borescope J-51951.

Figure 15: Example of NG belt

Figure 16: Example of NG belt

Figure 17: Example of NG belt

- Reference the Figures on pages 9 through 12 for comparison of an OK and NG belt condition.

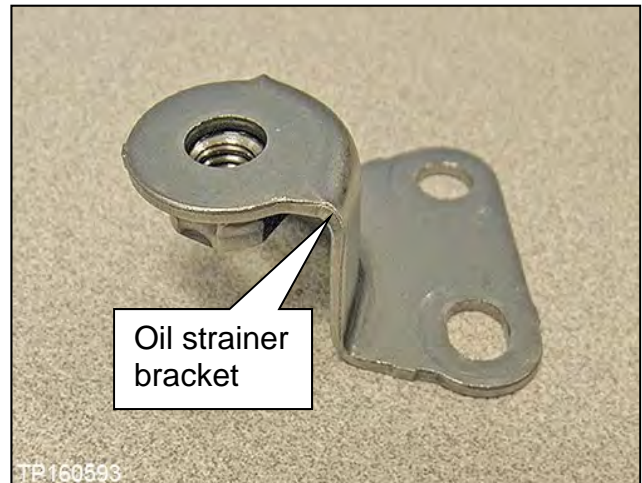
Figure 18

NOTE: If an oil strainer bracket was removed, discard it. An oil strainer bracket (Figure 18) will not be used with the new oil strainer.
