# TECHNICAL SERVICE BULLETIN

## Seat Pan Looseness, Lateral Movement And/Or Clunk/Thump Noise On Turns

**21-2185**  
16 July 2021

<b>Ford</b> 2020-2021 Explorer
<b>Lincoln</b> 2020-2021 Aviator
2020-2021 Corsair

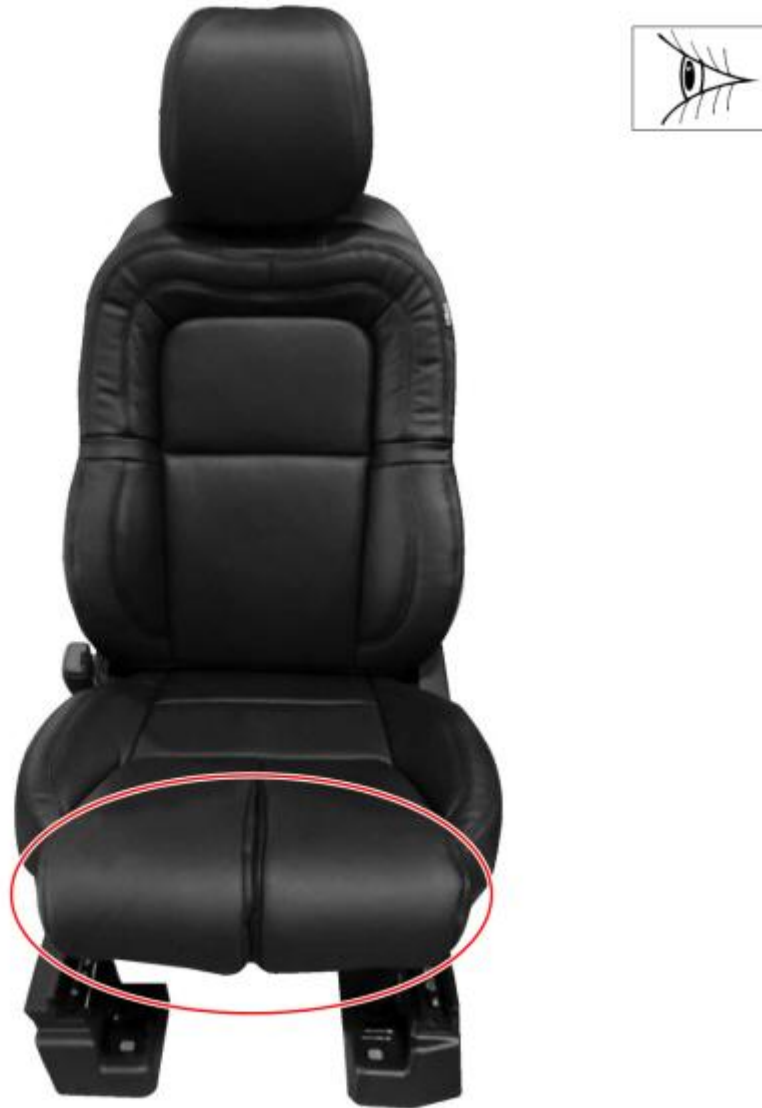
Figure 1

1. Are the vehicle front seats equipped with a leg extension split on the cushion? (Figure 1)

- (1). Yes - proceed to Step 2.
- (2). No - proceed to Step 14.
