87-18-08 - Air Conditioning, Cleaning of the R1234yf Refrigerant Circuit (U.S. Only)

Release date: 7/28/2021

Debris can be dispersed throughout the refrigerant circuit after A/C component damage. In order to maintain A/C operating efficiency, it is important to flush the refrigerant circuit after A/C component repairs.

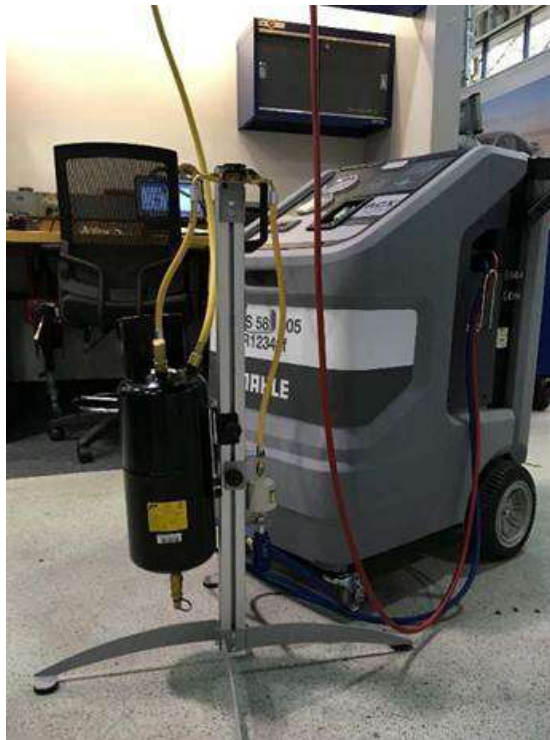
**Figure 1.** The VAS581005 Air Conditioning Service System with Flushing Device.

Use an approved R1234yf servicing machine and the R1234yf Flush Kit RTI360831840 (Figure 1).

Used for effective refrigerant handling and air conditioning circuit flushing after air conditioning component failure.

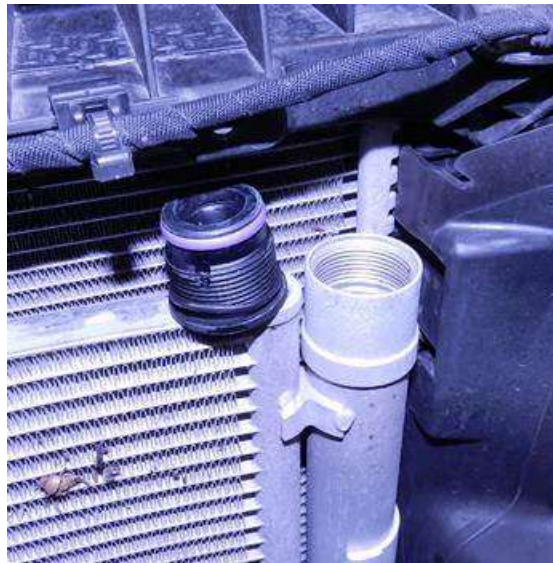
**Figure 2.** Location of the Receiver Drier

- 6. Remove receiver drier cartridge.  
Reinstall cartridge cap with O-ring. (Figure 2)

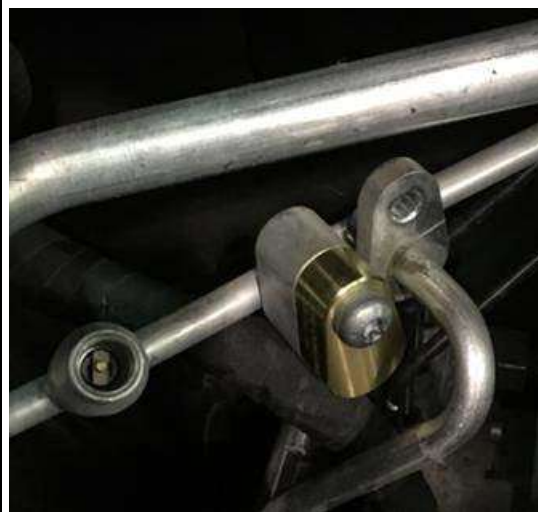
**Figure 4a.** Installation of high side rear A/C Line connection block adaptor VAS 6338/63.

(Atlas Only) The rear A/C unit refrigerant lines must be disconnected and replaced with block off adaptors VAS 6338/5 and VAS 6338/63 before performing the front A/C unit flush procedure.

8. (Atlas Only) Disconnect rear refrigerant lines and install adaptors VAS 6338/5 and VAS 6338/63 as shown. (Figure 4a, 4b)

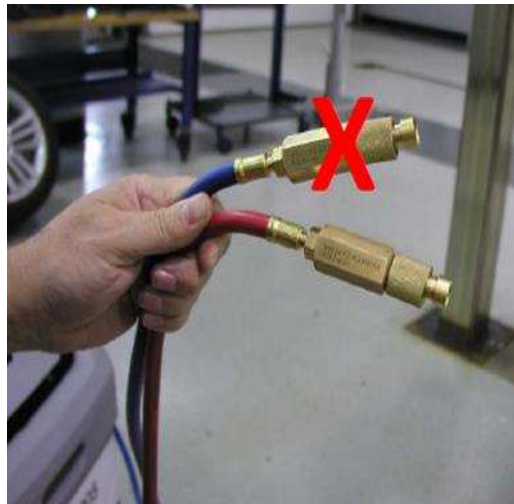
**Figure 5.** A.C hose adaptor 6338/44

9. Remove A/C Recovery machine high side coupler from hose.

Install flush adaptor VAS 6338/48 to high side A/C recovery machine hose. (Figure 5)

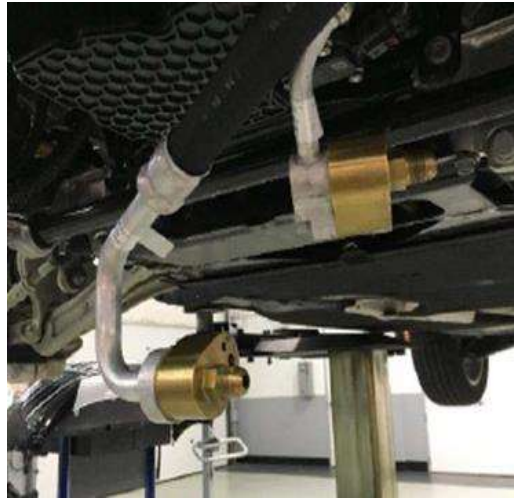
Figure 6. Installation of VAS 6338/3 and 6338/12.

10. Disconnect A/C compressor hoses from the compressor.

Install flush adaptor VAS 6338/3 on the high side compressor hose.

Install flush adaptor VAS 6338/12 on low side compressor hose. (Figure 6)

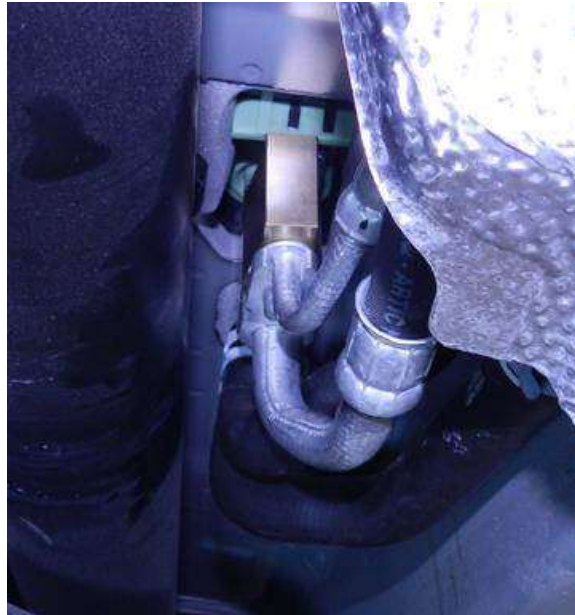
**Figure 13.** Location of rear air conditioning unit expansion valve.

23. Remove rear expansion valve and install VAS6338/38 as shown. (Figure 13)

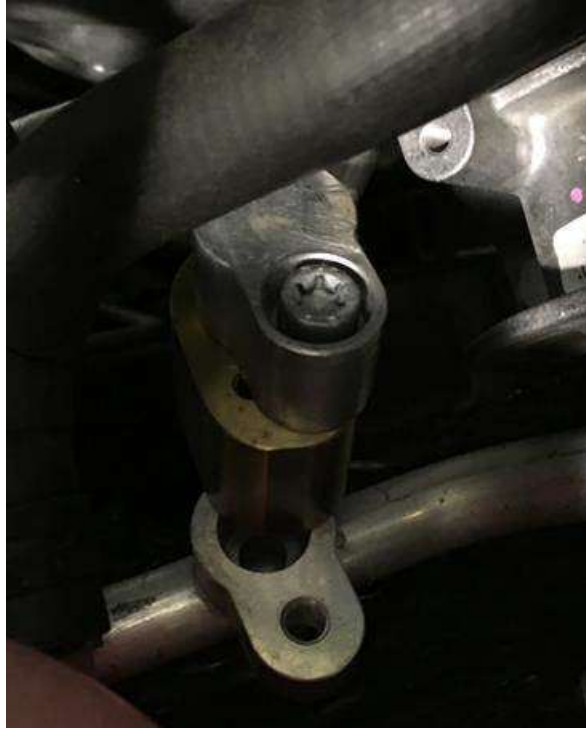
**Figure 14.** Location and connection of the adaptors for the rear unit A/C lines

24. Connect the VAS 6338/3 and VAS 6338/60 to the rear refrigerant A/C lines (Figure 14)

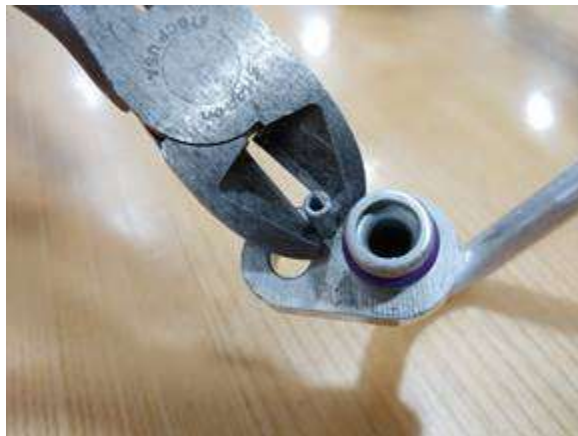
**Figure 15.** Removal of dowel pin.

Later models may have a dowel pin in the high pressure refrigerant line that does not allow the VAS 6338/60 to be installed. The pin must be temporarily removed to install the VAS 6338/60. DO NOT cut the pin flush with the refrigerant. Side cutters can be used to remove the pin and pliers to reinstall the pin (Figure 15 and 16).

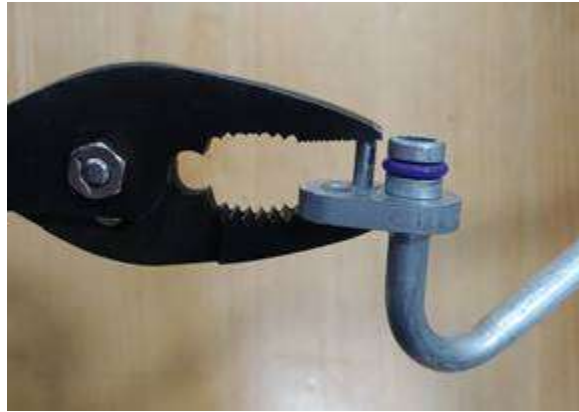
**Figure 16.** Installation of rear refrigerant line dowel pin.

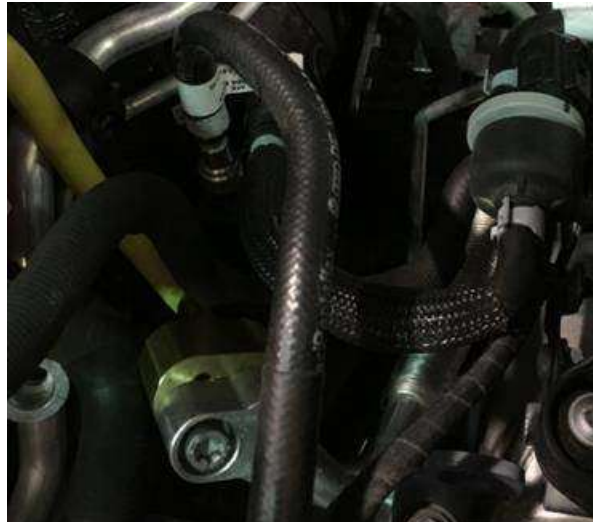
**Figure 17.** Attaching service station and flush hoses to rear A/C lines.

- 25. Connect the VAS 6338/48 to adaptor VAS 6338/60
- 26. Connect flush tank hose (Yellow) to the high side compressor hose adaptor VAS 6338/3. (Figure 17)

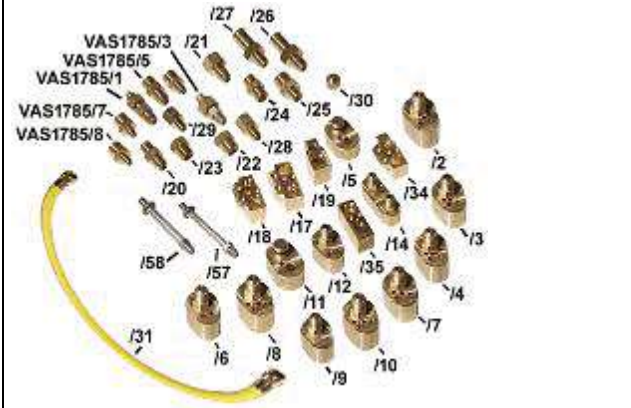
VAS 6338/1

Adapter set for refrigerant circuits

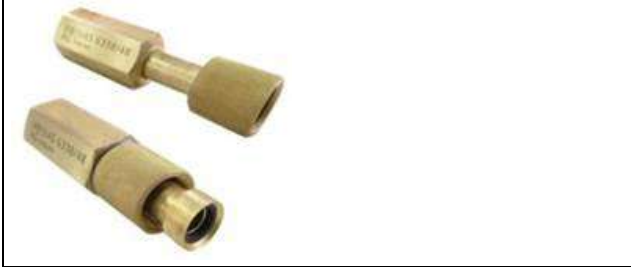
VAS6338/48

Refrigerant circuit adapter for MAHLE A/C Service  
Unit and R1234yf Flush Kit

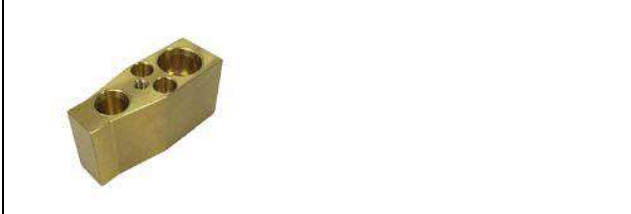
VAS6338/38

Refrigerant circuit adapter for expansion valve  
bypass

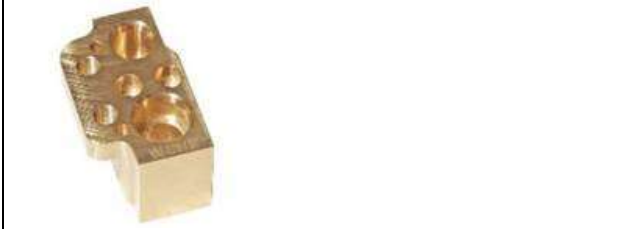
VAS 6338/18

Refrigerant circuit adapter for expansion valve  
bypass
