**\* \* TECHNICAL INFORMATION NOTICE \* \***

DATE: July 22, 2021  
TO: Mitsubishi Motors US Service and Parts Managers  
RE: Axle Shaft Thread damage due to improper disassembly  
TIN NO.: TIN-21-26-001

**AFFECTED VEHICLES:** 2022 Outlander and other models.

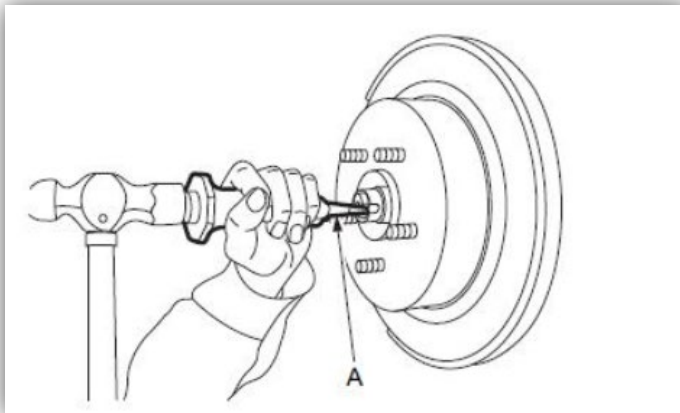
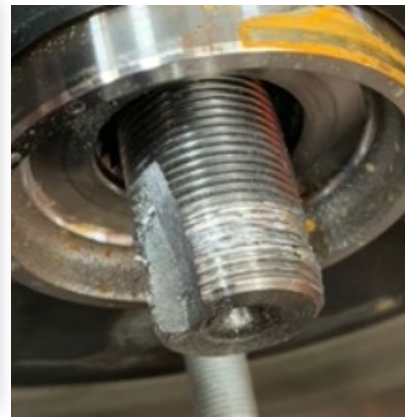
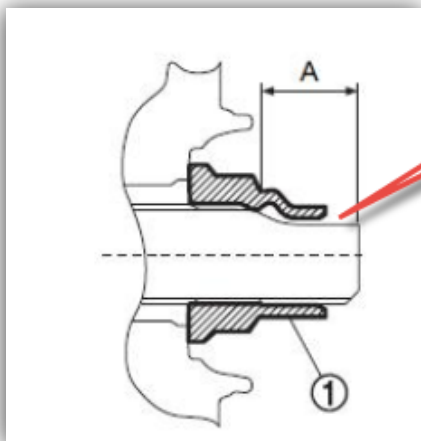
When removing the nut on the front CV Joint Axle be sure to "unstake" the nut prior to unthreading it from the axle shaft. Failure to do so will result in damage to the axle shaft threads. A narrow chisel or similar tool can be used to release the stacked area of the wheel hub lock nut.

Insert Chisel here and pry staked portion nut up and away from axle threads.
