SERVICE BULLETIN

Subject: Replacement of the roof hatches' wires and clips.

Bulletin No: TS45-SR-2101

Vehicle Model:TS45

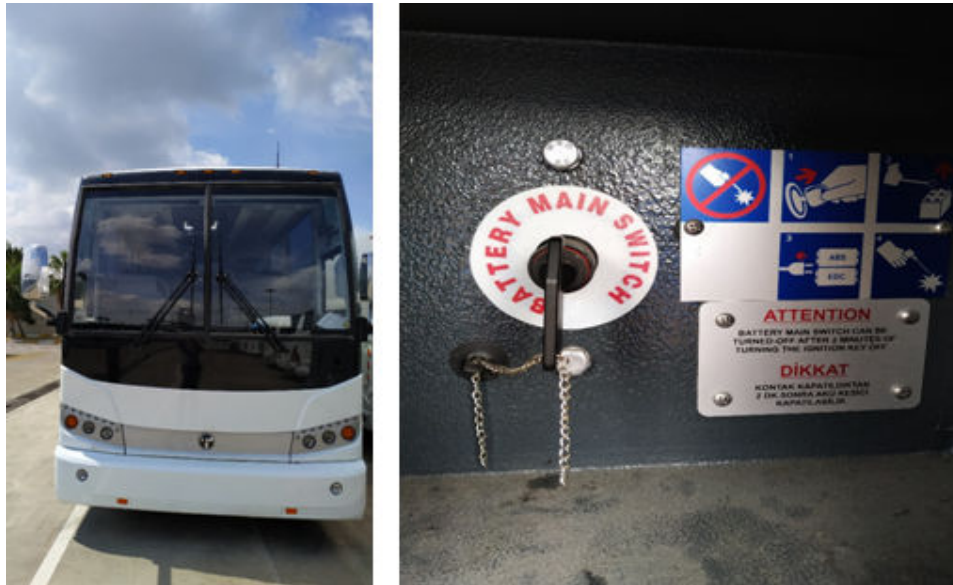
Figure-1

1. To be able to carry out service bulletin application, take the vehicle to safety area and shut off the engine and turn off battery main switch (See Figure-1)

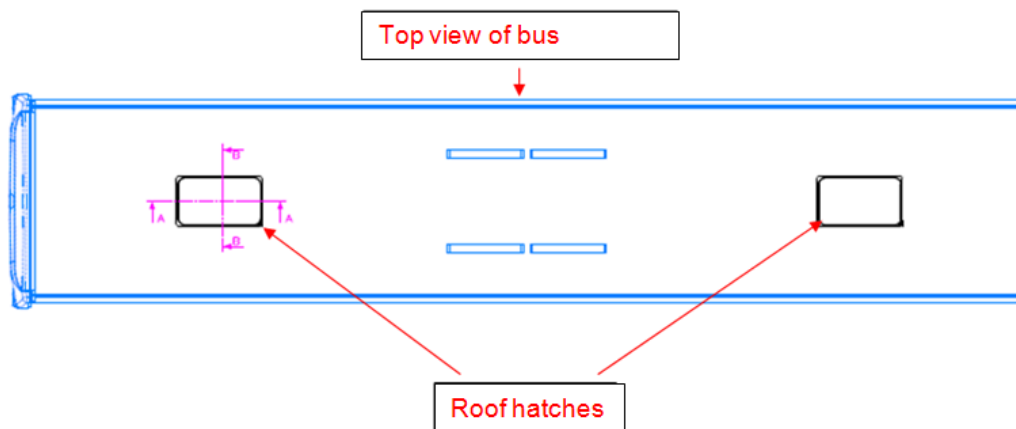
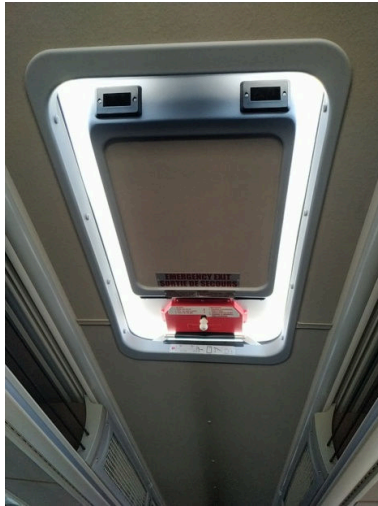
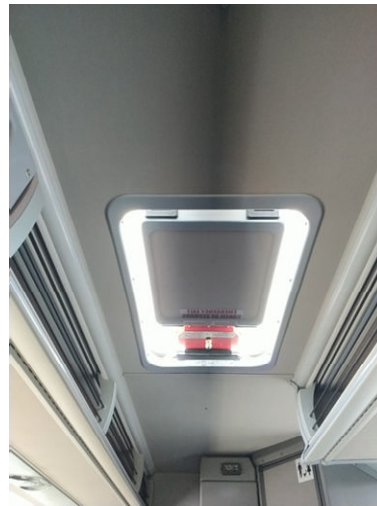
2. See two roof hatches on the vehicle roof (see Figure-2)

Figure- 2 Front and rear roof hatches.

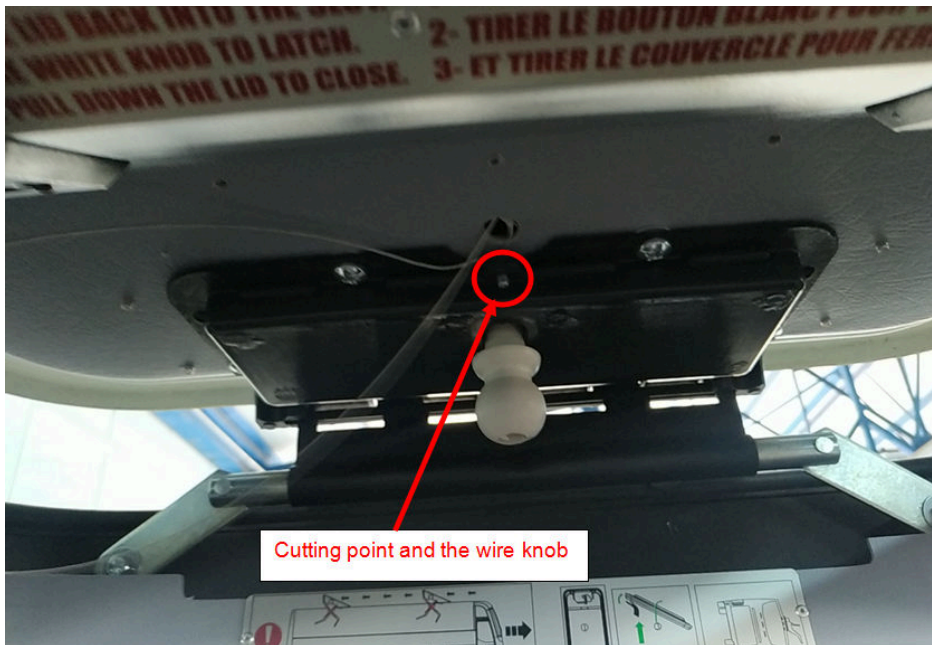
4. Cut the wire of the roof hatch at the point seen in Figure-4 by a flush cutter and remove the knob at the endpoint. Then pull and remove the wire.

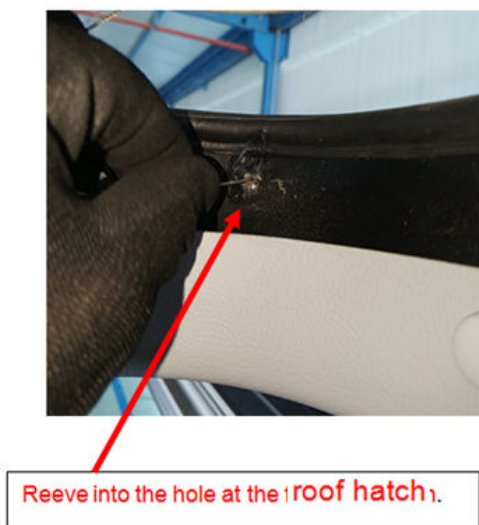
Figure-8

8. Pass the wire across the inside of the roof hatch and reeve it into the hole at the frame of the roof hatch (see Figure-8).

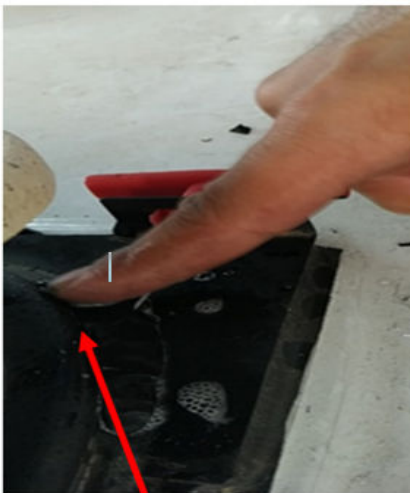
10. Clean the hole area the wire passed through in the roof hatch frame by Henkel Terostat 8550 cleaner (p/n TM900000HY) or if it can't be provided, use alcohol or another cleaner.
Then seal the the hole by using sealant of Henkel terostat ms939 (p/n SM-54Y) and sealent gun very carrefully !
This is very important to prevent the water leakage from outside into the vehicle (see Figure-10)

The hole at the frame of roof hatch

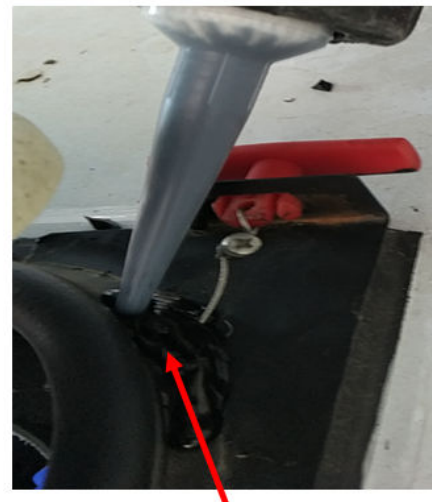
Figure-10

Sealing process of the frame hole after wire passed through.

NOTE: Materials of Henkel terostat 8550 cleaner (p/n TM900000HY) and Henkel terostat MS 939 sealent (p/n SM-54Y) used in the 10th instruction item must be supplied locally and added to the cost of the service bulletin.
