TECHNICAL TOPICS

BODY/CHASSIS

Cyclical Type Noise From Front Brakes	21MY Range Rover, RR Sport, Defender, Discovery, RR Velar, F-PACE
<u>Customer Voice:</u> - A customer may report that there is a cyclical knocking or judder type noise when braking.

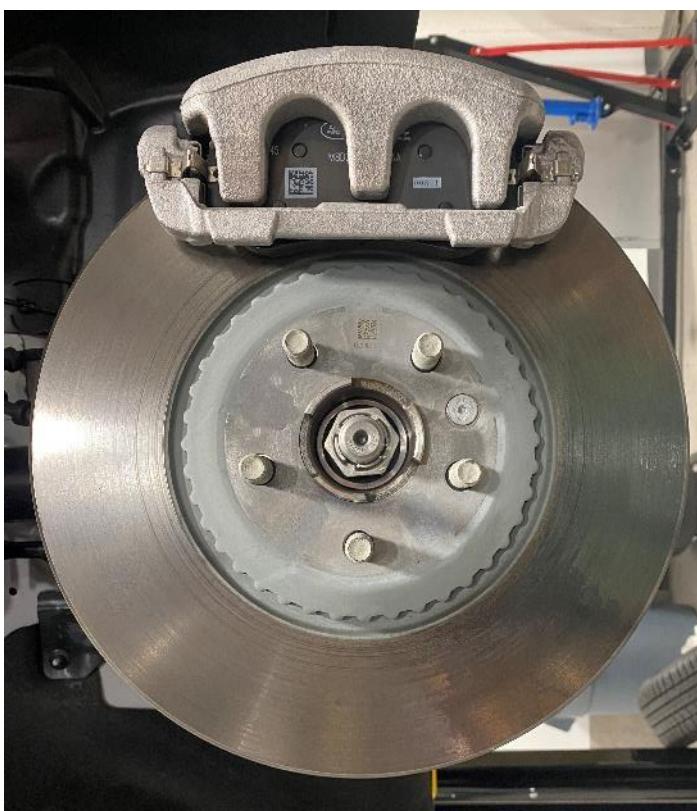
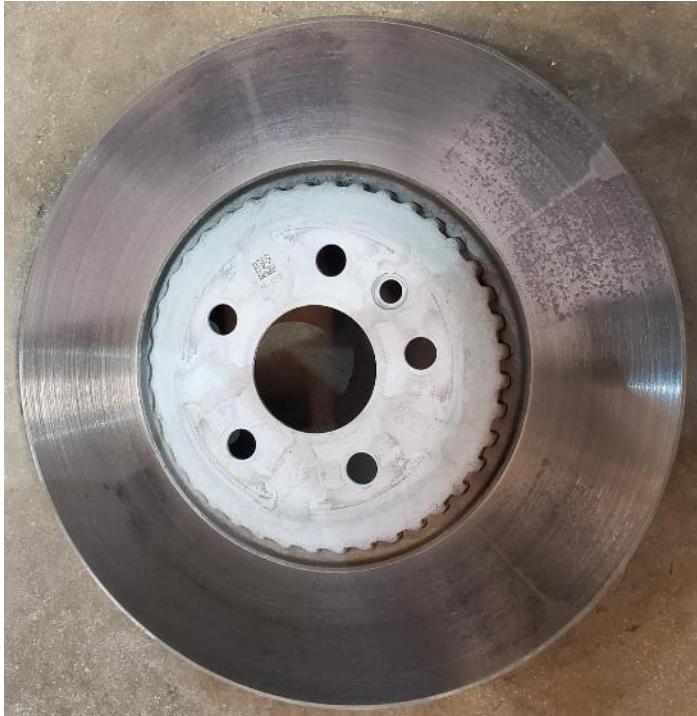
Examples of uneven brake pad material transfer onto the brake disc.

<u>Technical Description:</u> - This may be caused by brake pad material that has not evenly transferred onto the brake disc. <u>Status:</u> - SSM 75447 (Land Rover) and SSM 75448 (Jaguar) has been published to address this concern by providing repair guidance to clean the brake disc surfaces of pad material and prepare the disc and pad surfaces using 150 grit emery cloth. - The SSM also provides specific brake bed-in procedures that is very important to follow to ensure a successful repair.

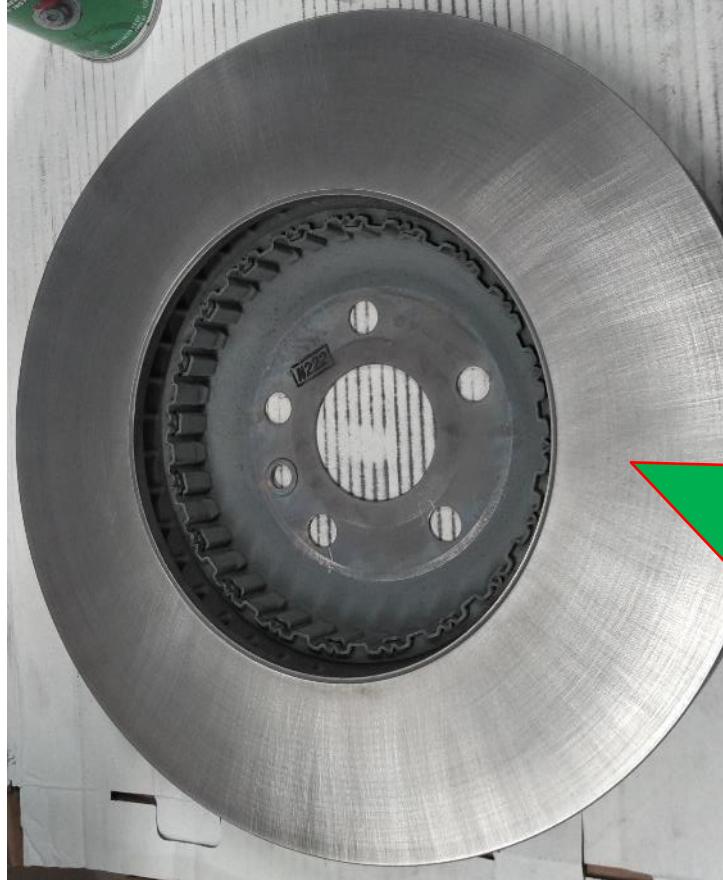
Correctly performed SSM
disc cleaning procedure.

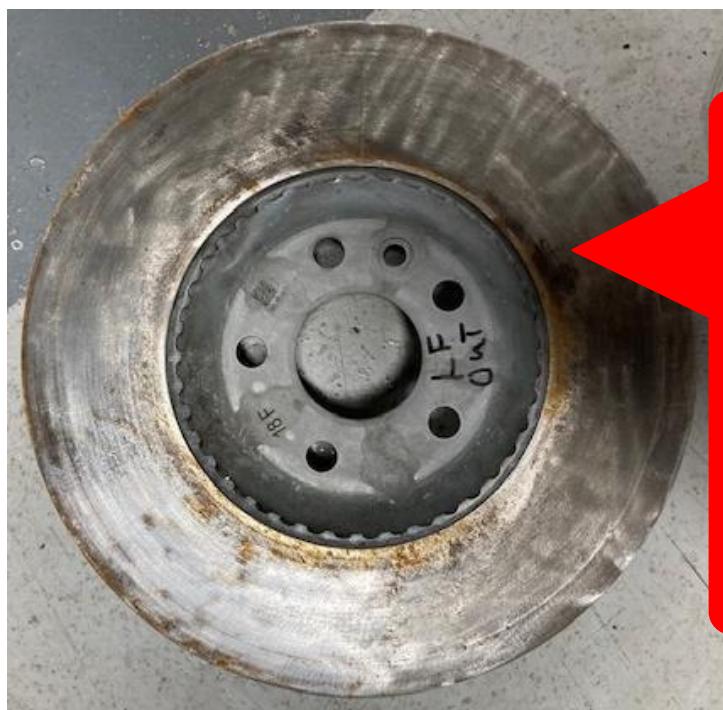
Poor attempt of performing
SSM disc cleaning procedure.

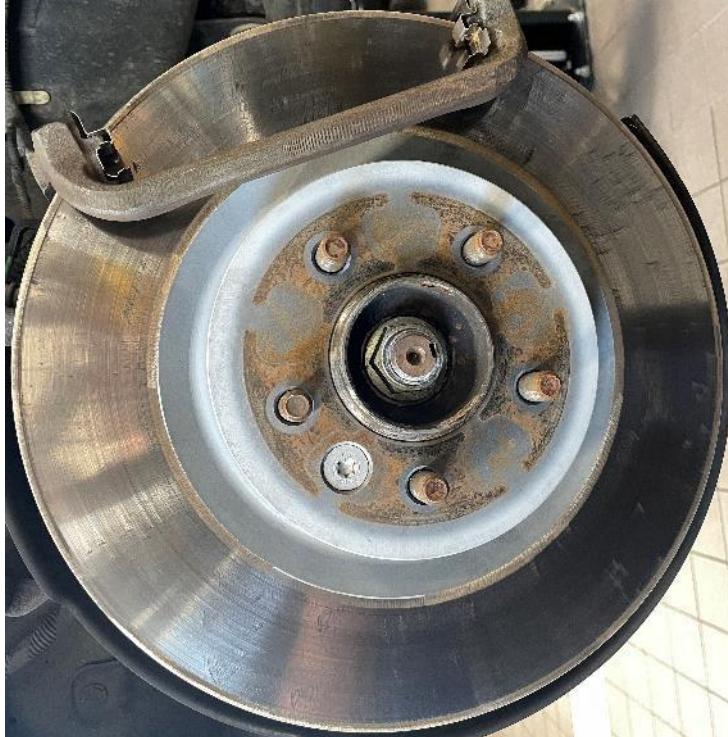
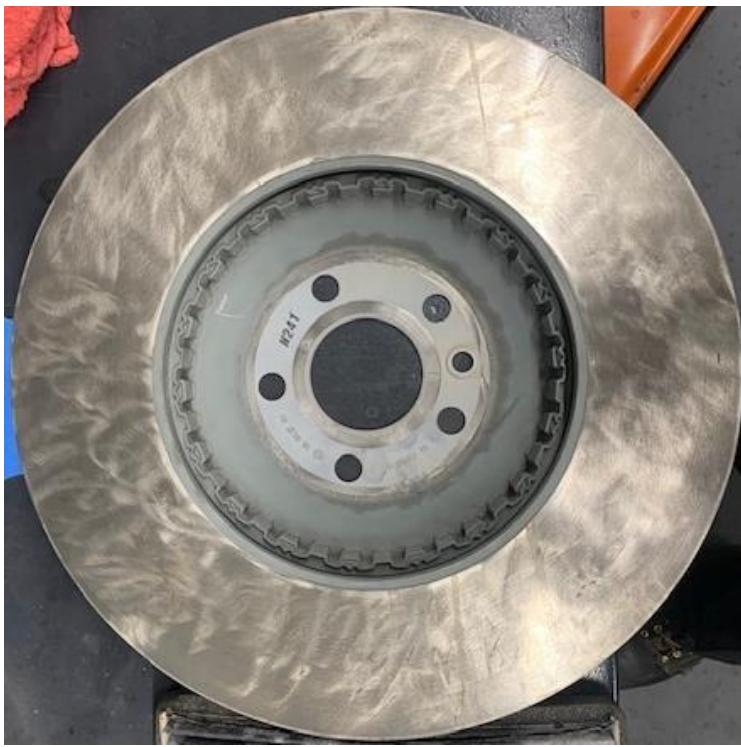
Examples of brake discs improperly sanded with a rotary tool causing a noise concern.

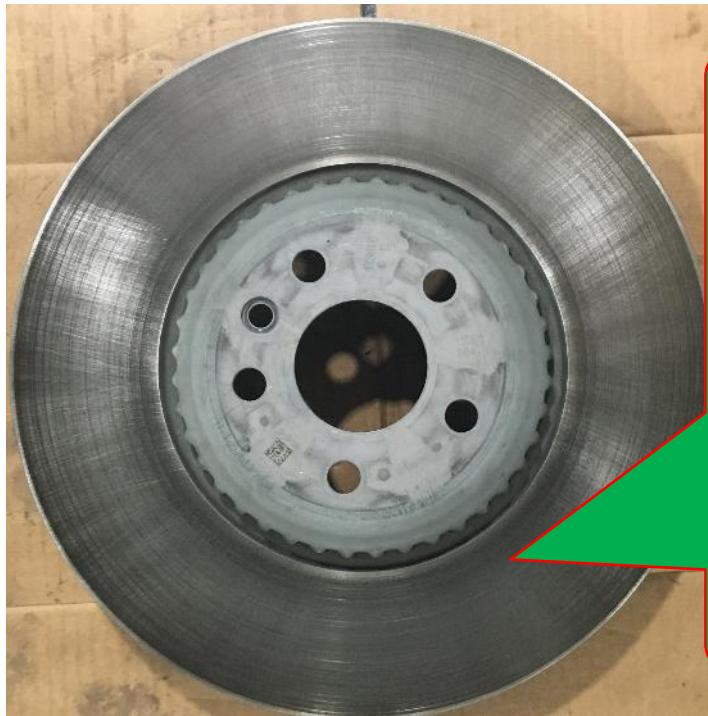
Correctly bedded in brake discs will have an even, dark layer of pad material on the friction surface.

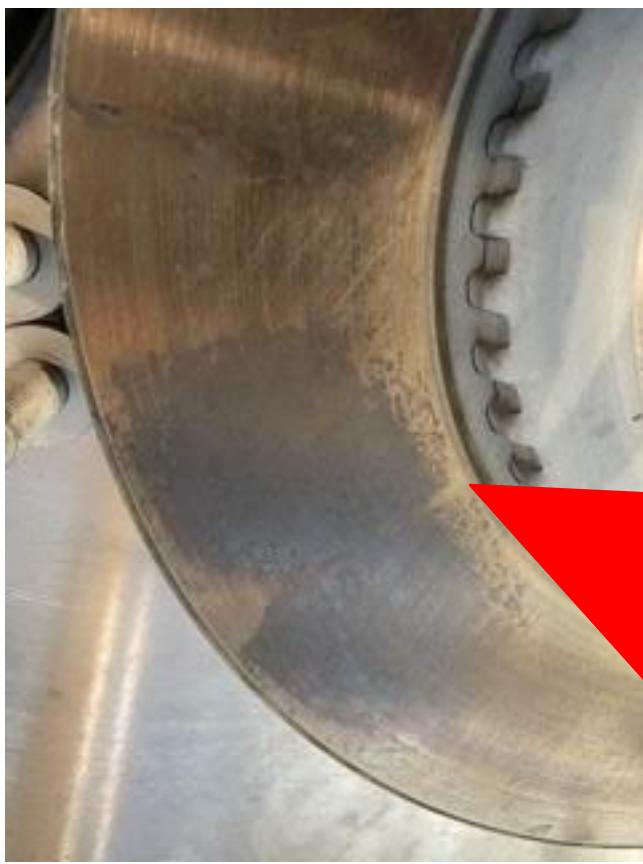
Avoid coming to complete stops with hot discs when performing the bed-in procedure to avoid static material transfer.
