# Technical product information

<b>Topic</b>	Bentayga W12 - DTC 310B00 - Low fuel pressure regulation
<b>Market area</b>	Bentley: worldwide (2WBE),Hongkong-Macau (5HK)
<b>Brand</b>	Bentley
<b>Transaction No.</b>	2055321/2
<b>Level</b>	EH
<b>Status</b>	Approval
<b>Release date</b>

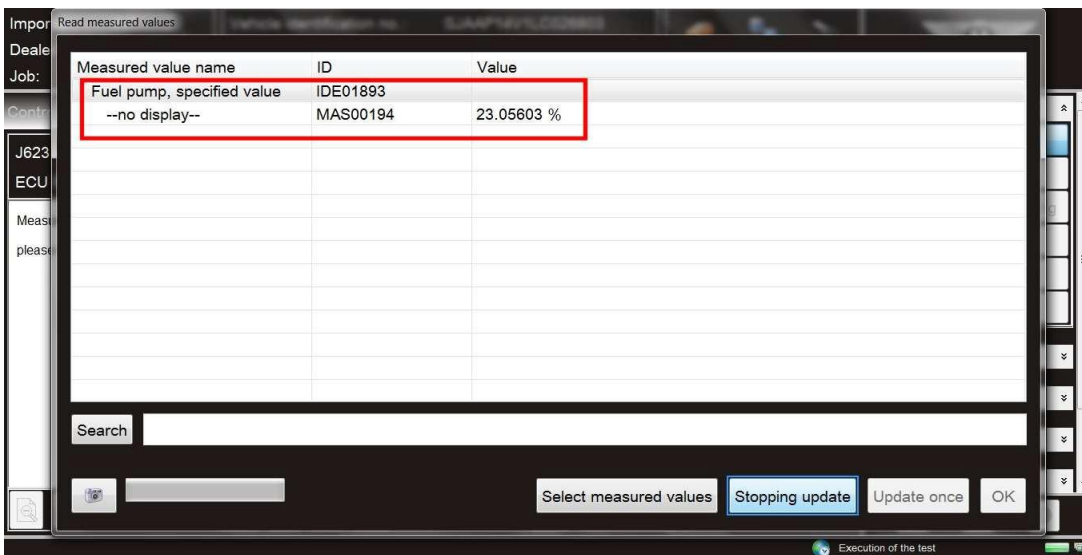
1) Check and confirm the Fuel tank pump assembly Pulse Width Modulation (PWM) value as follows:

- Ensure the engine is idling at operating temperature - Ensure a suitable battery charger is also connected as per Rep.Gr 27
- Select Engine control module 1
- Select Guided functions – Read measured values
- Referring to Figure 1 - Navigate to Measured value IDE01893
- Select Starting update and monitor the Value – The value should be below 25%

NOTE: If the fuel pumps run faster at idle (above 25%) this is a sign of either a significant leakage or that the wrong fuel pump control modules are fitted - Carry out an inspection of the vehicles repair history, should the fuel pump control modules have been previously replaced you must ensure the correct specification were fitted, however if there is no replacement history of the control modules continue to step 2 – Fuel low pressure check

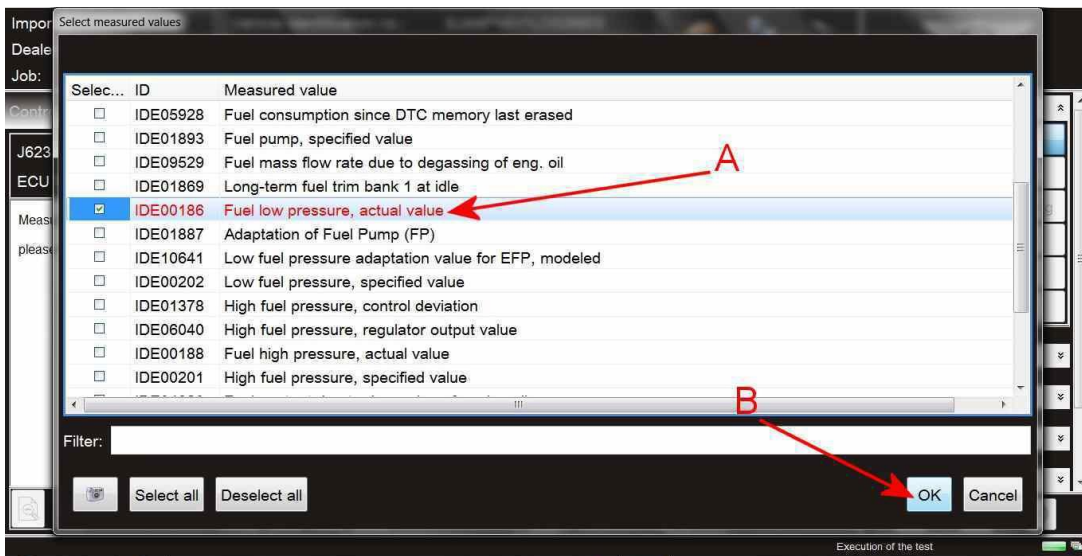
2) Fuel low pressure check - Referring to Figure 2 (Point A) navigate to Measured value IDE00186 Fuel low pressure, actual value

- Select OK (Point B)

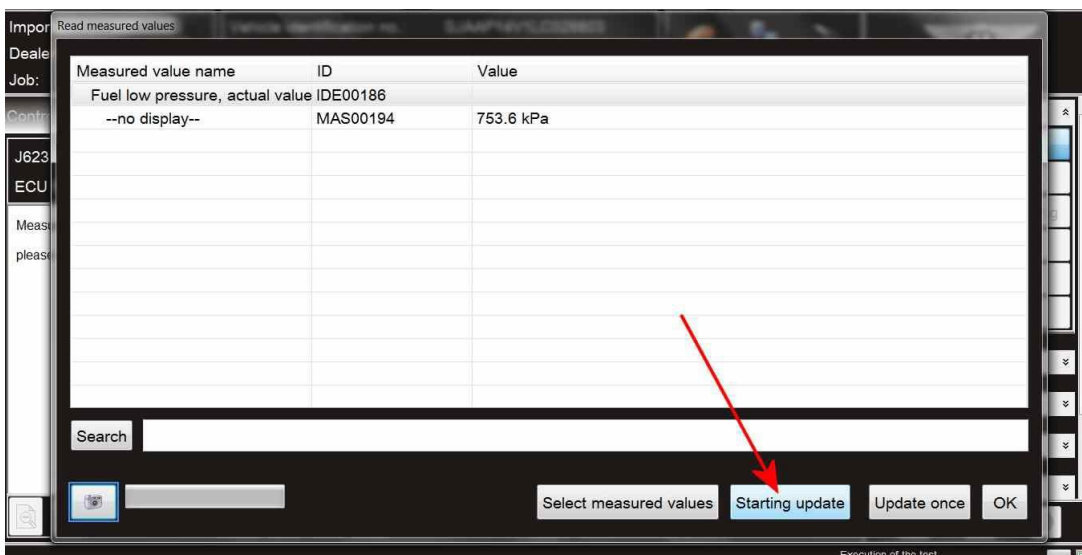
- Referring to Figure 3 – Select Starting update
- Switch off the engine and leave the ignition on
- Monitor the pressure decay of the low pressure fuel system for 10 minutes

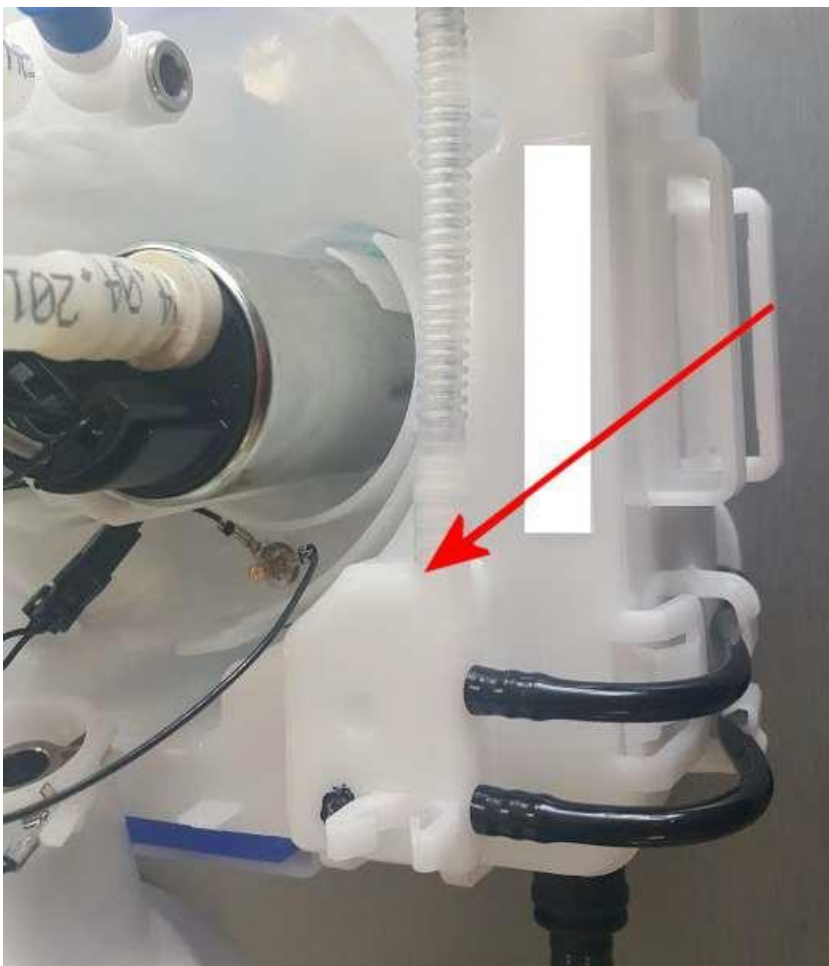
4) Referring to Figure 7 (For photographic purposes Figure 7, was taken with the fuel pump assembly removed from the fuel tank) Check the connection shown is not broken NOTE: Care should be taken when checking this part as damage can be caused when manipulating the fuel pump assembly

IMPORTANT: Only the components on the right hand side of the fuel tank are interchangeable, if there is a fault with any components on the left hand side or with any components which are not listed within the ETKA parts catalogue a new fuel tank is required

- Should any issues be found with the fuel pump assembly or fuel filter replace the fuel pump assembly and fuel filter as per the applicable Rep.Gr

- Should any issues be found with the fuel pump assembly or fuel filter after the checks from Steps 1 through to 4 have been conducted - The operative MUST raise a DISS query and await feedback before conducting any further work
