SIB 23 02 21

GEAR SHIFT ASSISTANT NOT WORKING (BREAK IN WIRE)

2021-07-09

Model	Model Description
K80	F 750 GS
K81	F 850 GS
K82	F 850 GSA
K83	F 900 R
K84	F 900 XR

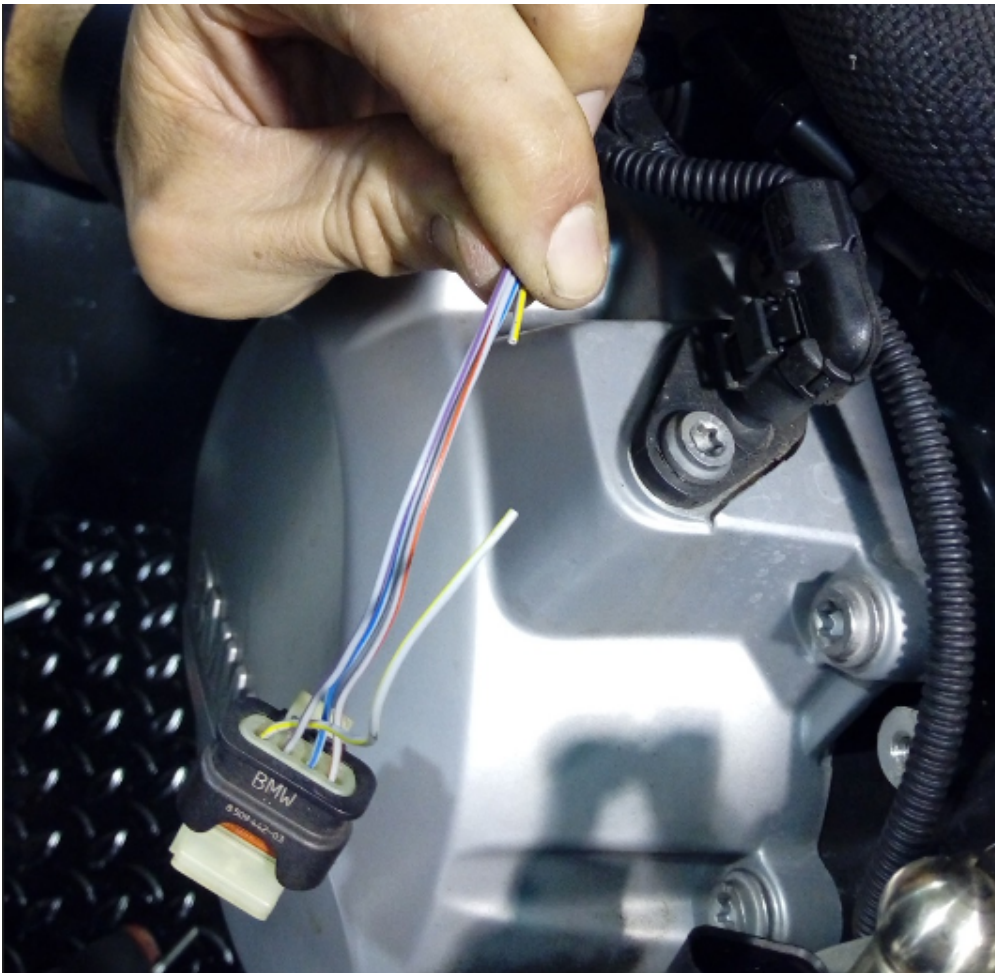
Figure 1: External break

Gear Shift Assistant (i.e. quick-shifter / clutch-less shifting) is not working. Damaged wire(s) in the main wiring harness (see Figure 1 and Figure 2).

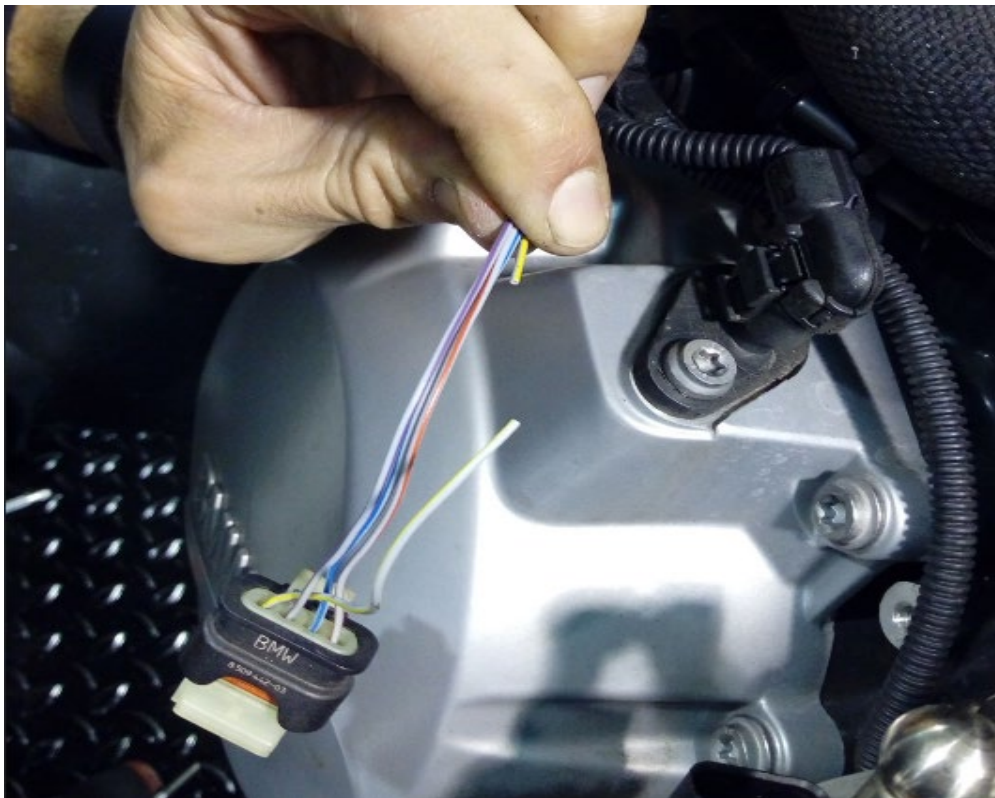
Figure 1: External break

Gear Shift Assistant (i.e. quick-shifter / clutch-less shifting) is not working. Damaged wire(s) in the main wiring harness (see Figure 1 and Figure 2).
