HVAC Evaporator Drain Hose Clogged Due to Insect Intrusion

Service Category Vehicle Interior

Section Heating/Air Conditioning

The information contained in this bulletin supersedes Service Bulletin No. L-SB-0018-14.

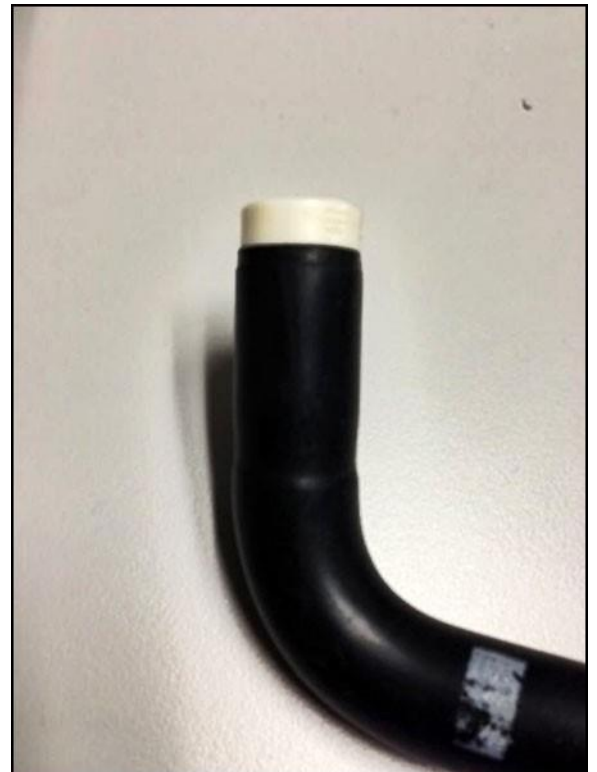
1. Follow the instructions provided in the Safety Requirements for Handling the ARINIX® Tip (Water Hose Connector) section of this bulletin.
2. Locate the HVAC evaporator drain hose.
3. Following the vehicle specific Repair Manual, remove the HVAC evaporator drain hose.
4. Put on all necessary PPE and install the ARINIX® Tip (water hose connector) into the NEW HVAC evaporator drain hose listed in the Parts Information section of this bulletin.
5. When installing the ARINIX® Tip, verify it is fully seated in the HVAC evaporator drain hose as shown in Figure 1.

6. Following the vehicle specific Repair Manual, install the HVAC evaporator drain hose.

1. Follow the instructions provided in the Safety Requirements for Handling the ARINIX[®] Tip (Water Hose Connector) section of this bulletin.
2. Locate the HVAC evaporator drain hose.
3. Following the vehicle specific Repair Manual, remove the HVAC evaporator drain hose.
4. Put on all necessary PPE and install the ARINIX[®] Tip into the original HVAC evaporator drain hose listed in the Parts Information section of this bulletin.
5. When installing the ARINIX[®] Tip, verify it is fully seated in the HVAC evaporator drain hose as shown in Figure 1.
6. Following the vehicle specific Repair Manual, install the HVAC evaporator drain hose.
