Volvo VN Models - Overhead Light Loose, Detaching From Headliner

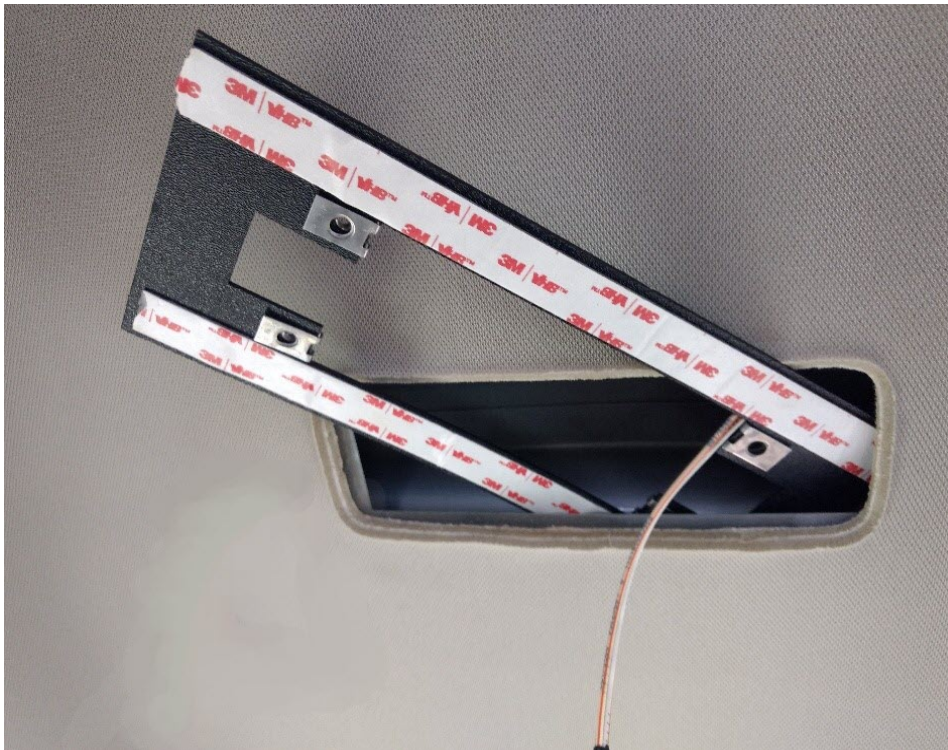
1. Remove the light assembly from the headliner and disconnect it from its wire harness.
2. Route the wire harness through the center of the backing plate, then insert the plate through the opening in the headliner.

Remove the backing from the tape strips center the four screw holes

Live UI backing plate in the headliner opening. Press the plate into place once centered.

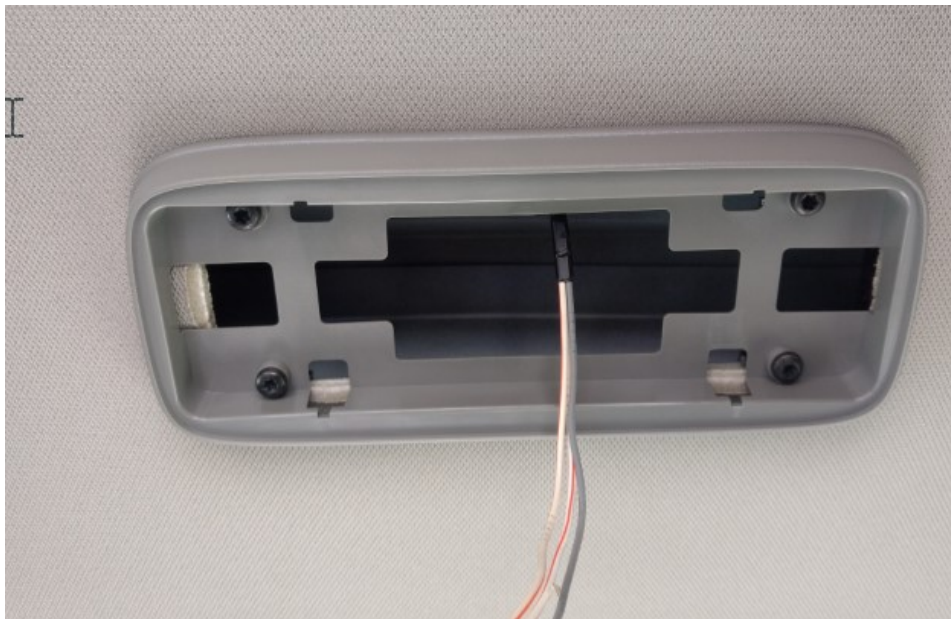
4. Attach the bezel to the backing plate using the four screws provided.

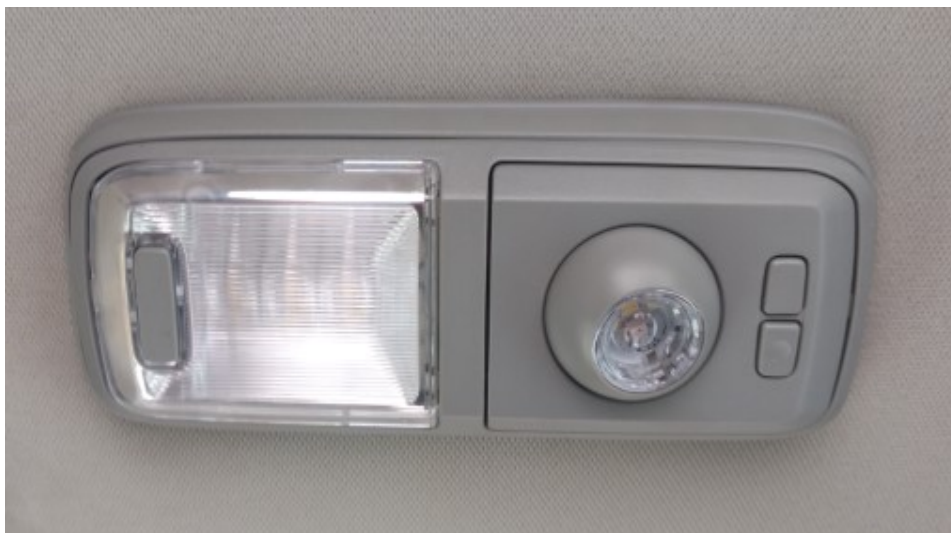
5. Reattach the wiring harness to the light and snap the light into the bezel. The completed assembly should look like the example below.
