Volvo Chassis - Model VN - Water Intrusion In Back Of Cab, Back Wall Of Bunk Leaking

In some Volvo VN models wet floors and water behind the bunk and cabinets have been reported.

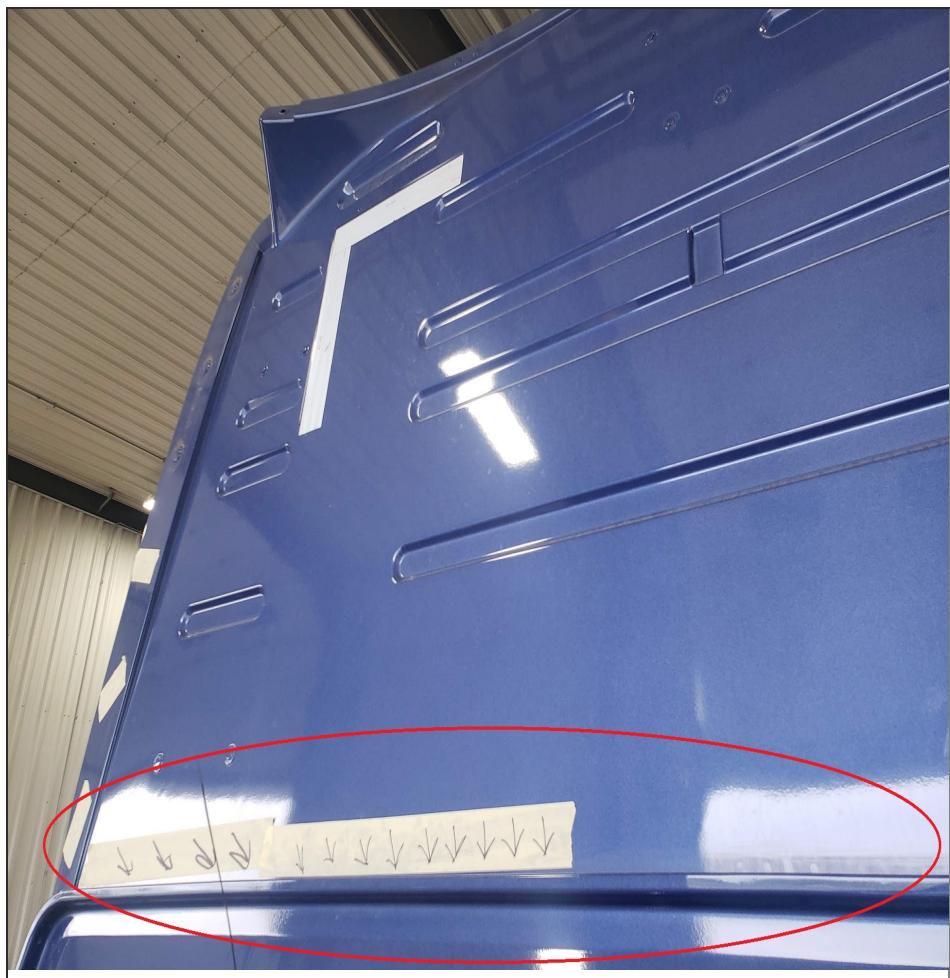
Affected models will have water intrusion in the back of cab area seen in the illustration below.
