## Technical product information

<b>Topic</b>	Service info: body/equipment: front exterior lighting steamed up/leaks
<b>Market area</b>	Bentley: worldwide (2WBE),Hongkong-Macau (5HK)
<b>Brand</b>	Bentley
<b>Transaction No.</b>	2050542/5
<b>Level</b>	EH
<b>Status</b>	Approval
<b>Release date</b>

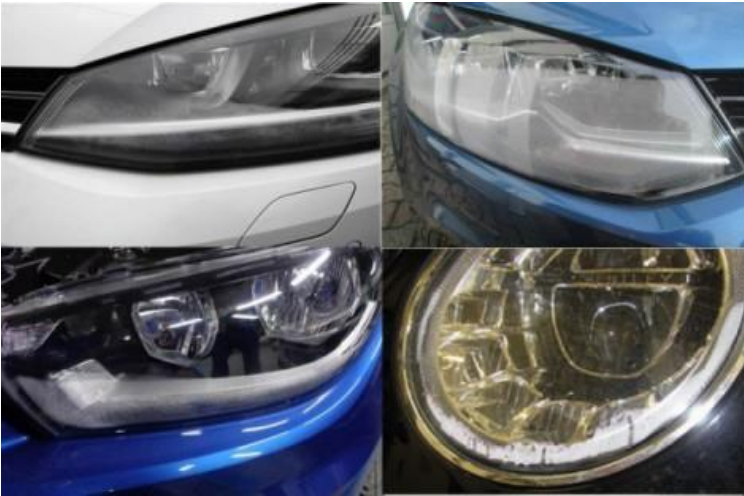
Illustration 1a (example for headlights)

1. The lenses of the headlights (illustration 1a) / front fog lamps (illustration 1b) are steamed up/damp from the inside with minor drips.

Customer statement for 1 (illustration 1a/1b): The lenses of the headlights/front fog lamps are steamed up/damp from the inside with minor drips.

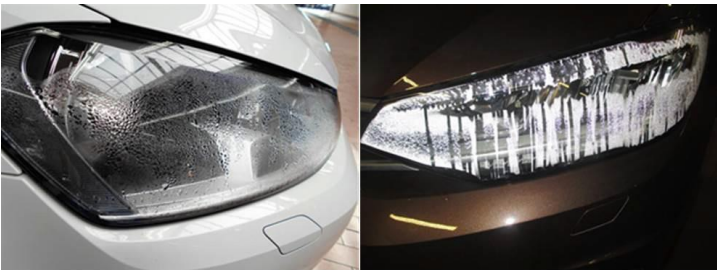
Illustration 2a (example for headlights)

2. Water is in the headlight (illustration 2a) / front fog lamp (illustration 2b), big drips.

Customer statement for 2 (illustration 2a/2b): Water is in the headlights/fog lamps, big drips on the complete lens. Leak on the headlights/front fog lamp.

1. Damp air settles on the inner lens of the headlights/fog lamps, with recognisable misting in certain weather conditions (comparable with the steaming up of spectacle lenses when entering a warm room in winter or of the bathroom mirror after a shower).
2. Leak on the headlights/front fog lamps. For example through open covers, a damaged seal of the cap or similar.

2. In case of an obvious water ingress/leak (a lot of drips on the inside of the lens, illustration 2) check first the cover and the seals on the headlight/front fog lamp. In case of water ingress (damaged seal, lens and so on) perform the appropriate repairs according to the repair manual/parts catalogue.

Ask the customer to keep an eye on the situation. If despite the above repair the customer complains again about leaking headlights/front fog lamps and water ingress or lots of drips can still be recognised after the checks, replace the headlights/front fog lamps according to the repair manual/parts catalogue.

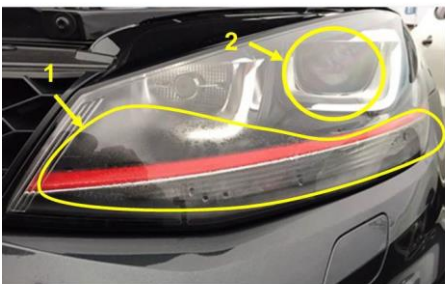
Illustration 3

1. In case of a headlight complaint the light emission surface on the lens (illustration 3, point 2) must be clear after a journey of 5-10 minutes with sufficient ventilation (for example country road/motorway) and switched-on dipped beam. It is no problem if the remaining surfaces of the inner lens (illustration 3, point 1) are steamed-up after a journey. But the time for the clearing process depends on the outside temperature, the vehicle speed (at higher speeds the ventilation of the headlights is better) and the relative air humidity.

The above situation is shown in illustration 3:

1 = steaming-up in the headlight

2 = light emission surface

In this case use the argumentation aid (physical situation) under Customer information. In this case a replacement of the headlights would not fix the problem and lead to a repeat repair.

If the headlights/front fog lamps are steamed up, the light emission surface on the lens (illustration 3, point 2) must be clear after a journey of 5-10 minutes with sufficient ventilation (for example country road/motorway) and switched-on dipped beam. It is no problem if the remaining surfaces of the inner lens are steamed-up after a journey.
