Technical product information

Topic	Rotating Display - Fault Diagnosis
Market area	Bentley: worldwide (2WBE),Hongkong-Macau (5HK)
Brand	Bentley
Transaction No.	2055580/6
Level	EH
Status	Approval
Release date

New Continental GT

Various rotating display operational complaints or noises.

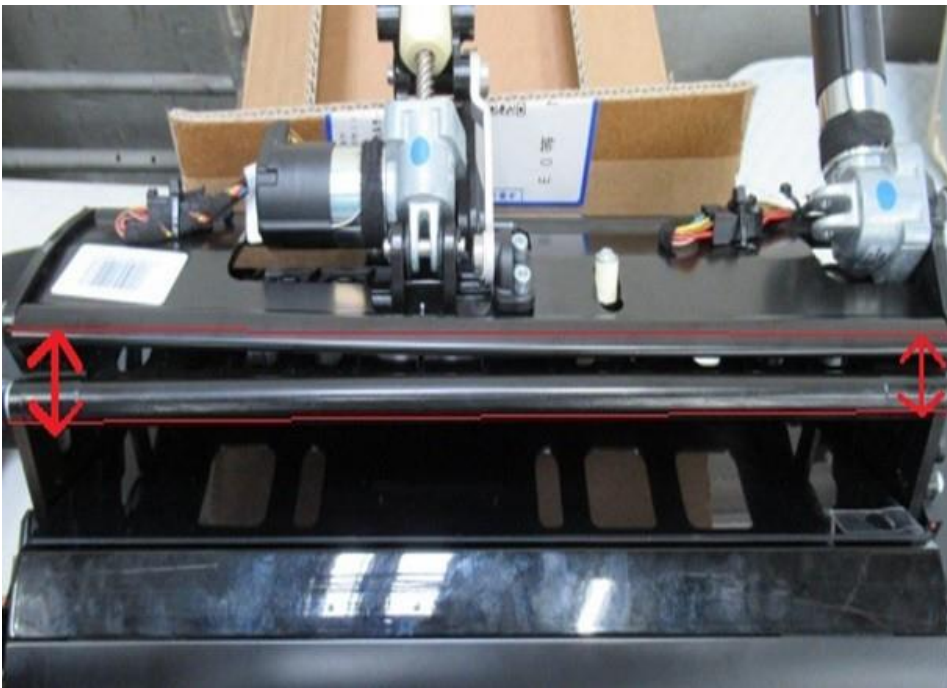
Figure 4

Check the alignment of inner to outer mechanism as shown (Figure 4).

If the mechanism is out of alignment raise a DISS technical query with photos attached, do not follow any more steps at this point.

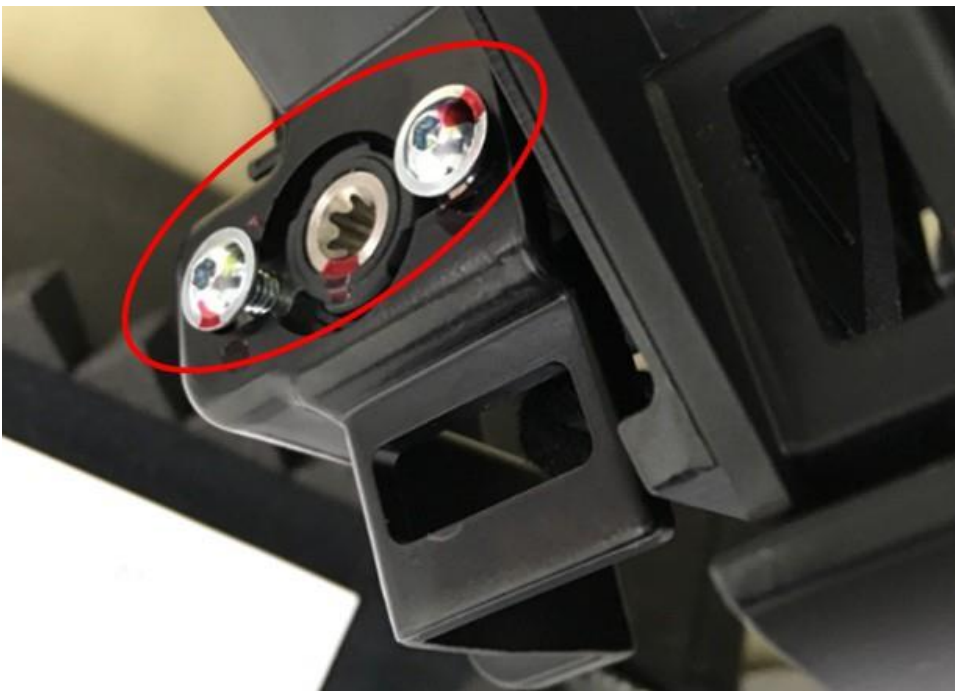
Figure 5

Check the tightness of the fixing screws highlighted (Figure 5), there are 8 fixing screws in total. Check and retighten where necessary (3 Nm).

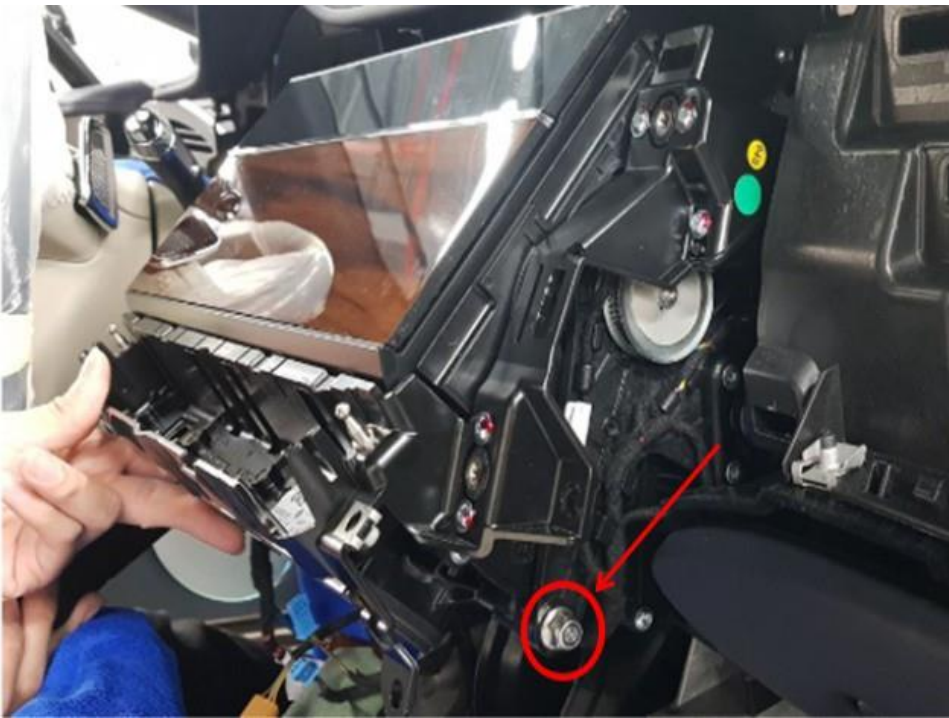
6

Check the tightness of the fixing nut highlighted (Figure 6), there is one nut on each side of the assembly. Check and retighten where necessary (5 Nm).

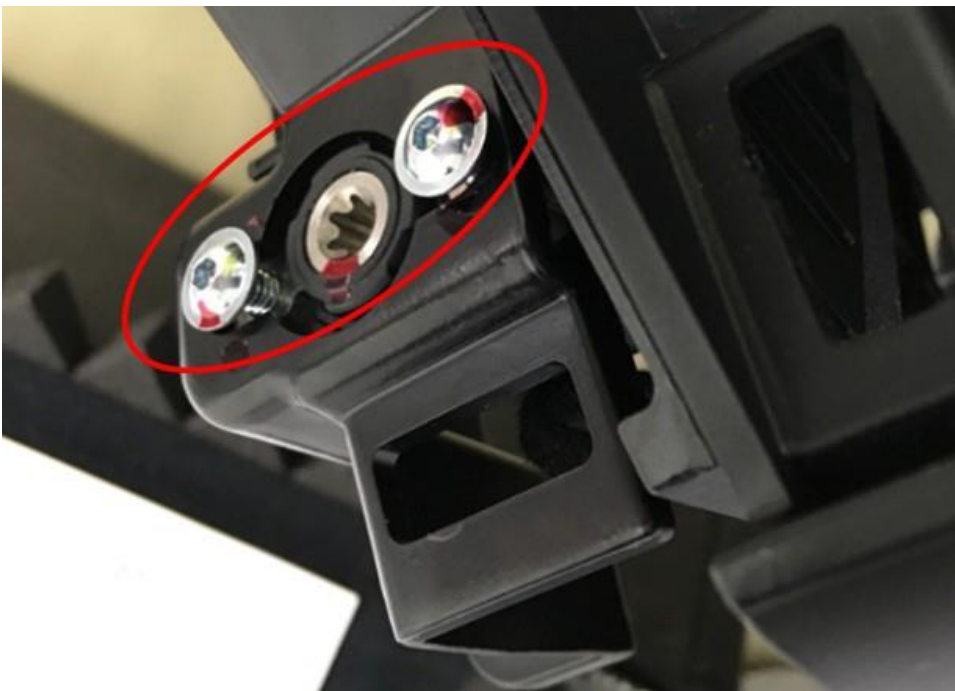
Figure 9

1. Remove rotating display then check and if necessary tighten fixing screws highlighted (Figure 9), there are 8 fixing screws in total. Check and retighten where necessary (3Nm).

2. Refit the rotating display to a state that it can be tested then carry out re-initialisation and retest.

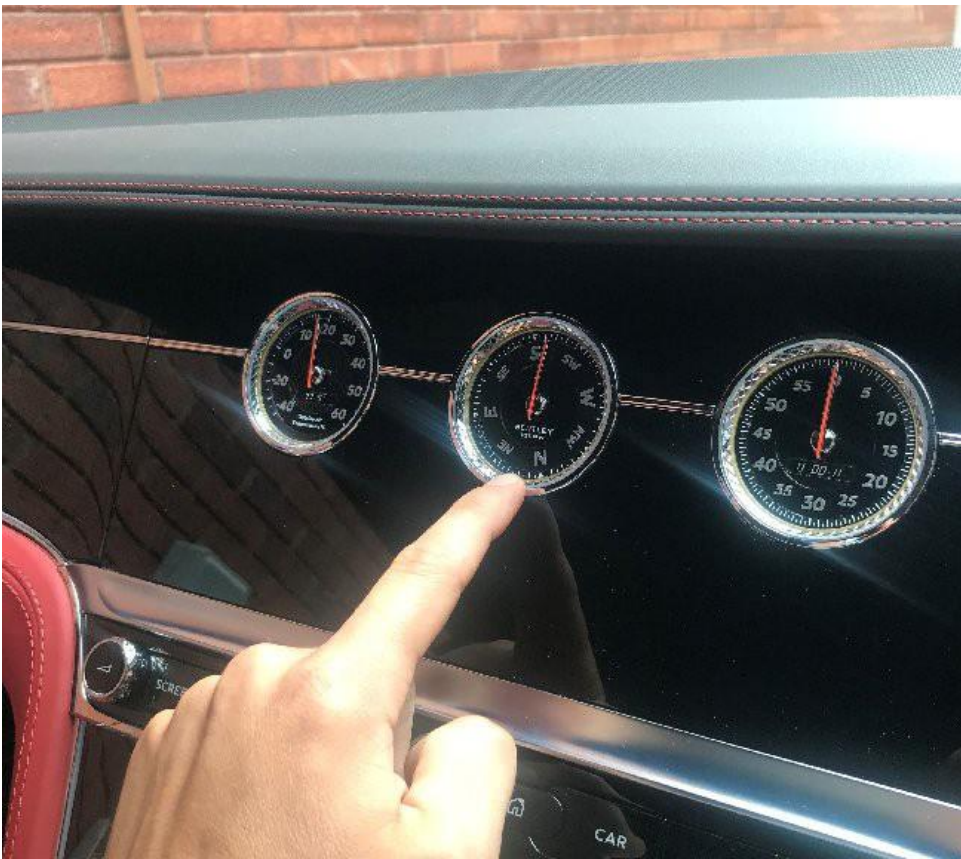
Figure 10

When noise is evident, press on outer bezels (Figure 10). If the noise disappears when the bezels of the dials are pressed then replace the dials.

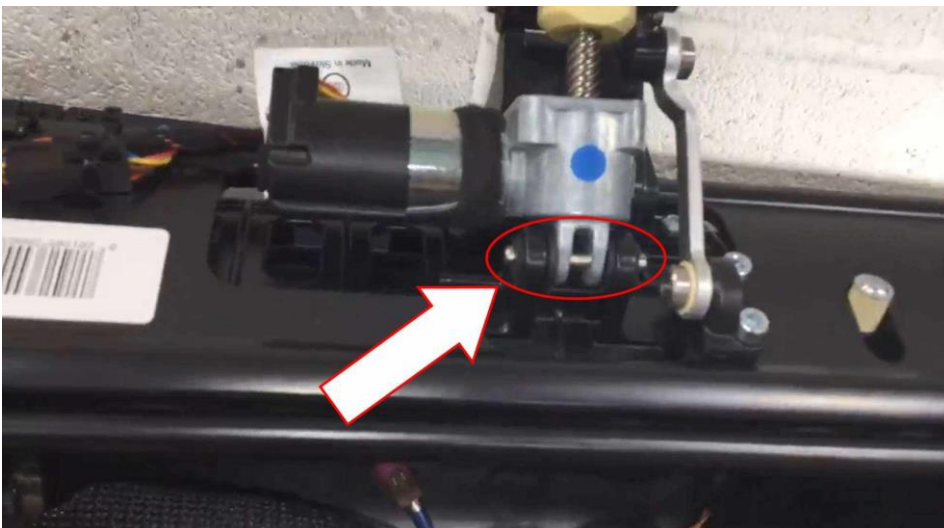
Figure 11

TIP: This symptom can in some cases be evident due to excessive movement within the rotating display motor pivot assembly (Figure 11)

- The operative should consider the motor pivot assembly

NOTE: To check the motor pivot assembly for excessive movement the rotating display clocks and dials should be removed – Refer to Rep. Gr 91
 IMPORTANT: Permission MUST be received via the open or new DISS query before removing the unit

- Refer to the Bentley Hub and refer to the video referencing TPI 2055580/-
- Should the movement be as shown in the video, the rotating display unit should be replaced
