## Technical product information

<b>Topic</b>	Seat belt buckle stop button - Missing
<b>Market area</b>	Bentley: worldwide (2WBE)
<b>Brand</b>	Bentley
<b>Transaction No.</b>	2058411/4
<b>Level</b>	EH
<b>Status</b>	Approval
<b>Release date</b>

### Bentayga - New Continental GT and GTC - New Flying Spur

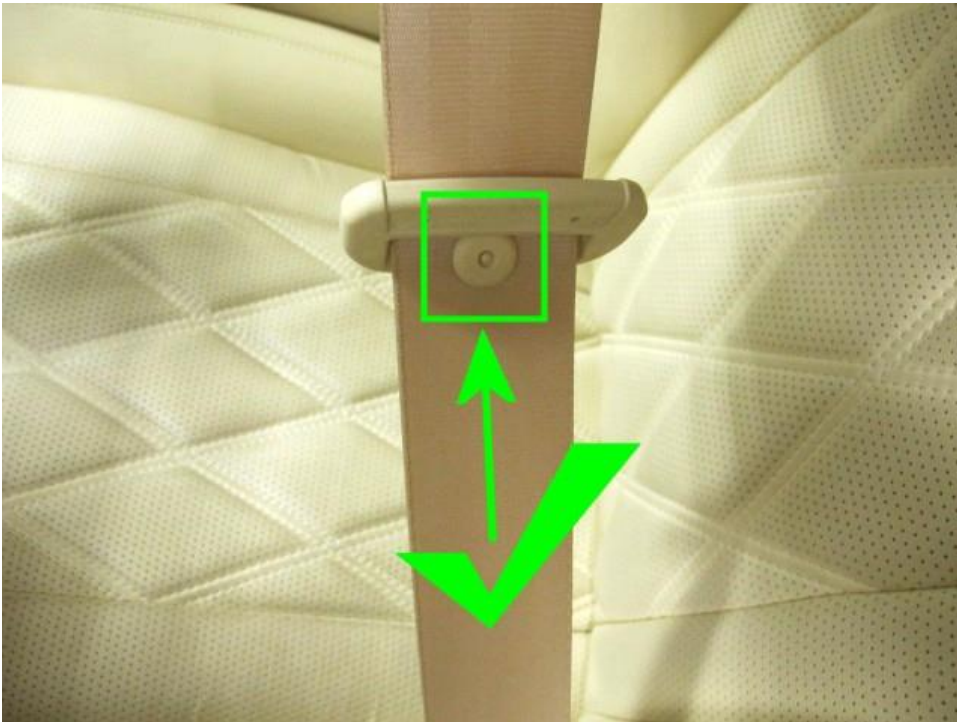
The seat belt buckle stop button should be evident as shown in Figure 1
