Technical product information

Topic	Air spring fault finding
Market area	Bentley; worldwide (2WBE)
Brand	Bentley
Transaction No.	2053492/7
Level	EH
Status	Approval
Release date

The front and/or rear suspension appears to have dropped.

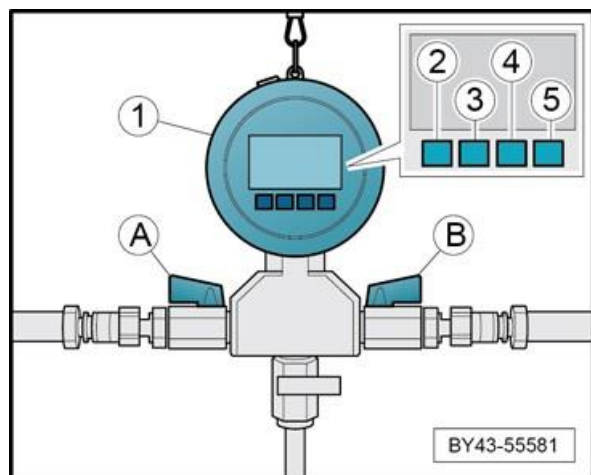
These checks should be carried out in conjunction with the Elsapro procedure "Air suspension – To check" with the use of the special tool "Air suspension leak tester VAS 751 001" shown in the image below as item (1). Refer to Elsapro, Repair Group 43, "Air suspension – To check".

The "Air suspension leak tester VAS751 001" is used to check the air spring struts, solenoid valve block, accumulators, compressors, air reservoirs and air pipes for leaks.

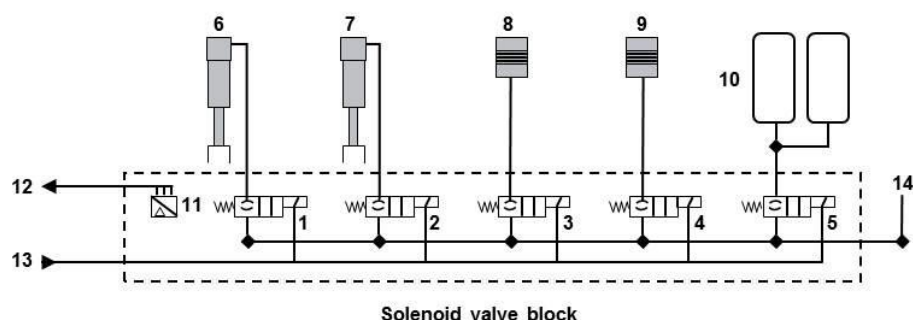
Reference chart

Please use this generic "Reference Chart" in conjunction with the customer description of the fault and the "Standard Ambient Conditions" of the DTC's if present, to focus on the relevant area (ie: if a DTC is pointing out to the accumulator and the event data from the DTC and the customer description explains that the issue appear while the vehicle was driving, then the potential source of the leak well might be in between reservoir, valve unit or compressor as these three components are active in these particular conditions).

Component	Description
1 - 5	Solenoid valves
6 & 7	Front axle suspension struts

8 & 9	Rear axle suspension units
10	Pressure accumulator
11	Pressure sensor
12	Pressure reading
13	Electrical activation of solenoid valves
14	Compressor connection

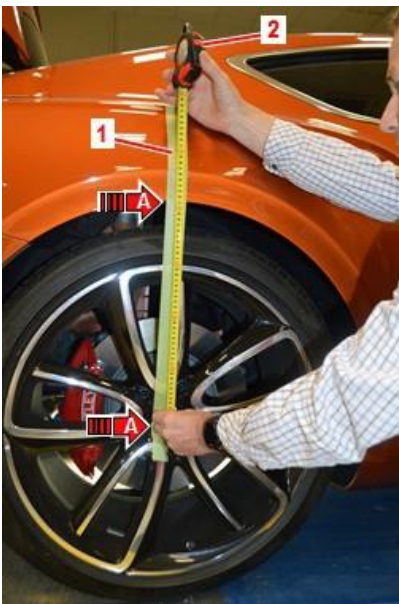
Figure 1

Adhere strips of masking tape (1) from the centre of each wheel to the highest part of the wheel arch as shown, making sure they are applied taut.

Using a tape measure (2), also measure and take note of the ride heights (A-A) at all four corners of the vehicle. See Figure 1.

Leave the vehicle overnight and again measure the ride heights (A-A) at all four corners of the vehicle. Compare these values with those taken previously.

If there is NO difference in ride heights, and the strips of masking tape are still ‘taut’ then no air leak is present. Please explain to the customer the long term storage or changing climate conditions would cause a drop in ride height which is normal. As soon as the vehicle is started, the compressor will level the vehicle automatically. No further action is required.

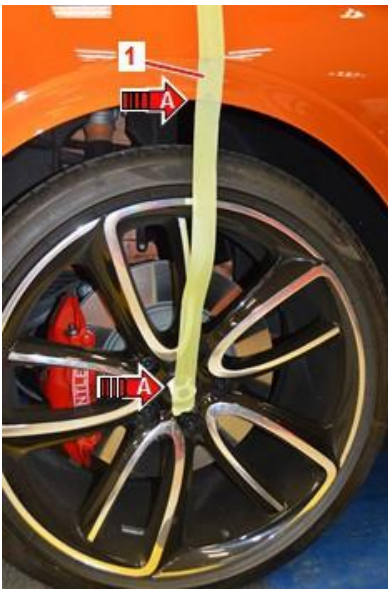
Figure 2

If there is IS a difference in ride heights, and the strips of masking tape (1) have ‘sagged’ (shown in Figure 2), then refer to the following leak finding procedures below.

It should be noted that if these checks involve a claim through warranty then photographic evidence of the vehicle sagging and air leak should be included.

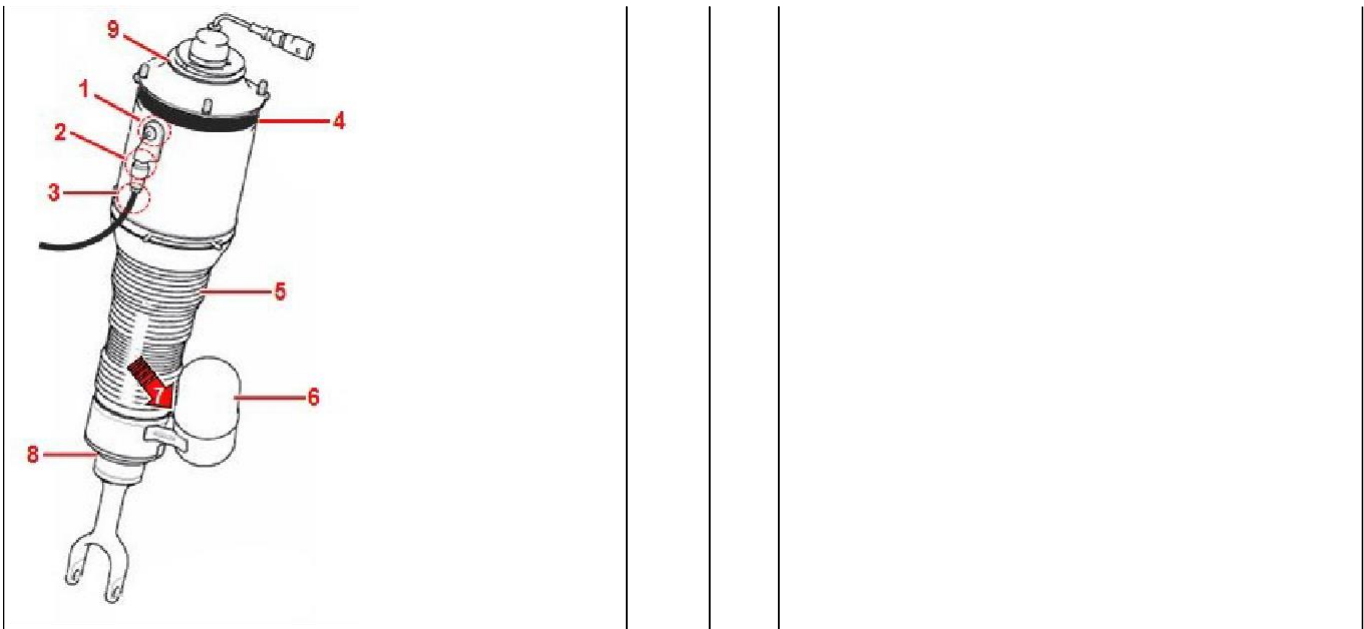
Front air spring check points - Continental series (*pre 2018*) and Flying Spur

Check	Yes	No	Comments
Brass fitting to air spring (1)			
Brass intermediate connection (2)			
Air feed pipe connection (3)			
Top of air spring (4)			
Air spring gaiter condition (5)			
Aircanister and canister to air spring (6 & 7)			
Bottom of the air spring (8)			
Top of the air spring (9). Within engine compartment, pull dust seal back to inspect!

Before any other checks are made to the front air springs check to confirm the pipes are fully inserted and firmly connected within the brass fitting.

With the air suspension fully charged, use leak detector spray or a mild soap solution to check the connections for leaks as shown in the accompanying table.

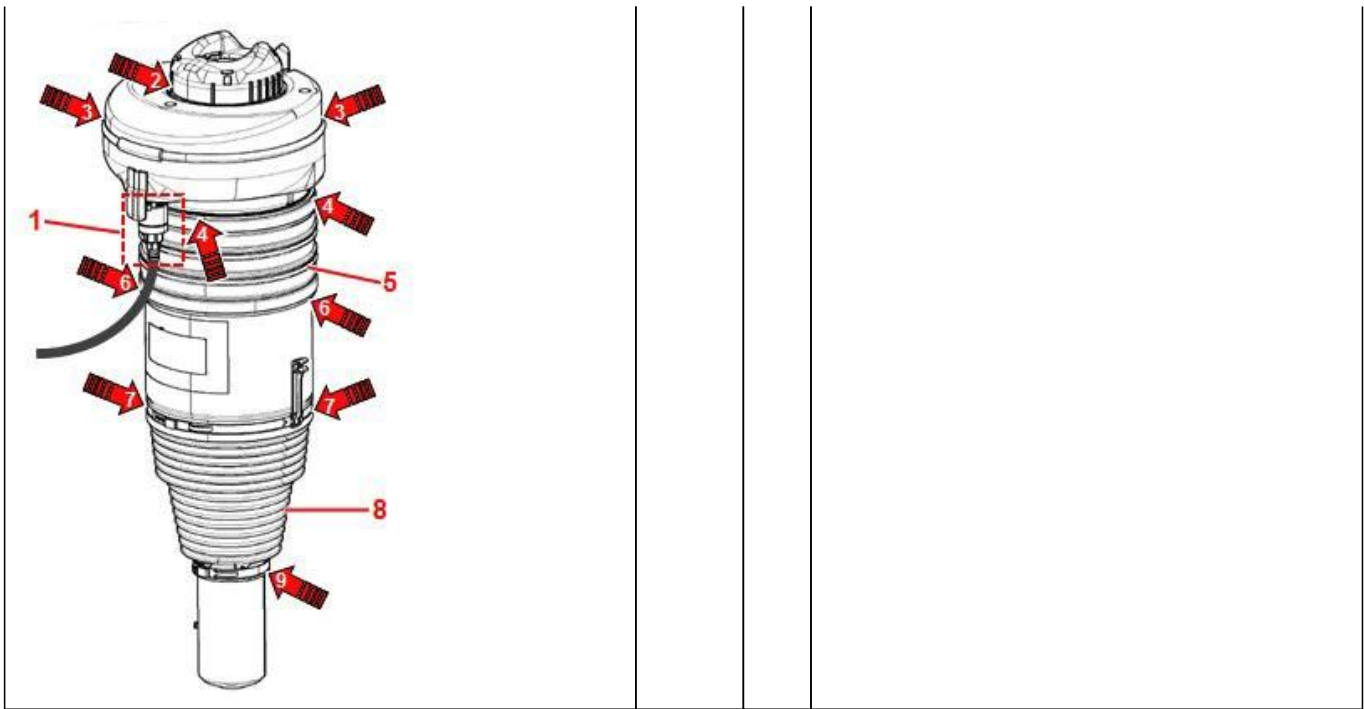
Front air spring check points – Bentayga

Check	Yes	No	Comments
Air connection to air spring (1) Top of air spring (2 & 3) Upper areas of air spring gaiter (4 & 6) Air spring upper gaiter condition (5) Lower areas of air spring gaiter (7 & 9) Air spring upper gaiter condition (8)

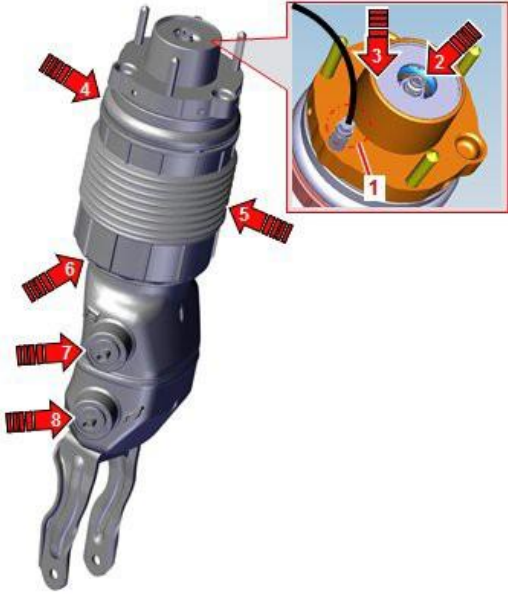
Front air spring check points – New Continental GT

Check	Yes	No	Comments
Air connection to air spring (1) Sealing area of top nut (2) Top crimp area (3) Top of air spring (4) Air spring gaiter condition (5) Lower areas of air spring gaiter (6) Switching valves, solenoids and welds (7&8)

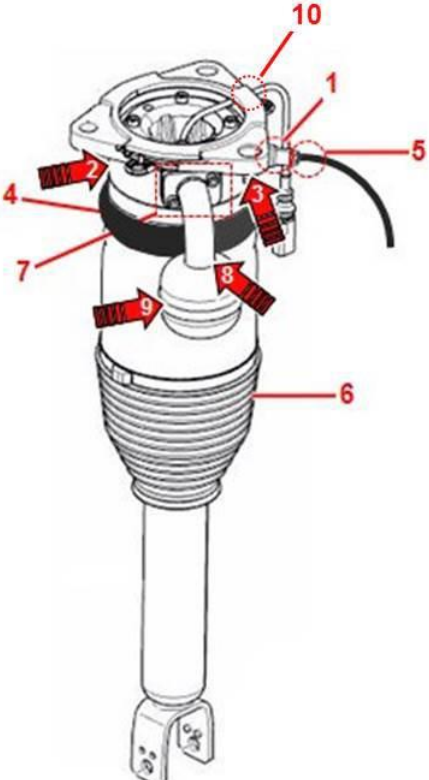
Rear air spring check points - Continental series (pre 2018) and Flying Spur

Check	Yes	No	Comments
Brass fitting to air spring (1) Top of air spring (2 & 3) Air spring bellows (4) Air feed pipe connection (5) Air spring gaiter condition (6) Air canister and canister to air spring (7, 8 & 9) Electrical cable route for air escaping (10)

Before any other checks are made to the rear air springs check to confirm the pipes are fully inserted and firmly connected within the brass fitting.

With the air suspension fully charged, use leak detector spray or a mild soap solution to check the connections for leaks as shown in the accompanying table.

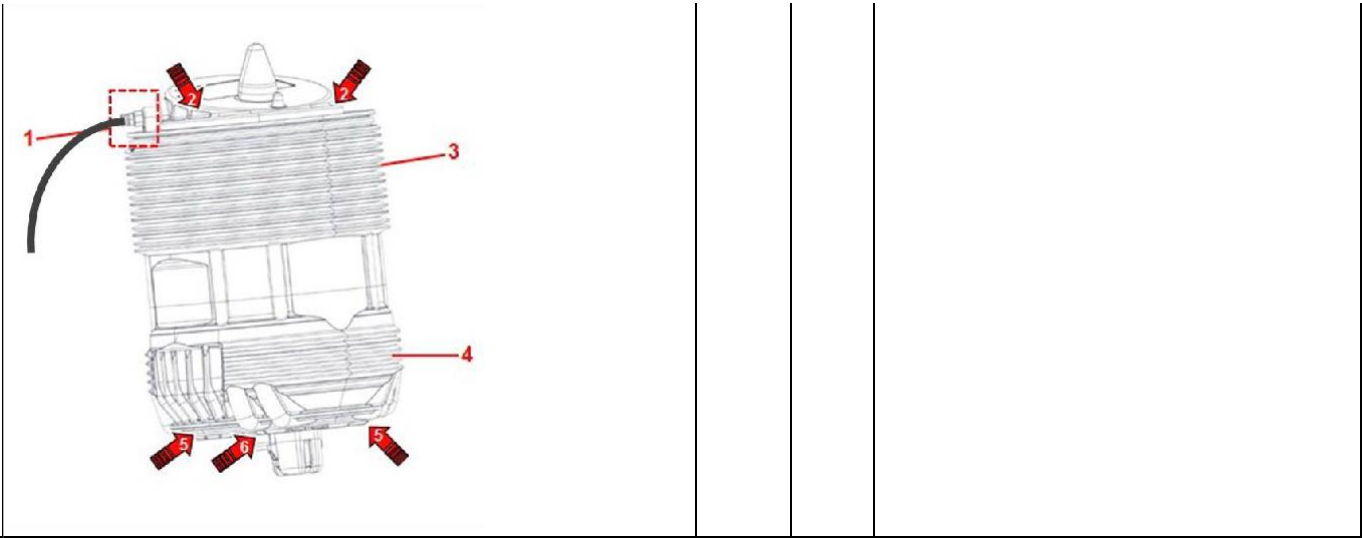
Rear air spring check points – Mulsanne

Check	Yes	No	Comments
Air feed pipe connection (1) Top of air spring (2 & 3) Upper air spring bellows (4 & 5) Lower air spring bellows (6 & 7) Air spring gaiter condition (8 & 9)

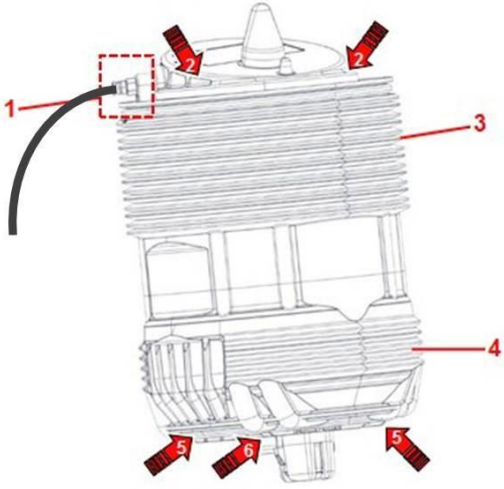
Rear air spring check points – Bentayga

Check	Yes	No	Comments
Air feed pipe connection (1) Top of air spring (2) Air spring gaiter condition (3 & 4) Lower areas of air spring (5 & 6)

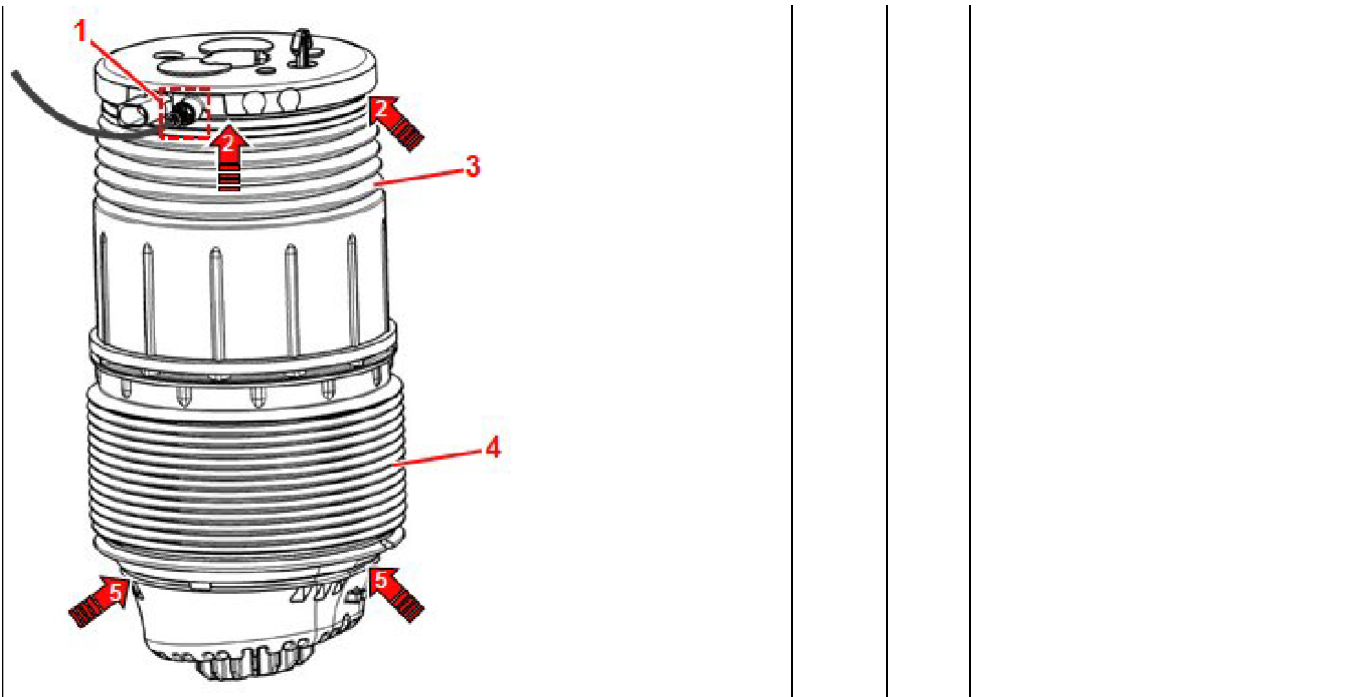
Rear air spring check points – New Continental GT

Check	Yes	No	Comments
Air feed pipe connection (1) Top of air spring (2) Air spring gaiter condition (3 & 4) Lower area of air spring (5)

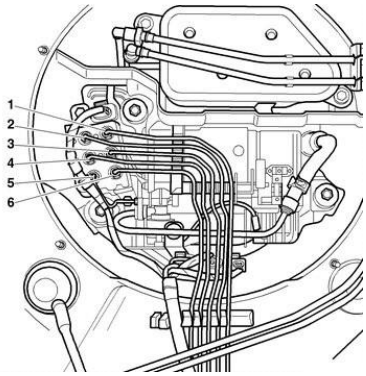
Air supply check points - Continental series (pre 2018) and Flying Spur

Check	Yes	No	Comments
Air pipe connections (1 to 6)

In the event of an air leak from the air pipe/brass fittings on the supply unit the brass fittings and internal olive can be replaced individually.

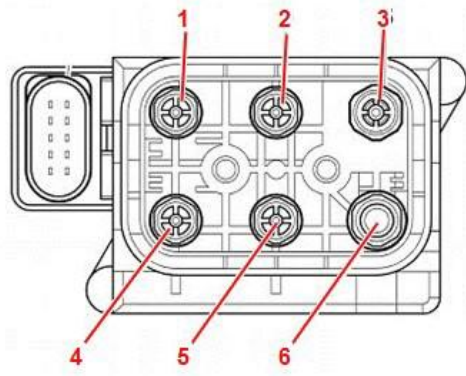
Air supply check points - Mulsanne

Check	Yes	No	Comments
Air pipe connections (1 to 6)

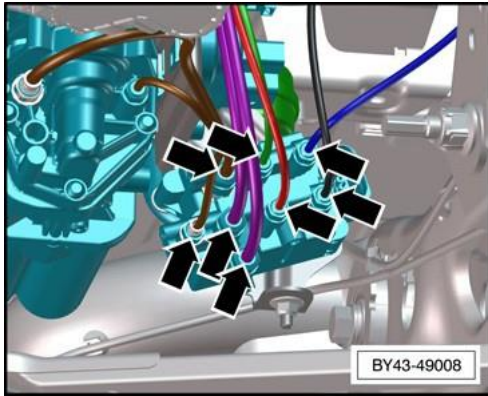
Air supply check points – Bentayga

Air pipe connections (arrows)

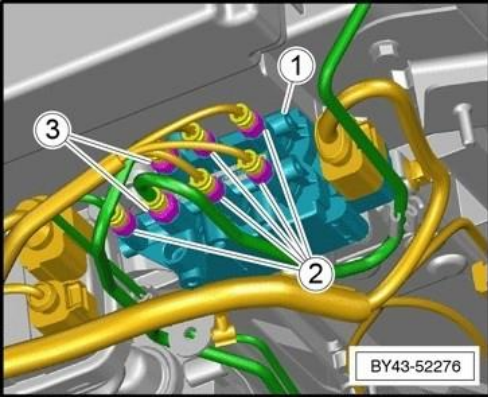
Air supply check points – New Continental GT

Check	Yes	No	Comments
<p>Air pipe connections (2 & 3)</p>

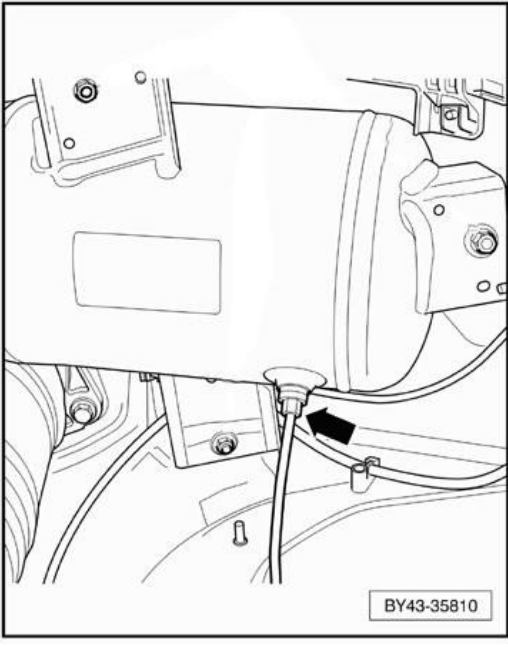
Air supply check points - Continental series (pre 2018) and Flying Spur

Check	Yes	No	Comments
<p>Air pipe connection (arrow)</p> <p>Location - GT & Flying Spur: LH rear wheel arch</p> <p>Location – GTC: Behind backboard trim panel</p>

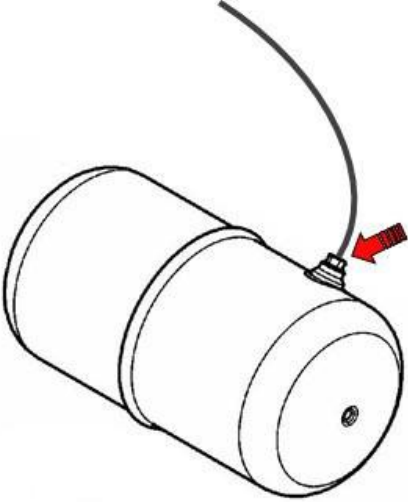
Air supply check points - Mulsanne

Check	Yes	No	Comments
Air pipe connection (arrow) Location – Boot floor

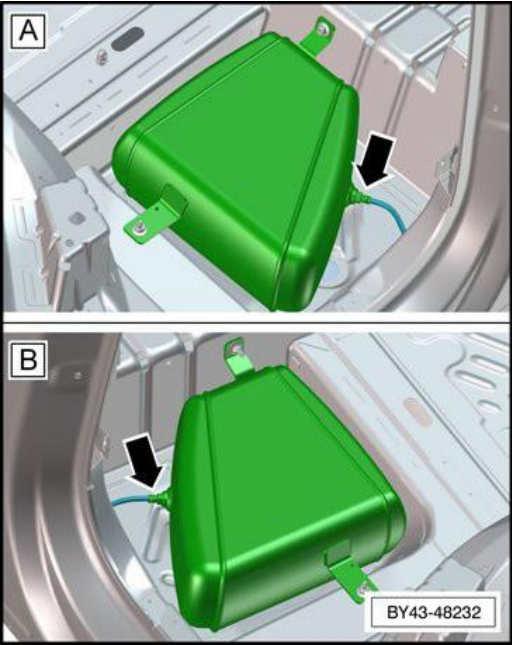
Air supply check points - Bentayga

Check	Yes	No	Comments
Air pipe connections on the twin tanks (arrows) Location – Rear footwells beneath carpets

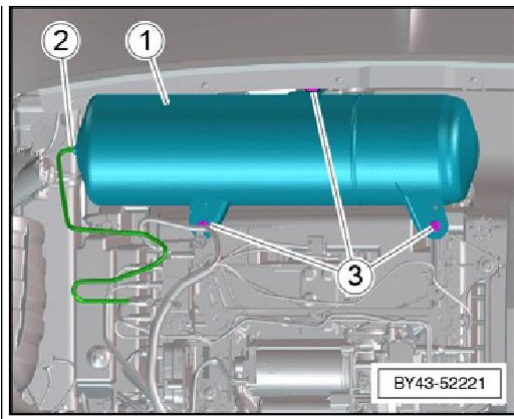
Air supply check points – New Continental GT

Check	Yes	No	Comments
Air pipe connection (2) Location – Underside of boot floor

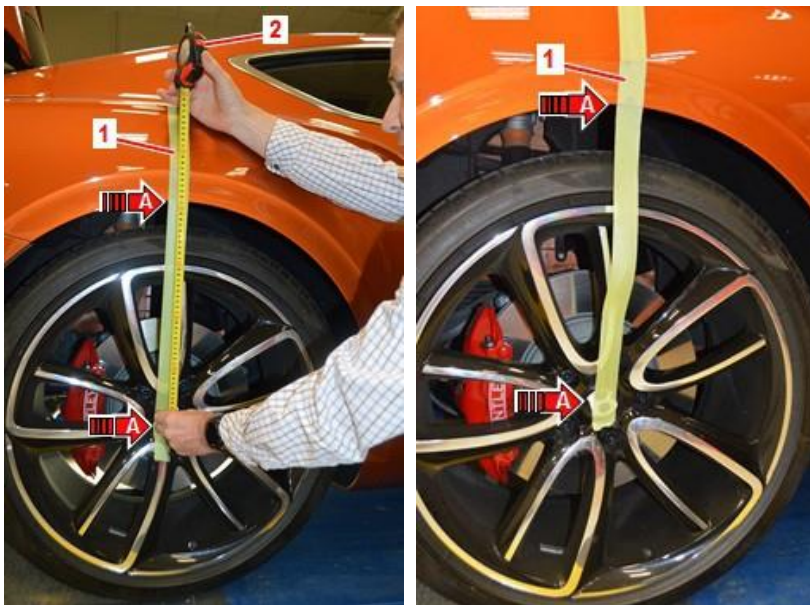
Figure 3

- Tape (1) applied before and after, showing the tape sagging. See Figure 3.
- All ride height measurements (A-A) before and after. See Figure 3.
- Soap solution bubbling at the point of air leak (where possible).

It should be noted that if checks involve a claim through warranty then photographic evidence of the vehicle sagging and air leak should be included with the DISStechical query where possible.
