## CAMPAIGN BULLETIN P8314 Fuel Hose Campaign Quality Review

Reference: PC832

# PC832 – 2016-2018 Q50 AND 2017-2018 Q60 WITH 2.0L TURBO ENGINE; LOW PRESSURE FUEL LINE

## SERVICE PROCEDURE

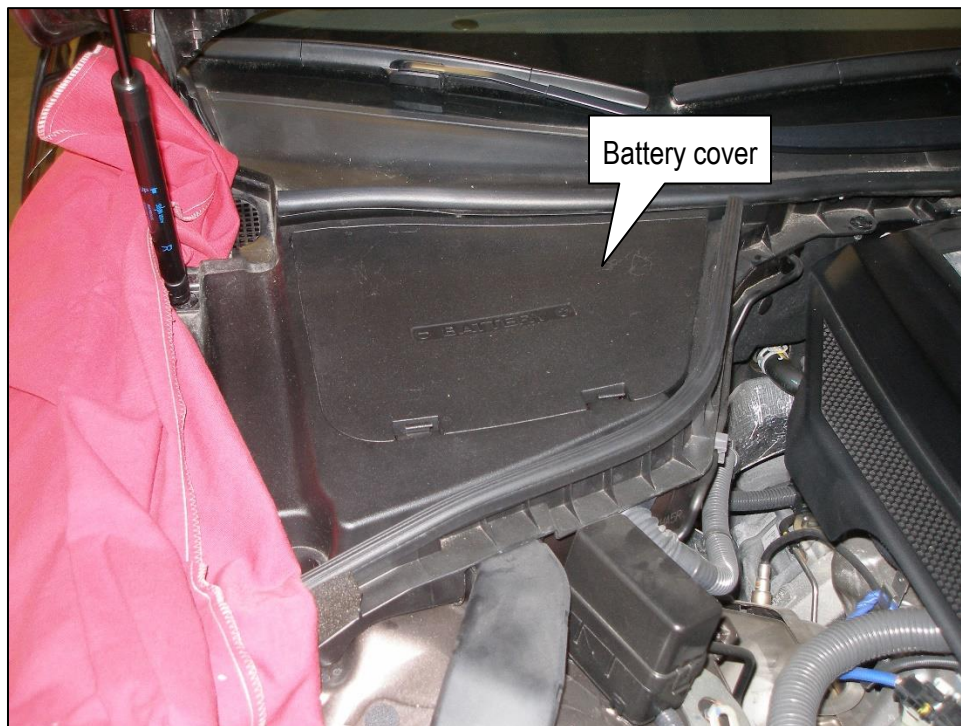
Figure 1

1. Set the vehicle on a lift.
2. Release fuel pressure in the fuel lines:
  - a. Remove the battery cover.

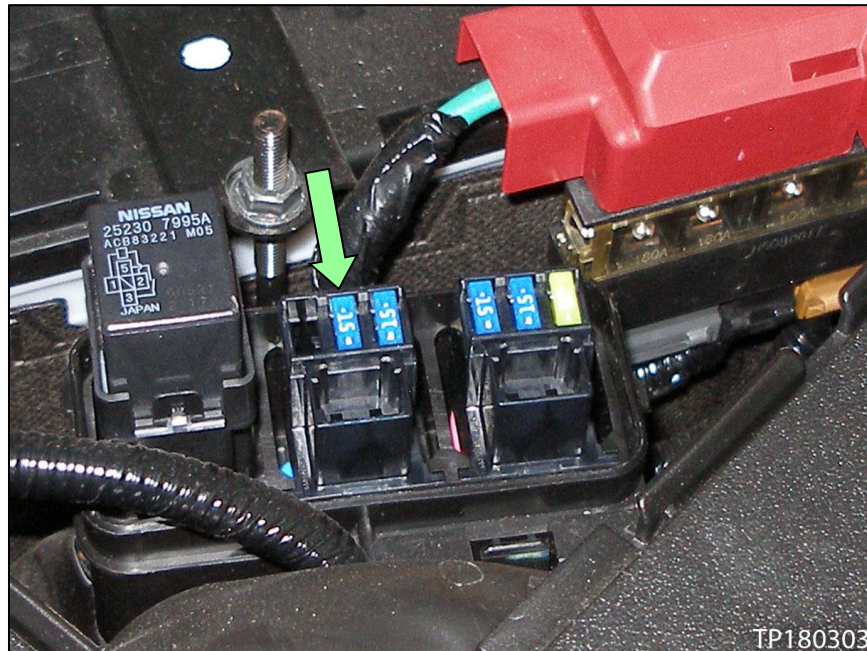
Figure 2

- b. Remove the fuse and fusible link cover, and then remove the 15 amp fuse (for fuel pump) where shown in Figure 2.

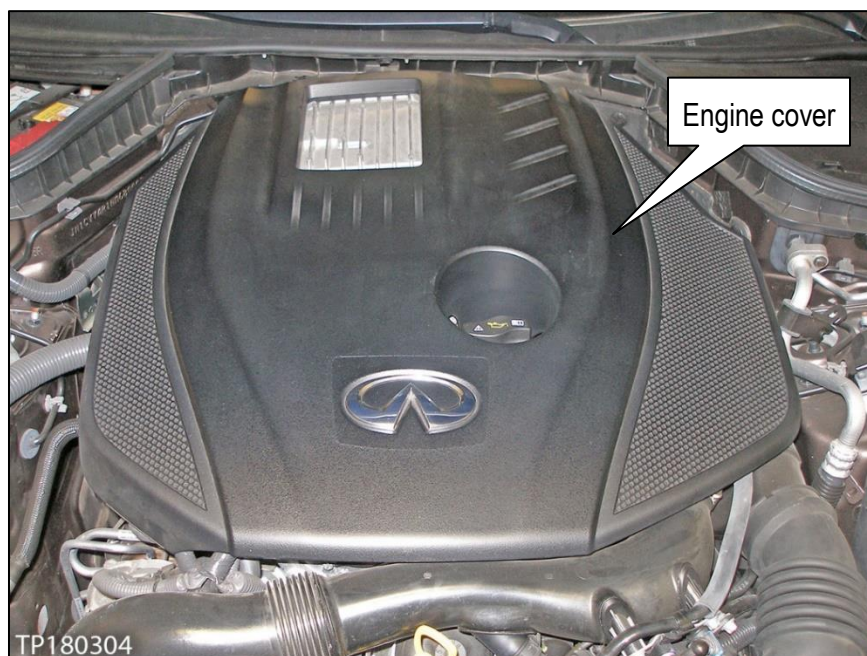
Figure 3

- c. Start the engine, and then let it idle until it stops.  
**NOTE:** Revving the engine a few times will make the engine stop sooner.
  - d. After the engine stops, crank the engine a few times to release all fuel pressure.
  - e. Turn the engine/ignition OFF.
3. Remove the engine cover.
    - The engine cover is held on with rubber insulators. Grab one corner, and then carefully pull off.

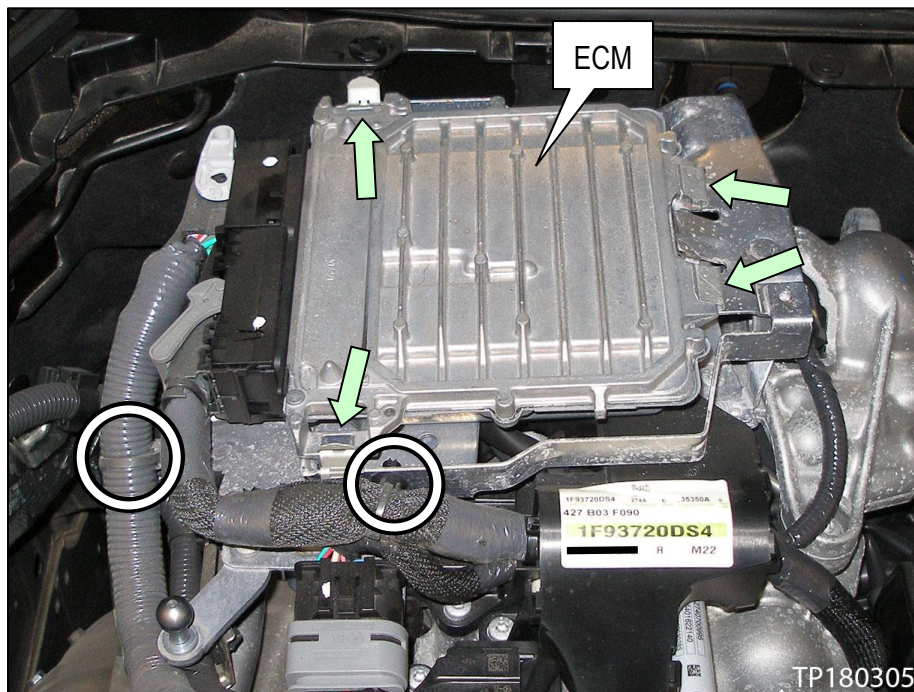
Figure 4

4. Move the ECM to the side:
  - a. Unfasten the two (2) electrical harness clips (see circles in Figure 4).  
**NOTE:** The electrical harness clips will be reused.
  - b. Unfasten the ECM from its four (4) clips (see arrows in Figure 4).
  - c. Carefully lift and move the ECM, still connected, to the passenger side of the engine.

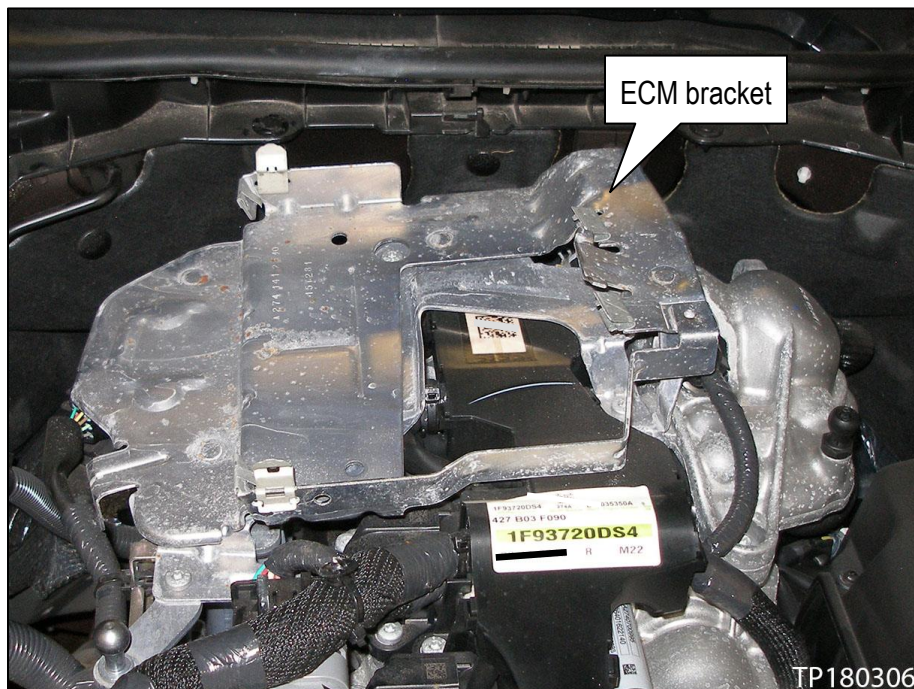
Figure 5

5. Remove the ECM bracket.
  - The ECM bracket is held on with rubber insulators. Grab one corner, and then carefully pull off.

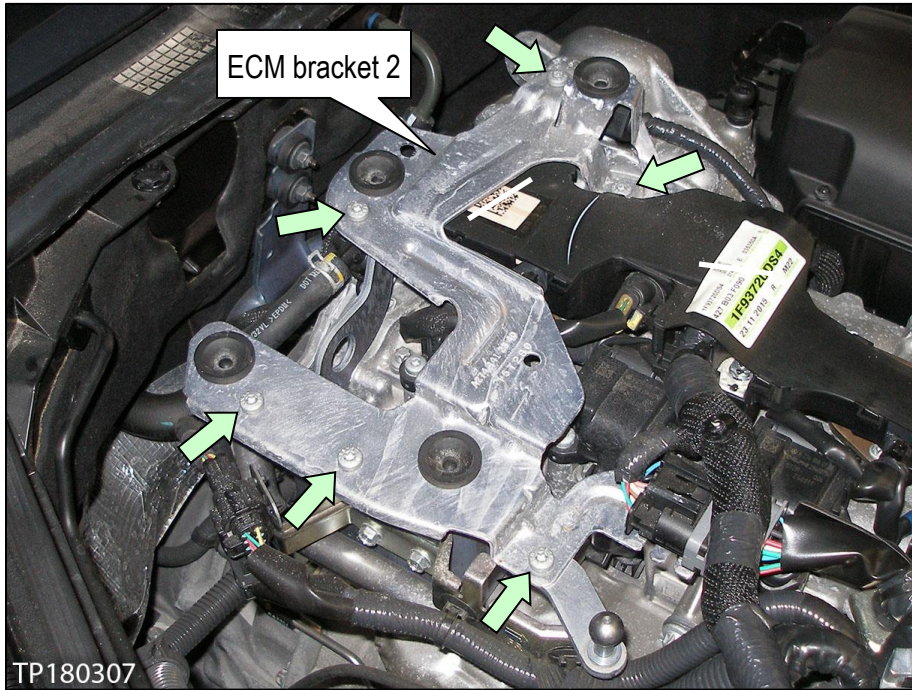
Figure 6

- Remove the six (6) ECM bracket 2 T30 bolts, and then carefully move the ECM bracket 2 partially toward the passenger side of the engine.

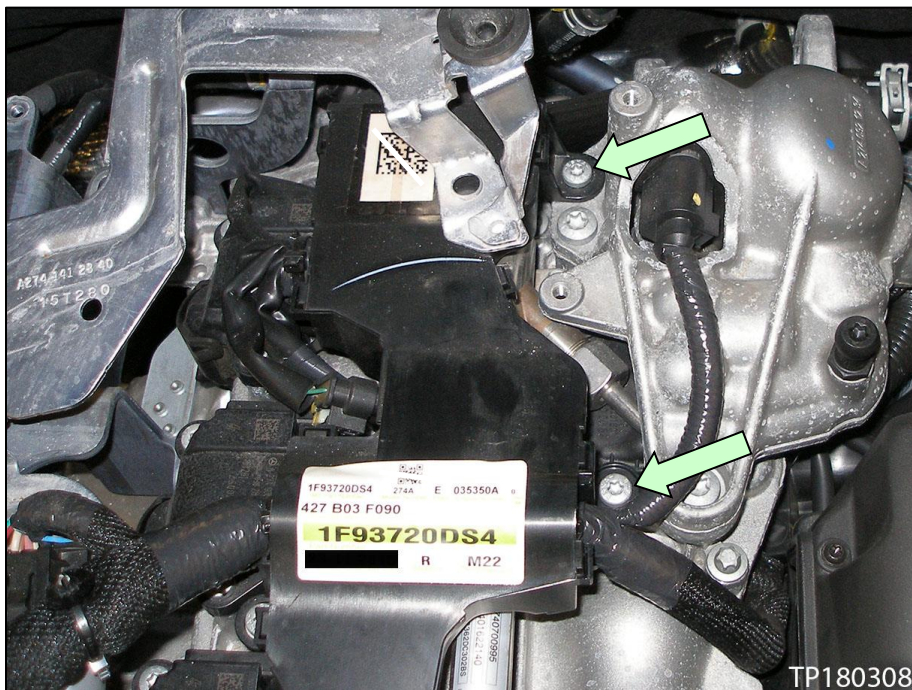
Figure 7

- Remove the two (2) electrical harness protector T30 bolts.

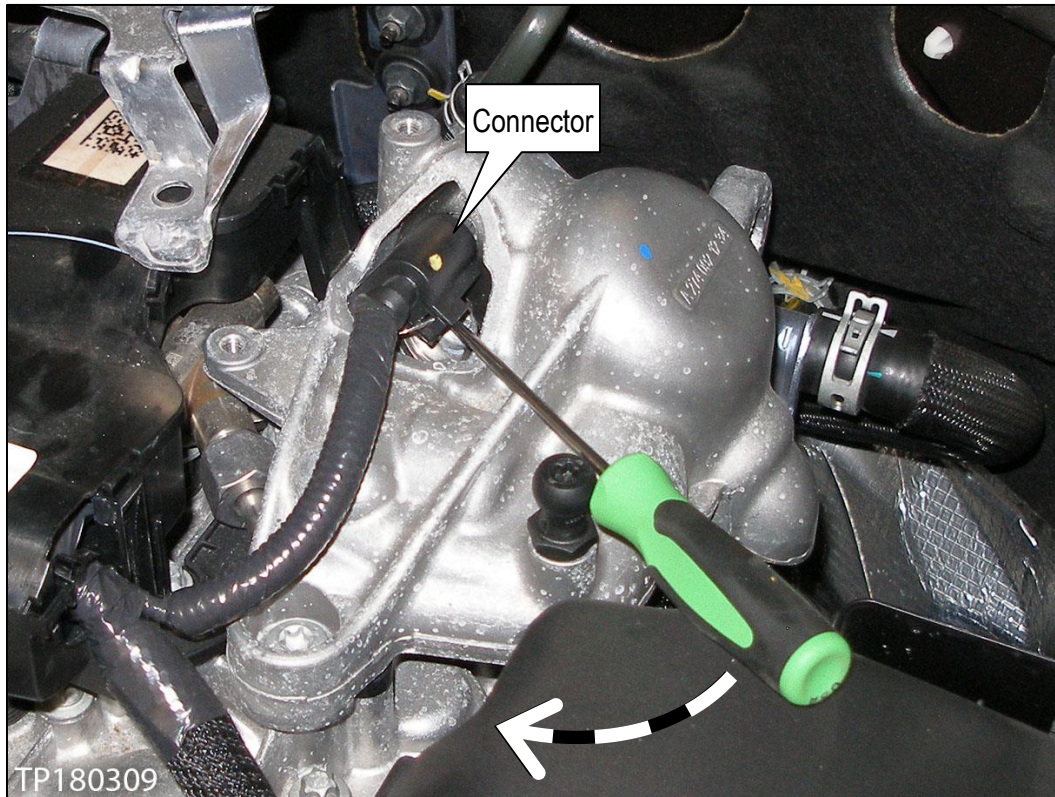
Figure 8

8. Disconnect the high pressure fuel pump electrical connector.
  - Carefully use a pick or similar tool to unlatch the lock, and then pull off the connector.

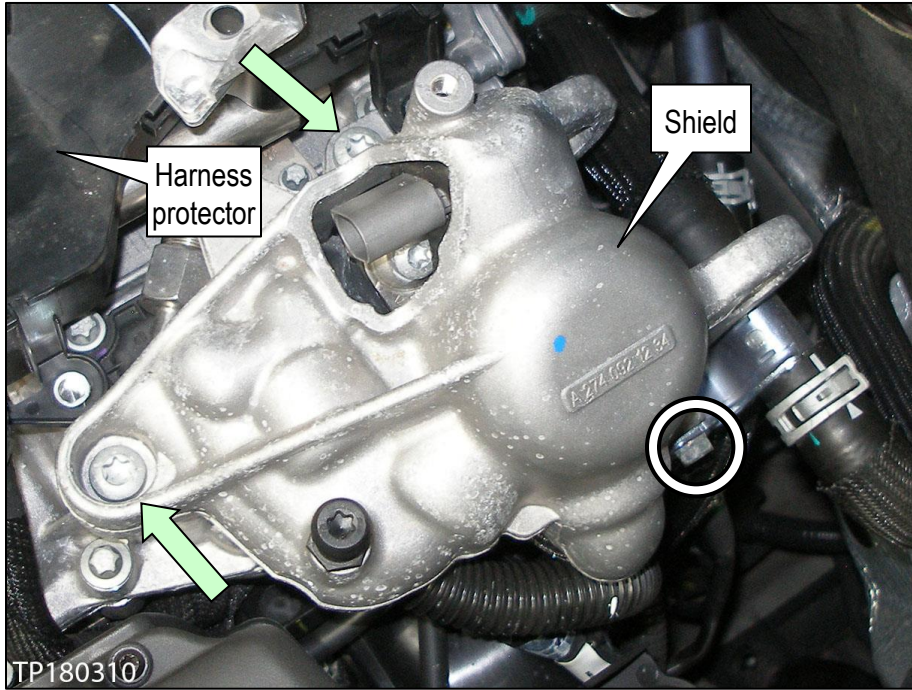
Figure 9

9. Remove the four (4) shield T45 bolts, and 10 mm bolt (see Figures 9 and 10).
- Arrows = T45 bolts, circle = 10 mm bolt.
  - Remove the shield by holding the electrical harness protector toward the passenger side.

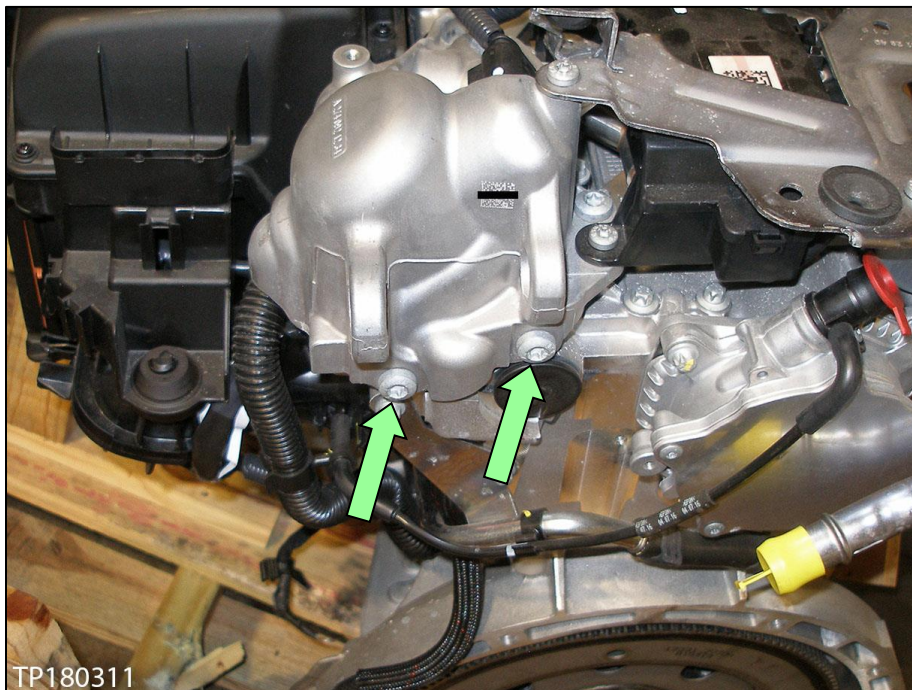
- Two of the T45 bolts are located behind the shield (between the engine and engine wall).
  - Figure 10 shows the engine out of the vehicle. This is for viewing purposes only.

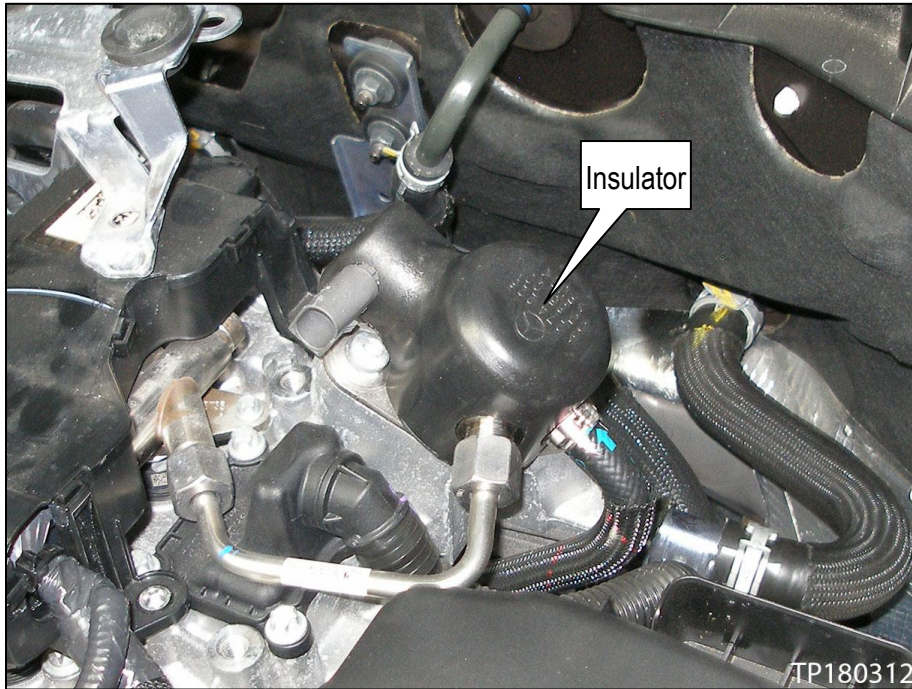
Figure 11

10. Remove the high pressure fuel pump insulator.

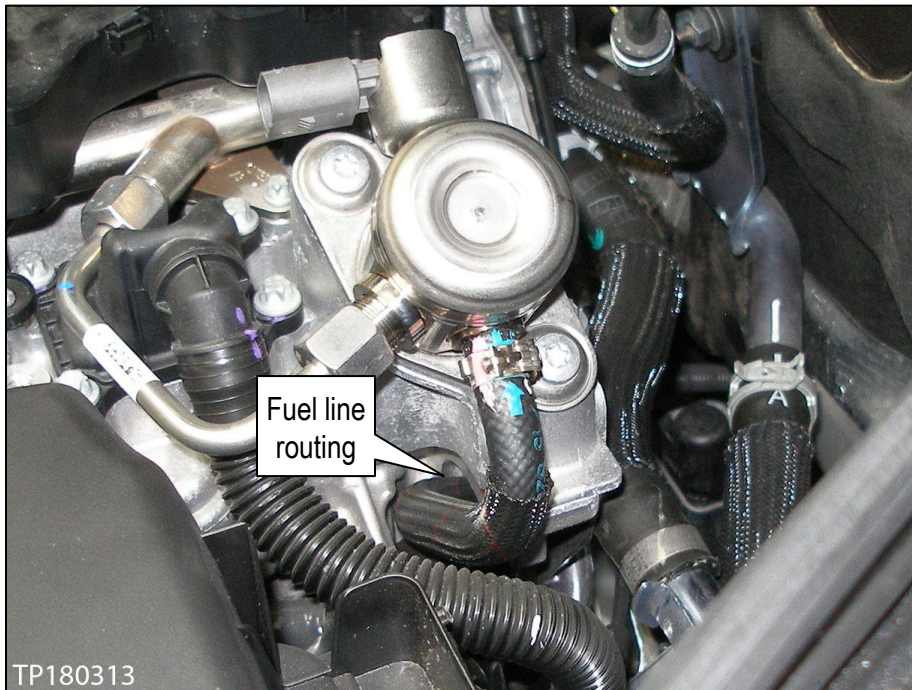
Figure 12

11. At this time, closely observe the routing of the low pressure fuel line from the top side of the vehicle.  
**CAUTION:** It is important to know the correct routing of the low pressure fuel line. A misrouted fuel line may cause it to contact other component parts.

1. Install the new low pressure fuel line with service valve in reverse order of removal.
  - Refer to Figures 12, 15, and 16 to aid in low pressure fuel line routing.

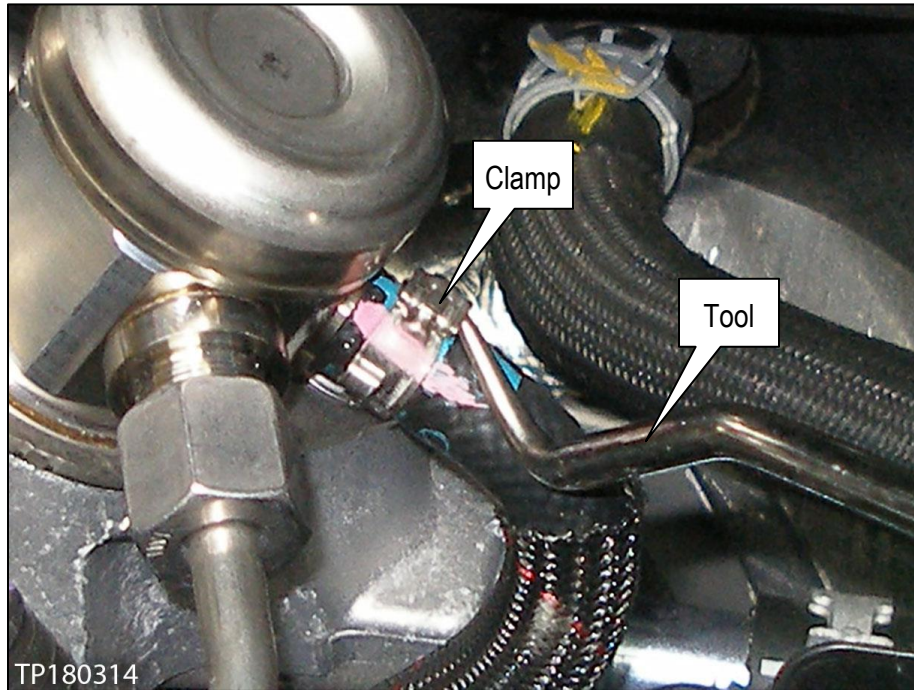
Figure 13

12. Unfasten the low pressure fuel line upper clamp.
  - This is a new style clamp. Go to page 17 for further detail.
  - **Do not disconnect the low pressure fuel line from the high pressure fuel pump at this time.**
  - Place a shop rag under the end of the low pressure fuel line (this is to help catch any residual fuel when disconnecting it).

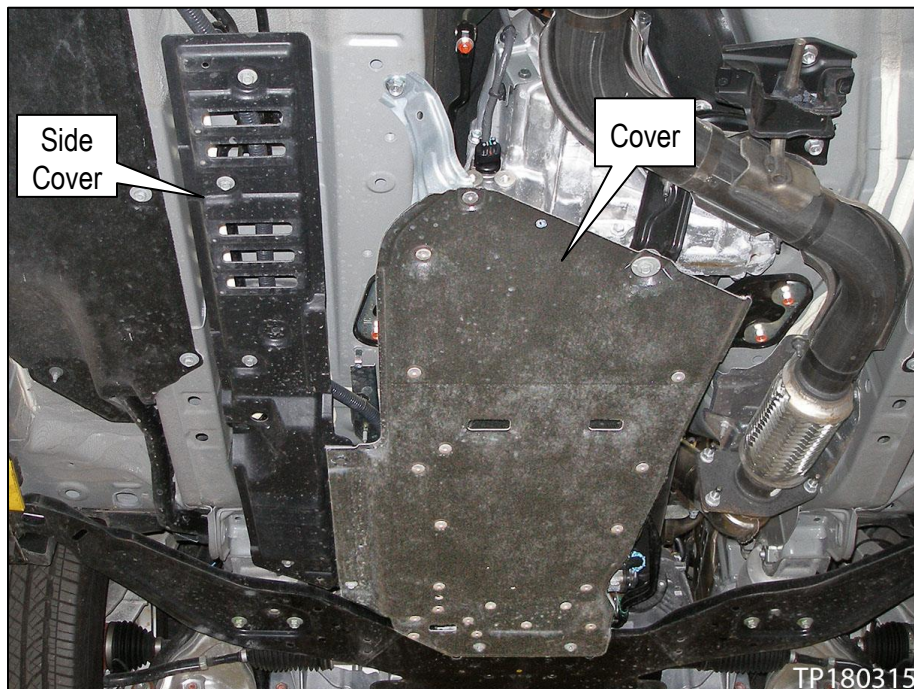
Figure 14

13. Raise the vehicle on a lift, and then remove the floor under cover and the floor under side cover.

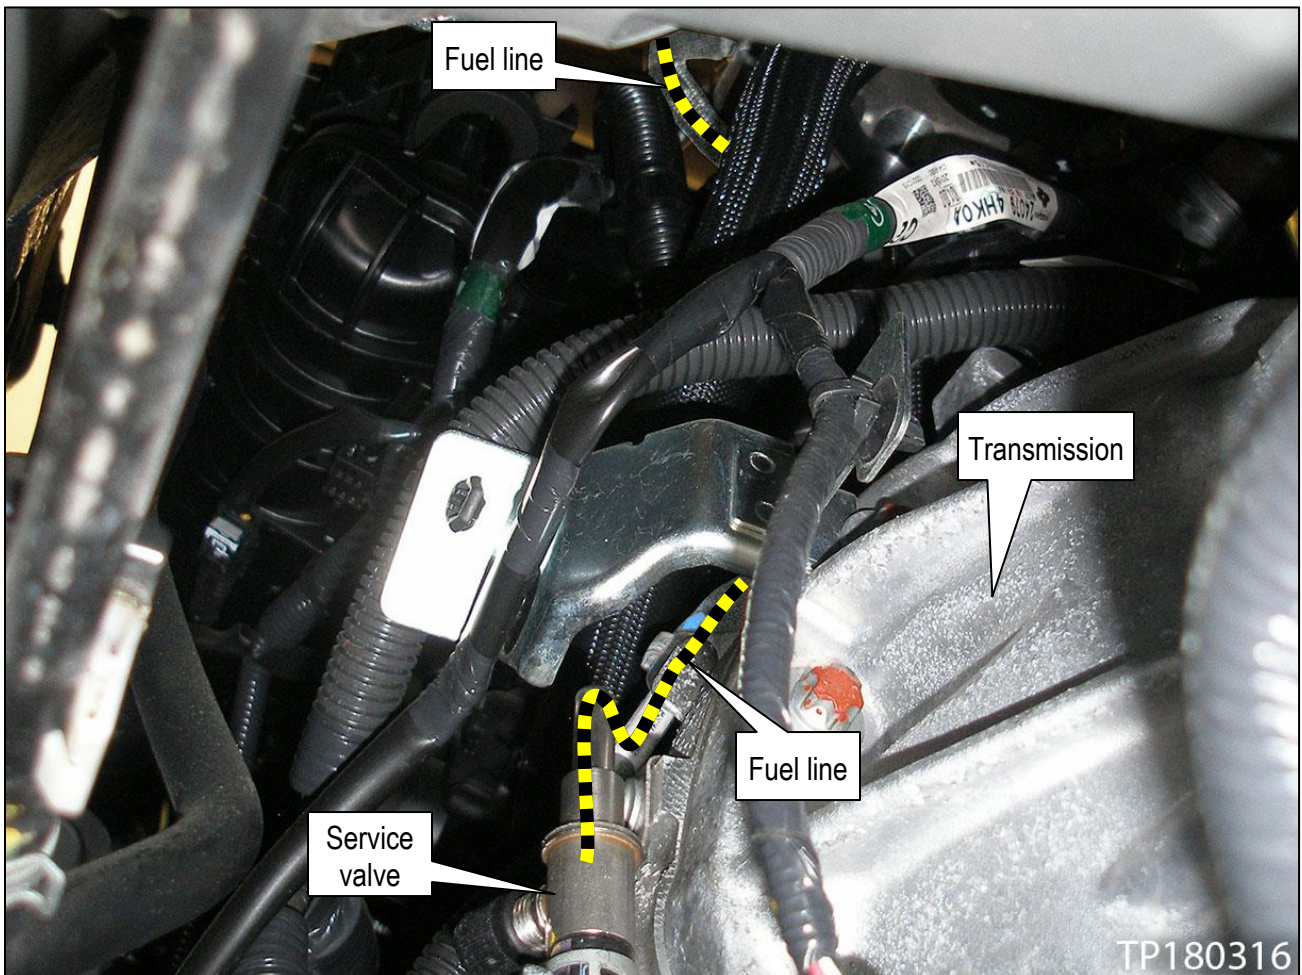
Figure 15

- At this time, closely observe the routing of the low pressure fuel line from underneath the vehicle.

**NOTE:** A bracket and some other parts were removed for better viewing only. These parts do not need to be moved for this procedure. Also refer to Figure 16 on the next page.

**CAUTION:** It is important to know the correct routing of the low pressure fuel line. A misrouted fuel line may cause it to contact other component parts.

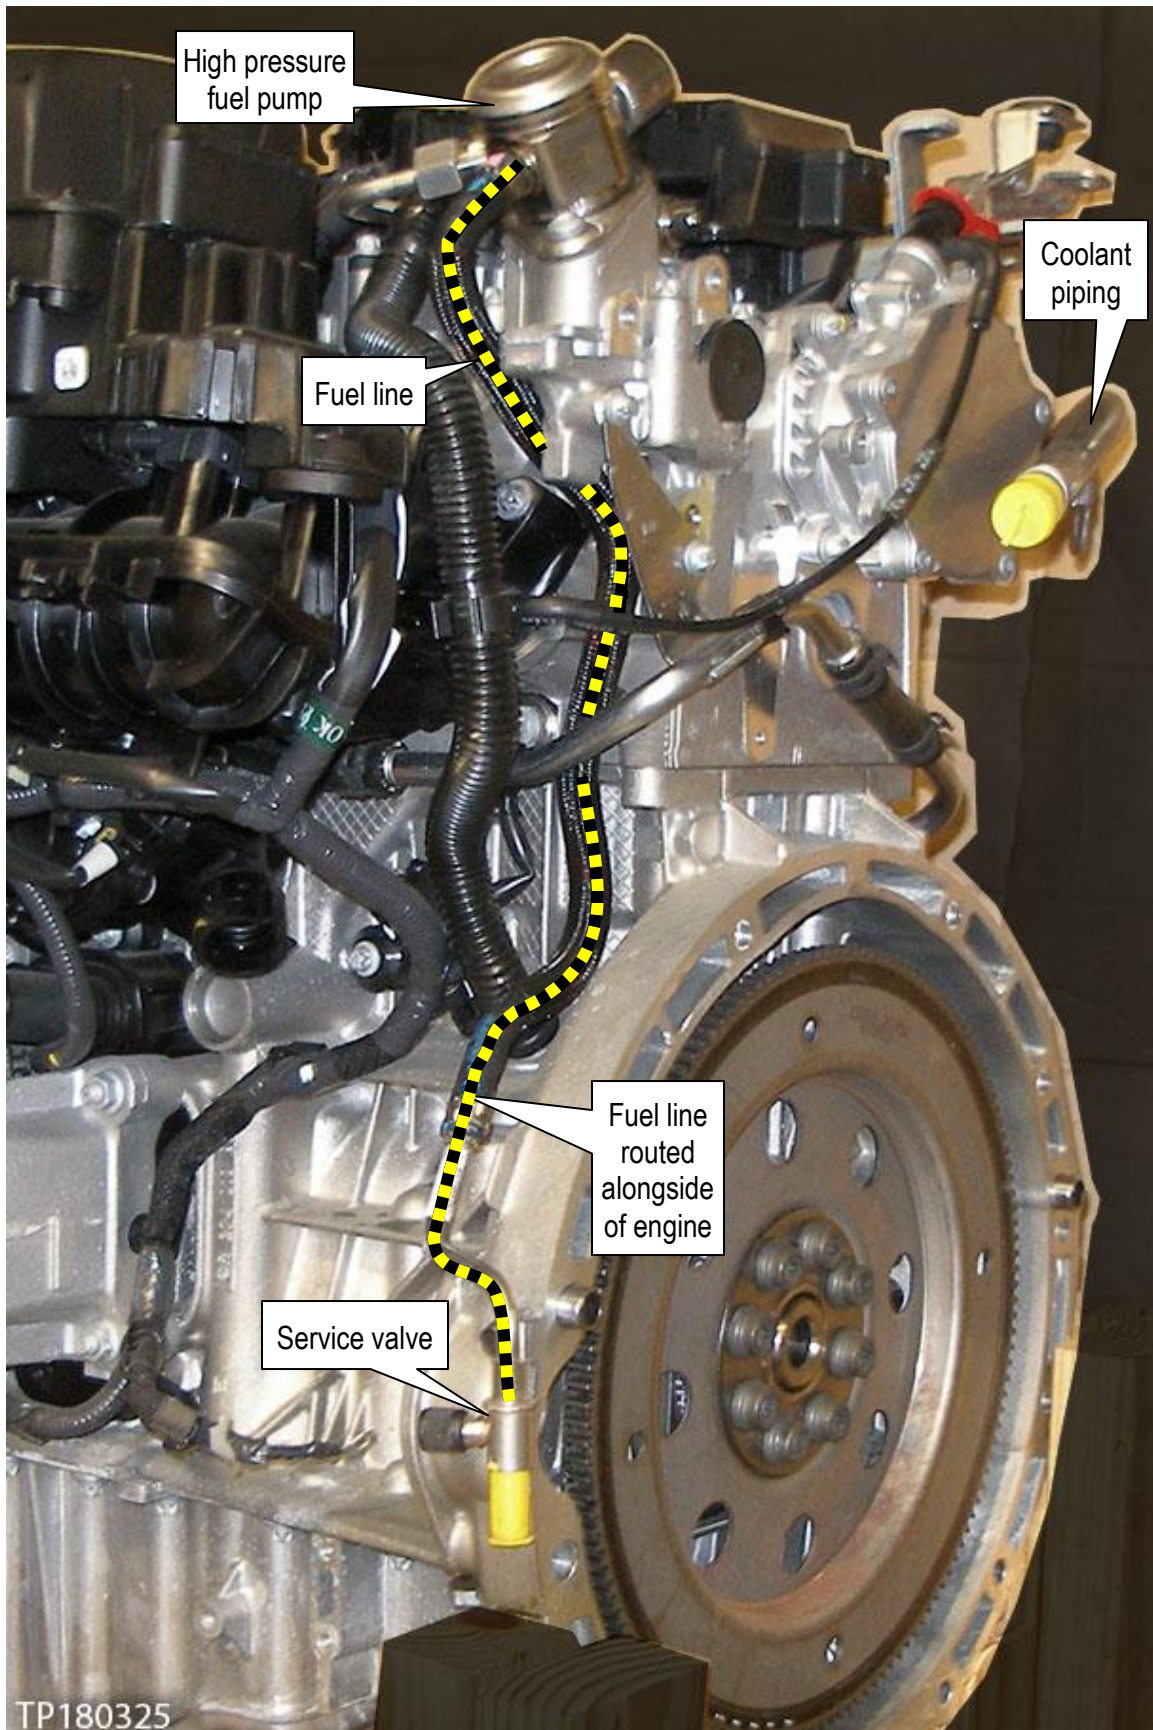
Figure 16 shows the engine out of the vehicle. This is for viewing purposes only.

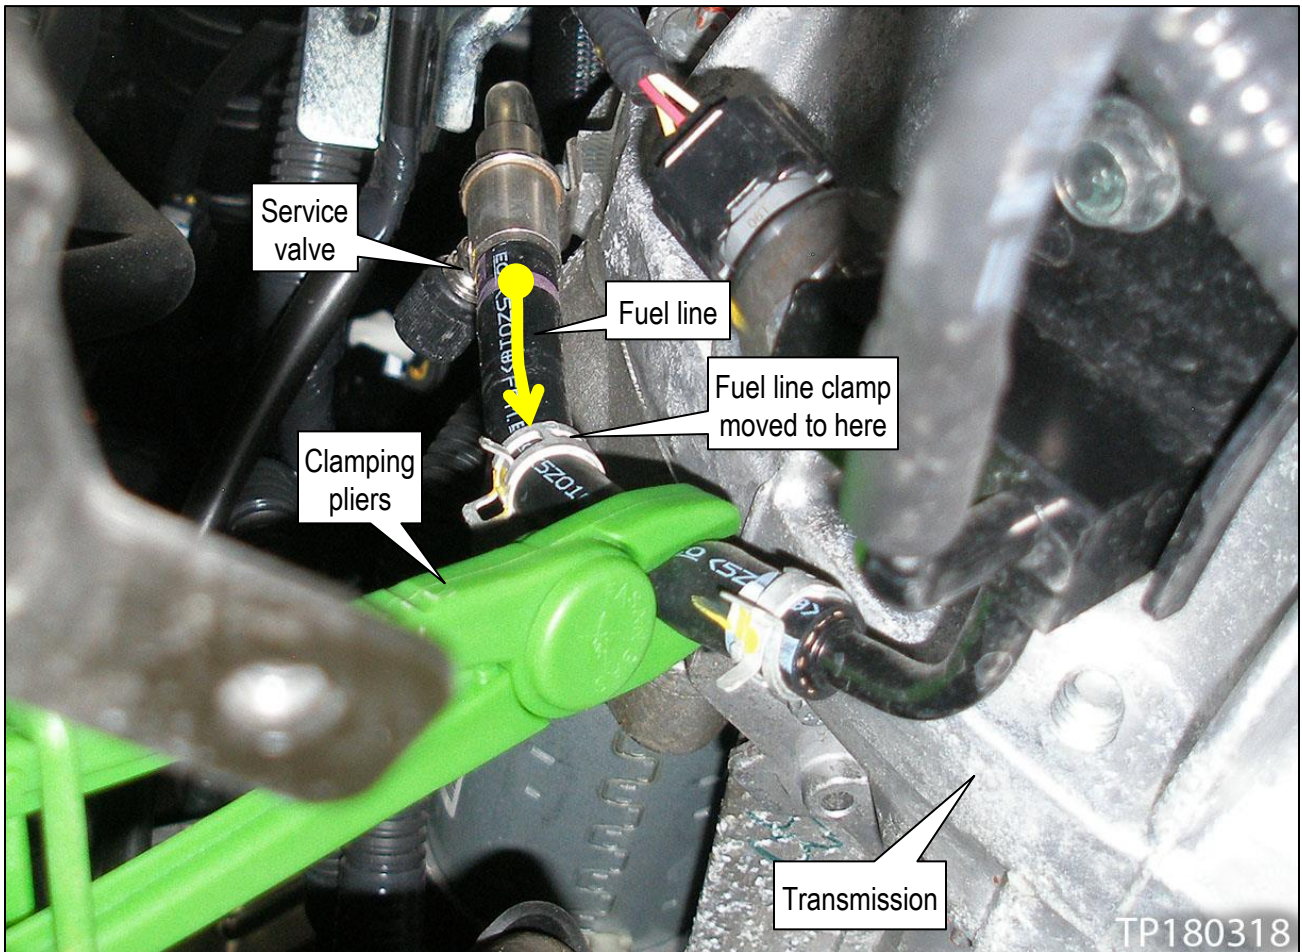
Figure 17

14. Place a suitable drip pan under the area of the low pressure fuel line.
15. Properly clamp the fuel line with suitable clamping pliers.
  - This will prevent residual fuel leakage from the lower fuel line.
16. Unclamp (loosen) the clamp at the service valve and move it further down the lower fuel line.

**NOTE:** This clamp will be reused.

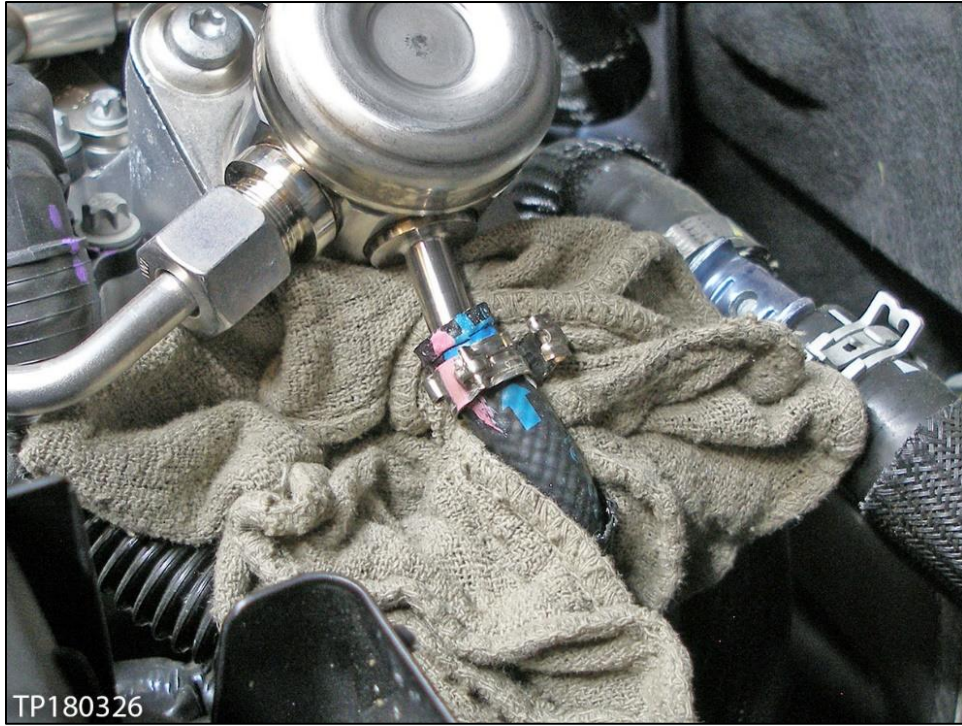
Figure 18

18. Lower the vehicle, and then disconnect the low pressure fuel line from the high pressure fuel pump.

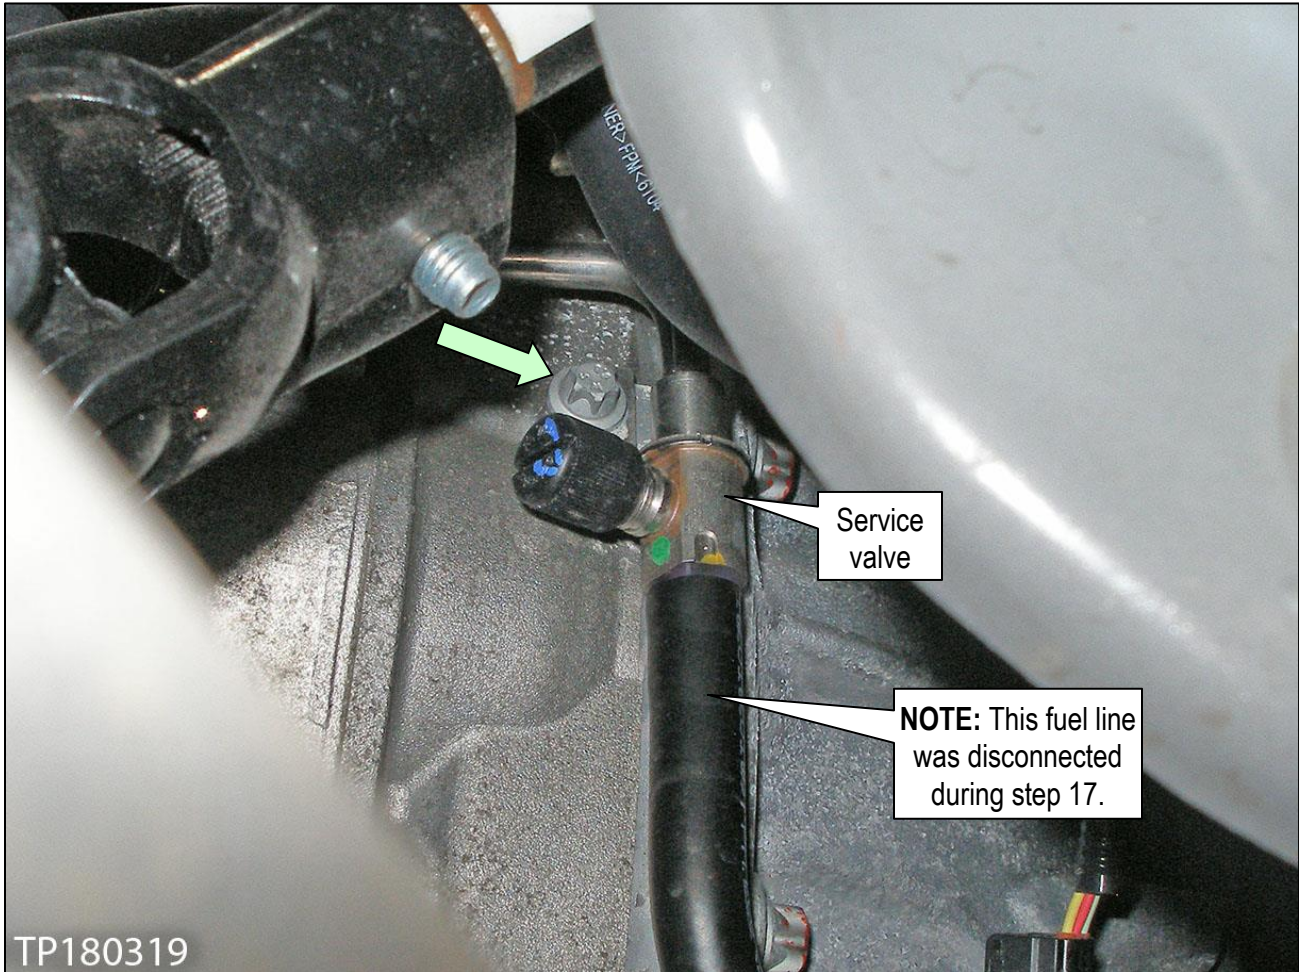
19. Raise the vehicle, and then remove the service valve bracket's E10 bolt.

**NOTE:** Figure 19 shows the lower fuel line still connected. It was disconnected previously during step 17.

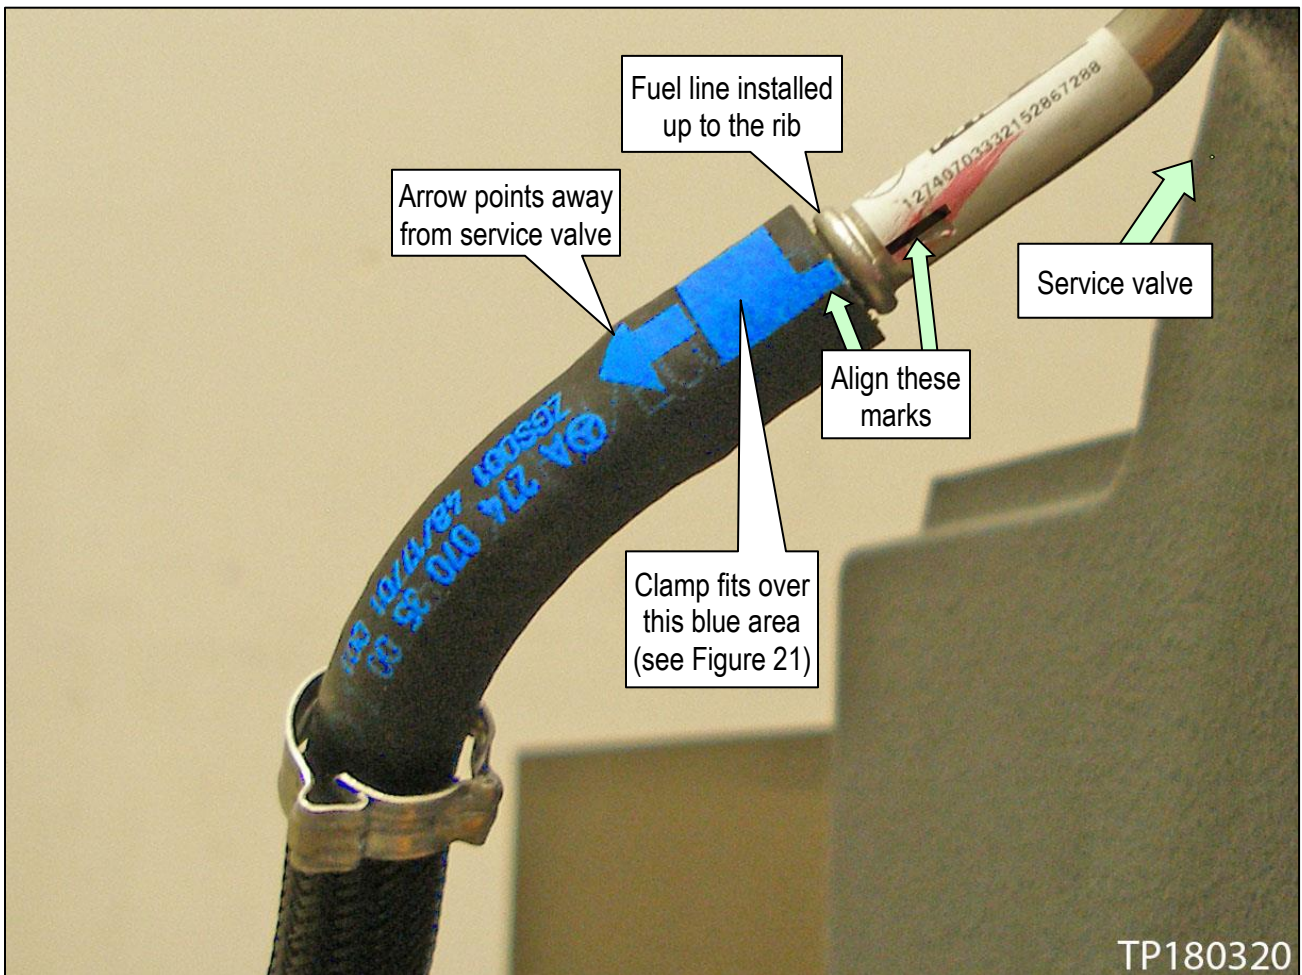
Figure 20

21. Unfasten the clamp, and then remove the low pressure fuel line from the service valve.
22. Install the **new** low pressure fuel line to the service valve:
  - a. Slide a new clamp on the end of the new low pressure fuel line that connects to the service valve.
    - The blue arrows on the low pressure fuel line will be pointing away from the service valve.
  - b. Line up the low pressure fuel line's blue mark with the service valve's black mark.

**WARNING:** Failure to properly install the low pressure fuel line and its clamps may cause fuel leakage.

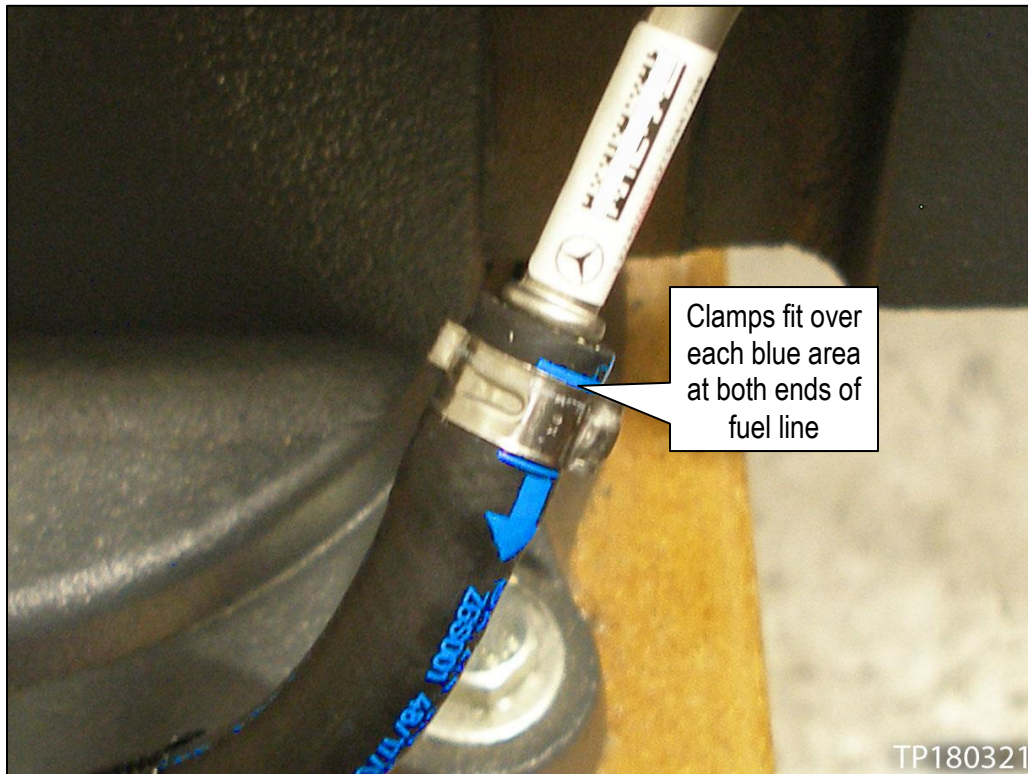
Figure 21

- c. Position the clamp on the blue mark, and then fasten the clamp with suitable pliers.

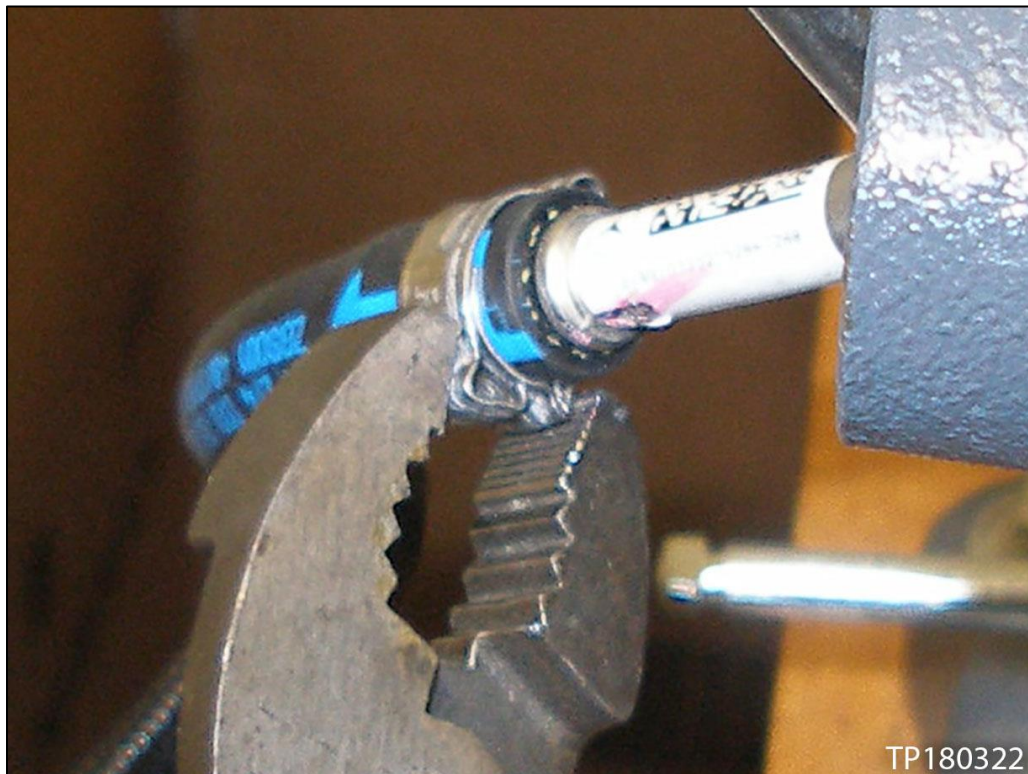
Figure 22

- Squeeze the clamp until it snaps together.

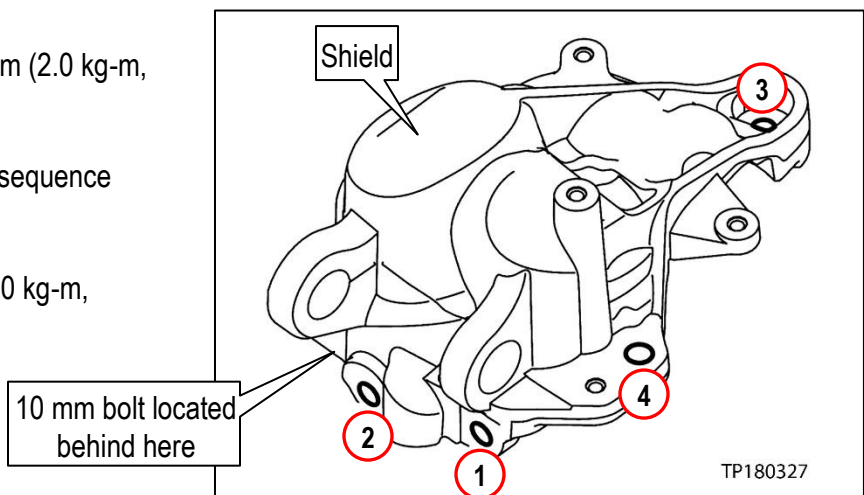
- Shield T45 bolts torque: 20.0 N•m (2.0 kg-m, **15 ft lbs**)

➤ Torque the T45 bolts in the sequence shown in Figure 23.

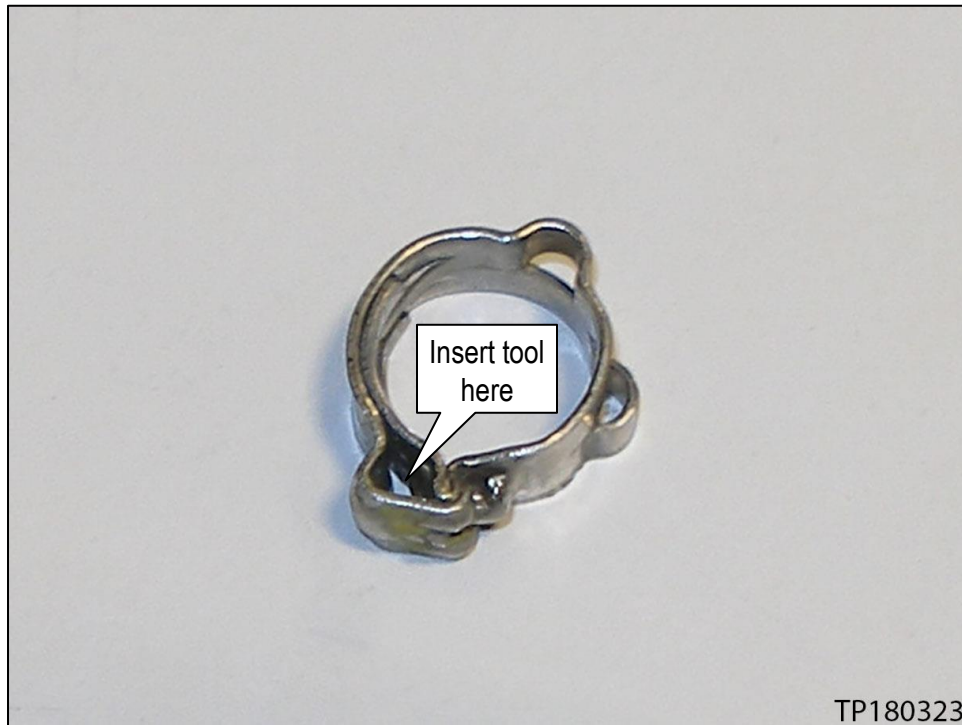
Figure 24

1. Insert a suitable pick in the location shown in Figure 24.
2. To unfasten, lift the edge by prying up over the lip.
