CAMPAIGN BULLETIN PG7B5 Driver Side Curtain Air Bag Campaign Quality Review

Reference: PC834
Date: August 27, 2021

PC834 – 2017 QX30 DRIVER CURTAIN AIR BAG MODULE

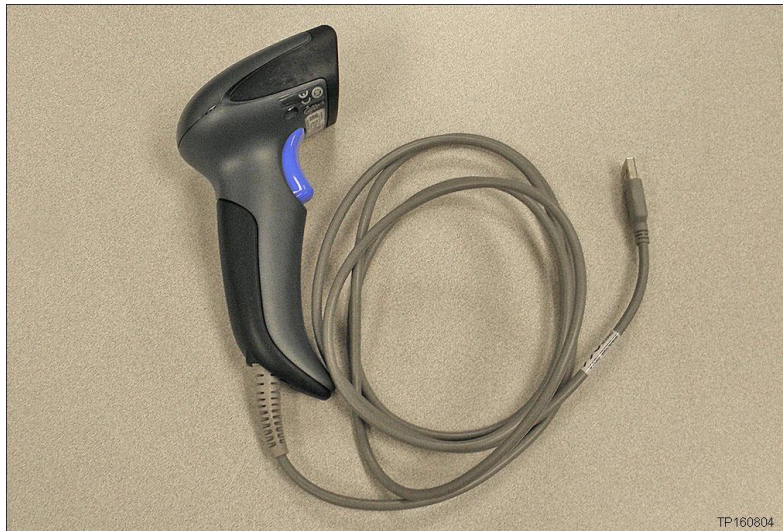
Figure A1

Quick Scan Tool (J-52352)

- Each retailer has been shipped one Quick Scan Tool (J-52352).
- Additional tools can be obtained from Tech•Mate at 1-800-662-2001.

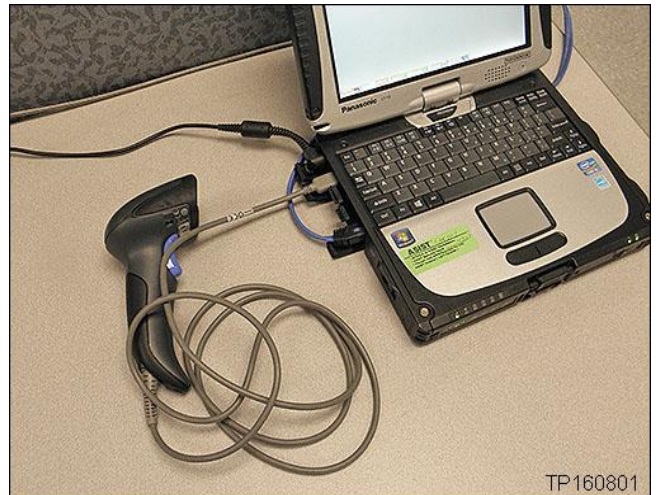
Figure A2

- a. Attach the quick scan tool (J-52352) to your CONSULT PC USB port.

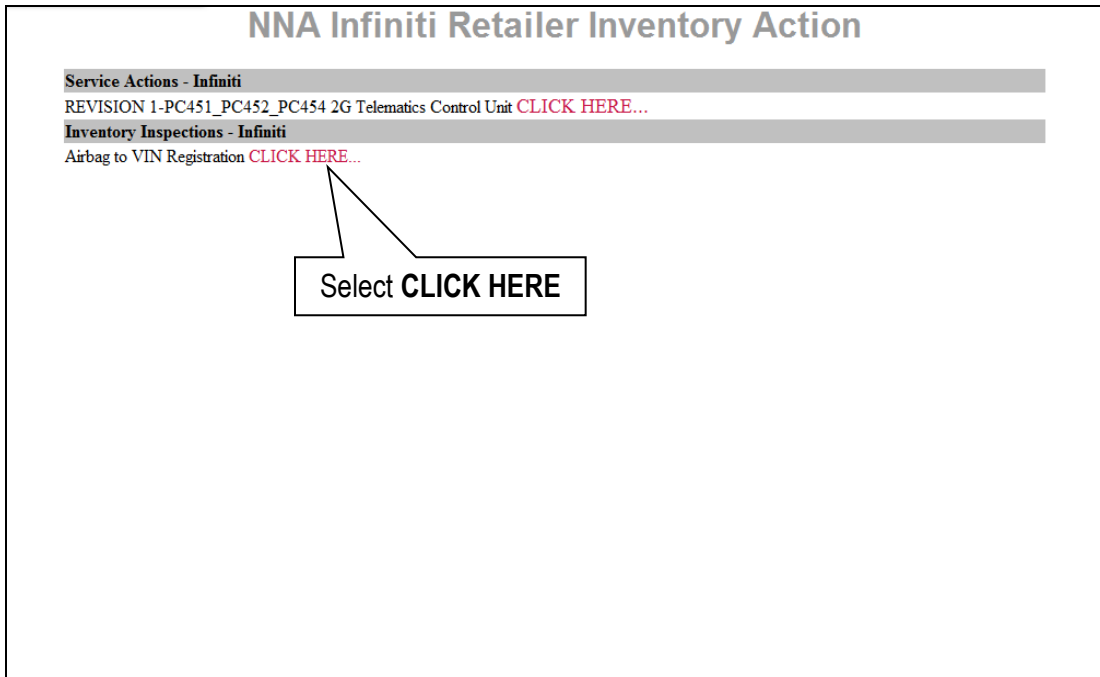
Figure A4

- c. Select **CLICK HERE** (Air Bag to VIN Registration).

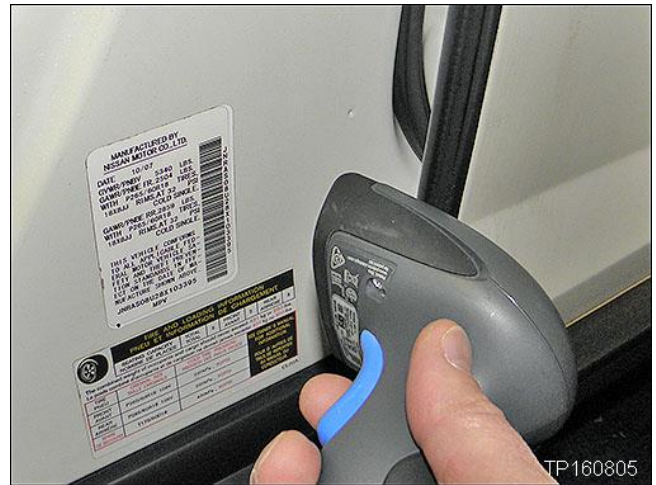
Figure A5

d. Use the quick scan tool to scan the bar code (VIN) on the B-pillar label.

- Some labels may not scan quickly.
- Hold the scan tool approximately 6 inches away from the label.
- Hold the trigger down until the label is read (this may take several seconds).

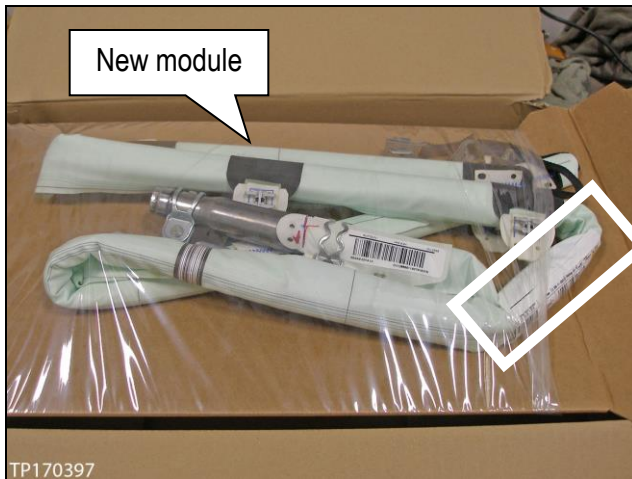
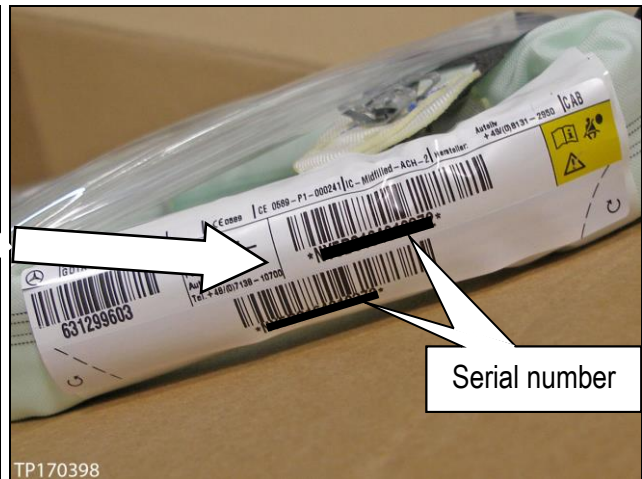
- e. Use the quick scan tool to scan the bar code (serial number) on the new module.
- Remove the module from the shipping box and locate the bar code label (see Figure A7 and A8).
 - Hold the scan tool approximately 6 inches away from the label.
 - The serial number will automatically populate (see Figure A6 on previous page).

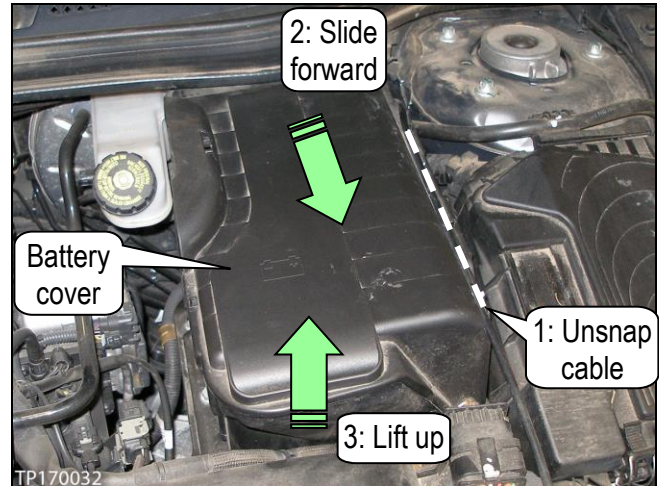
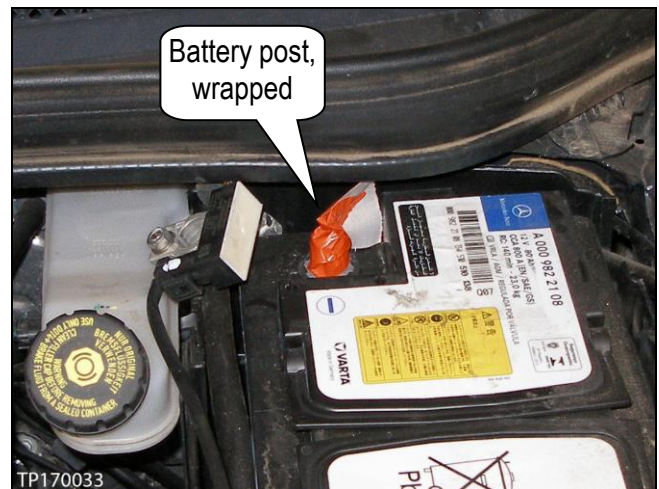
Figure 1

5. Disconnect the negative battery terminal cable.

- a. Remove the hood release cable from the battery cover.
- b. Remove the battery cover by pulling forward, and then lifting up.
- c. Unfasten the negative battery cable.
 - Before servicing the SRS, turn the ignition switch OFF, disconnect the negative battery cable and wait at least three (3) minutes.
 - For approximately 3 minutes after the negative battery cable is removed, it is still possible for the air bag and seat belt pretensioner to deploy. Therefore, never work on any SRS connectors or wires until at least 3 minutes have elapsed.
- d. Wrap the battery post or negative battery cable end with electrical tape.

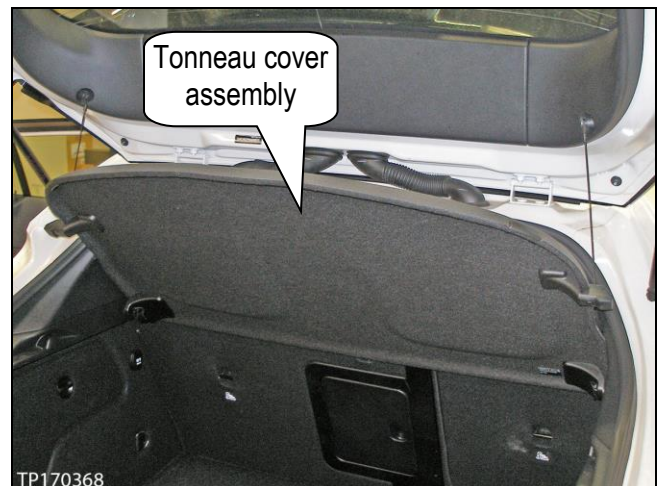
Figure 3

6. Remove the tonneau cover assembly.

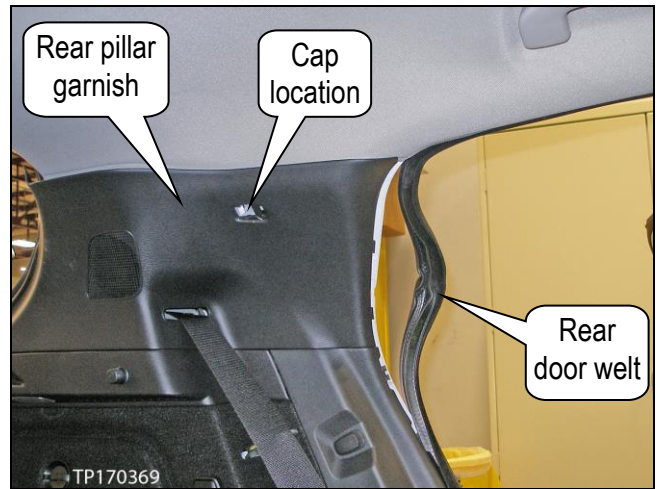
Figure 4

7. Detach both rear pillar garnishes.
 - a. Pull off the rear door welts in the area of the rear pillar garnishes.
 - b. Remove the cap with a suitable pry tool.

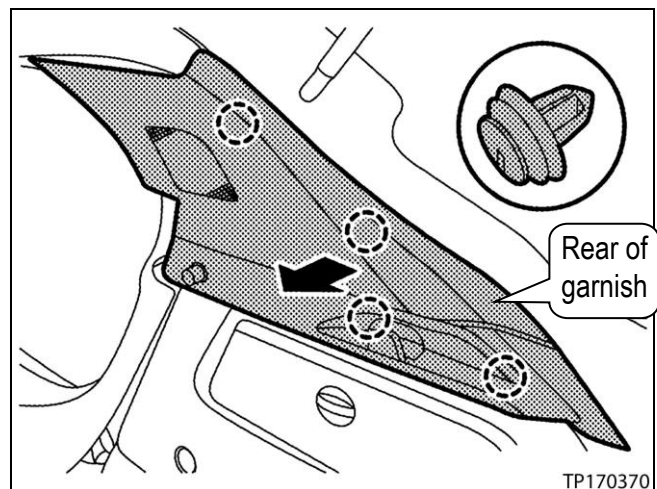
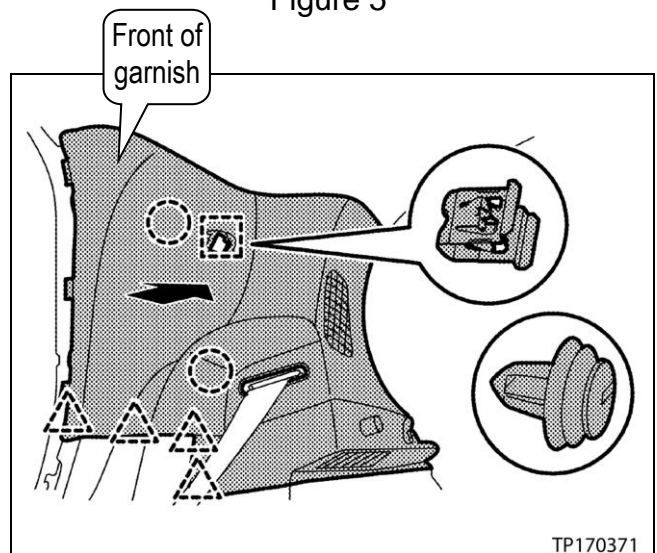
- c. Unfasten all rear pillar garnish clips and pawls, starting at the rear (see Figure 5 and 6).

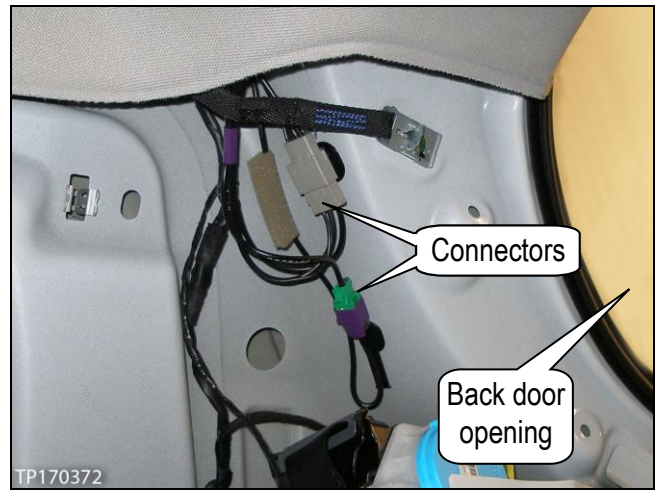
Figure 7

8. Disconnect the two (2) electrical connectors located behind the rear pillar garnish RH.

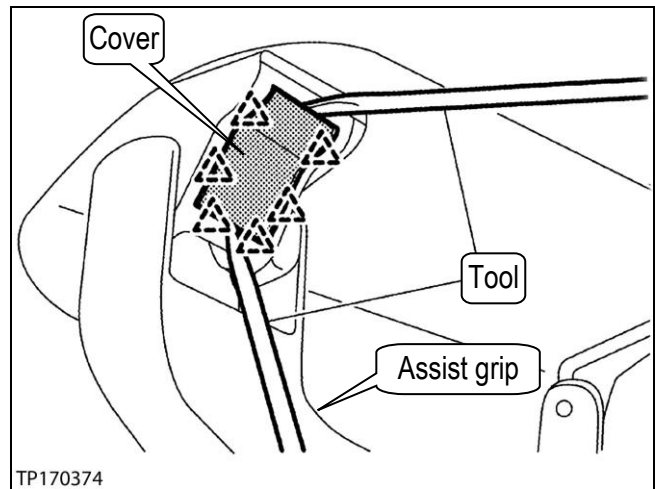
Figure 8

9. Remove all four (4) assist grips.
- a. Carefully remove the covers with two suitable pry tools.

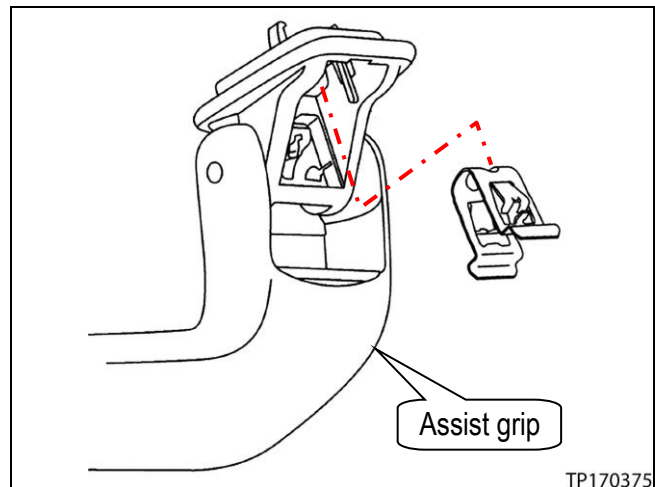
Figure 9

- b. With both covers removed, pinch in the metal clips, and then pull off the assist grip.

NOTE: Reinstall the metal clips in the assist grips before reinstalling the assist grips.

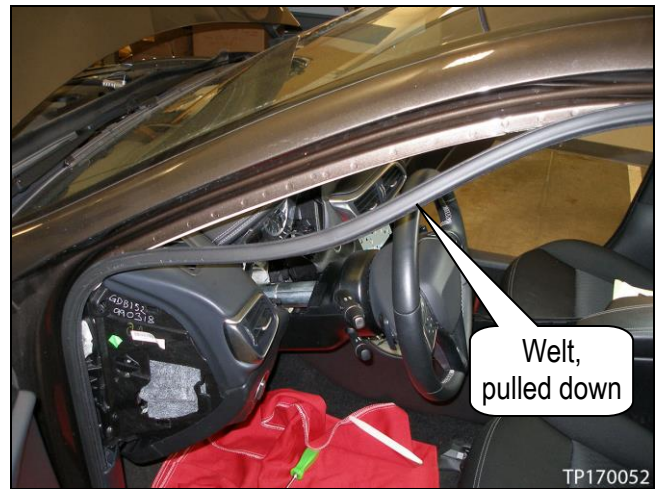
Figure 10

10. Remove both front pillar garnishes.
 - a. Pull down the front door welt away from the front pillar garnish (see Figure 10).

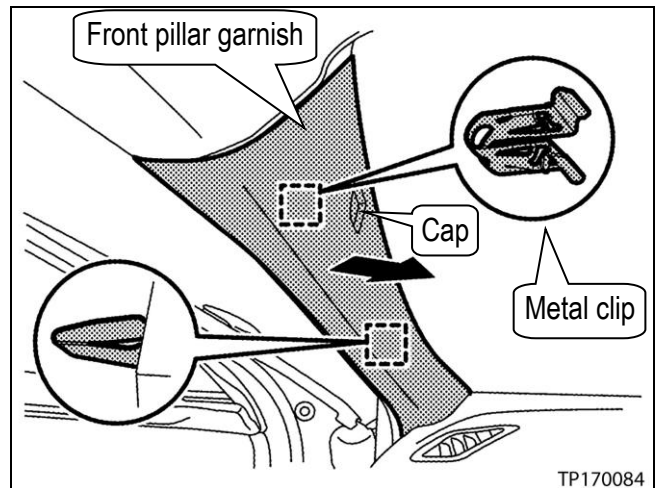
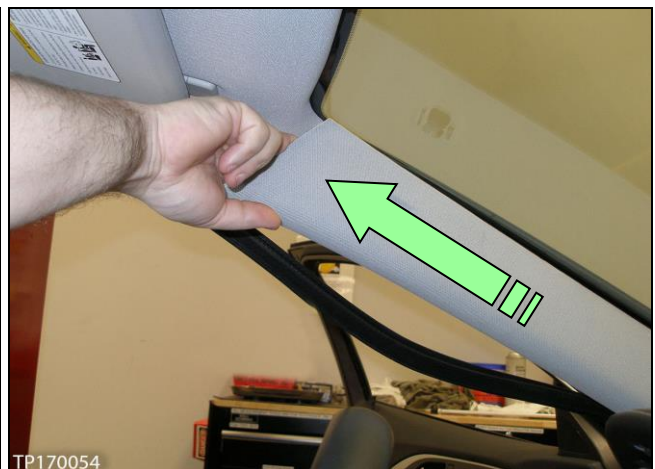
- b. Remove the front pillar garnish cap with a suitable plastic trim tool.
 - See Figure 11 for cap location.
 - c. Unsnap the clips by pulling away from the pillar, and then remove the front pillar garnish by pulling upward.
 - See Figure 11 and 13.

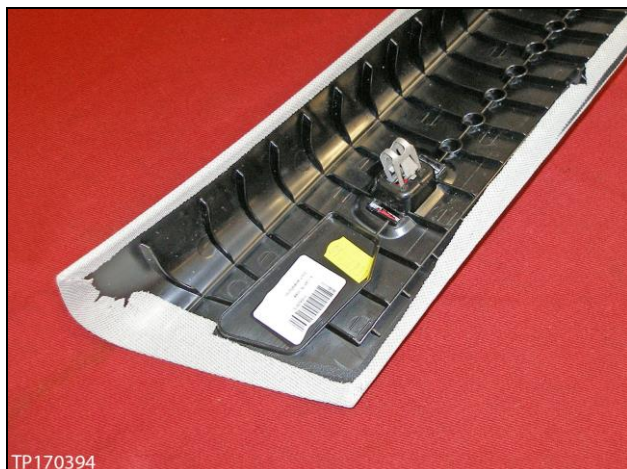
Figure 12

WARNING: The metal clip needs to be installed in each front pillar garnish before the front pillar garnishes are installed in the vehicle (see Figure 12).

WARNING: The metal clips need to be installed in each front pillar garnish before the front pillar garnishes are installed in the vehicle (see page 9).

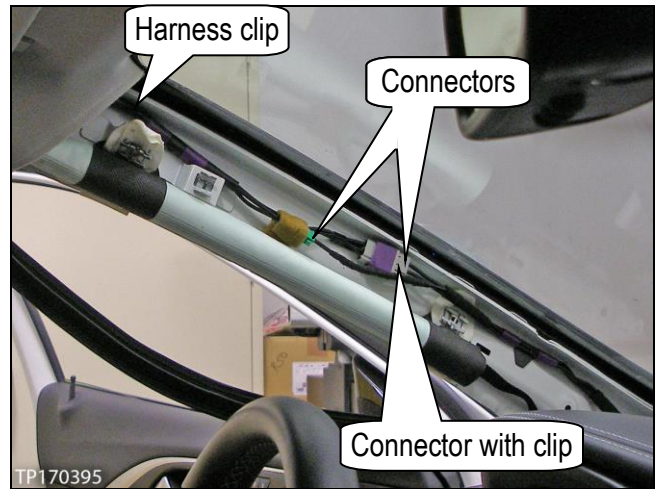
Figure 14

11. Disconnect the two (2) electrical connectors and 2 clips behind the front pillar garnish LH.
 - One clip fastens the harness, the other holds one of the connectors (see Figure 14).

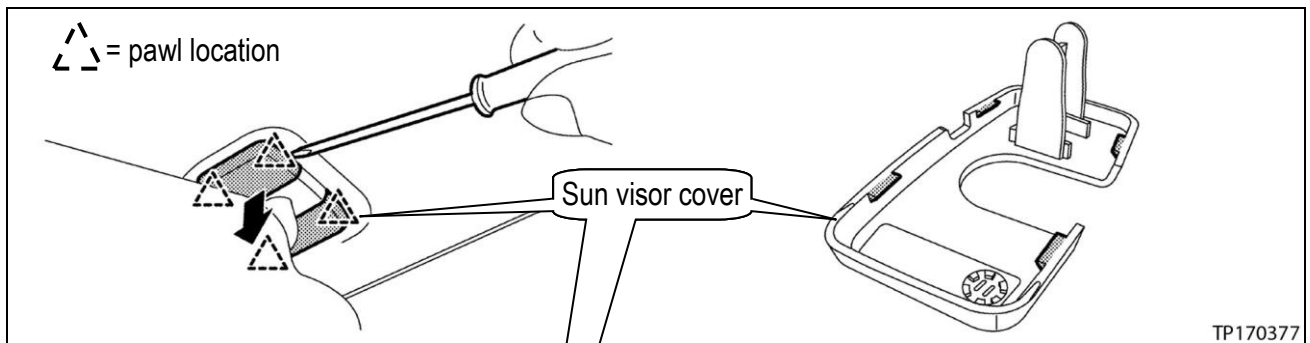
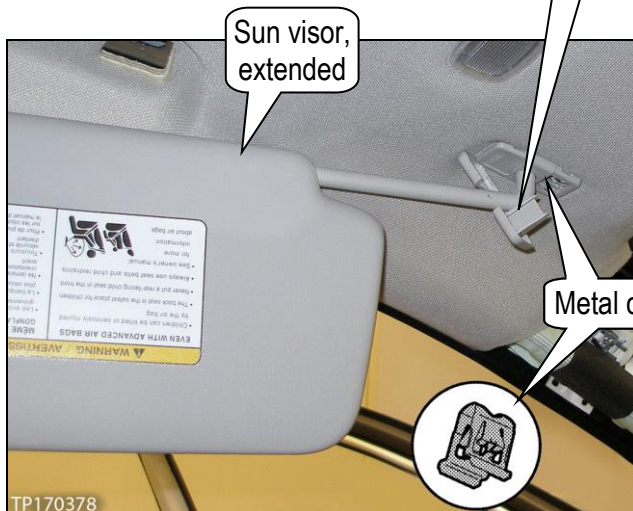
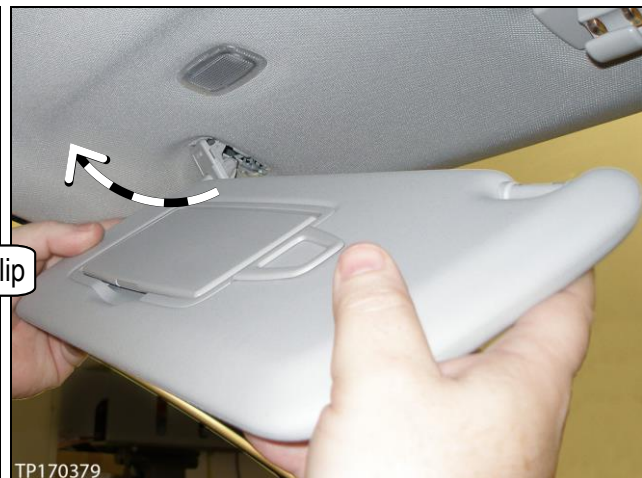
Figure 15

12. Remove both sun visors.
 - a. Using a suitable tool, unfasten, and then remove the sun visor cover (see Figure 15).
 - To remove the sun visor cover, the sun visor may need to be extended (see Figure 16).
 - b. Carefully unfasten/remove the metal clip (see Figure 16 for clip location).

NOTE: If a metal clip falls inside where it fastens to the roof, it can be retrieved with a magnet after the headlining has been removed.
 - c. Position, and then rotate the sun visor and its pivot mounting together as shown in Figure 17.

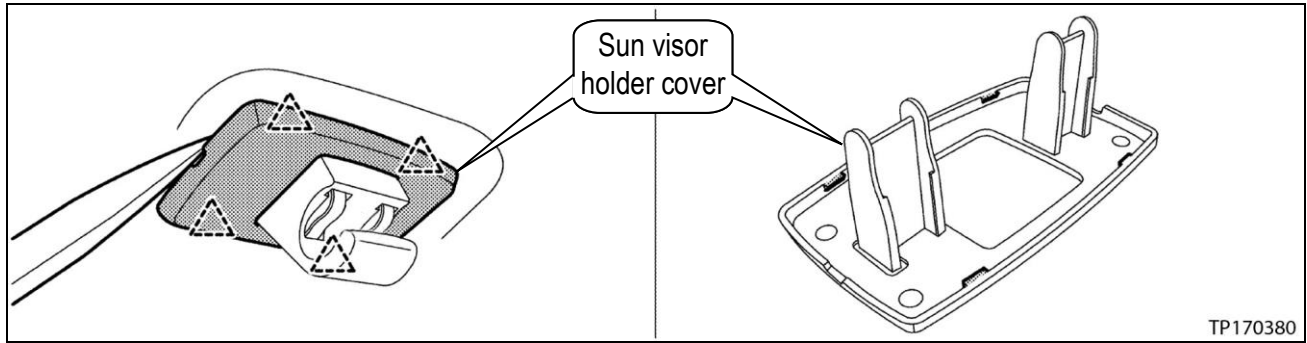
13. Unfasten, and then remove both sun visor holder covers (see Figure 18 and 19 below).

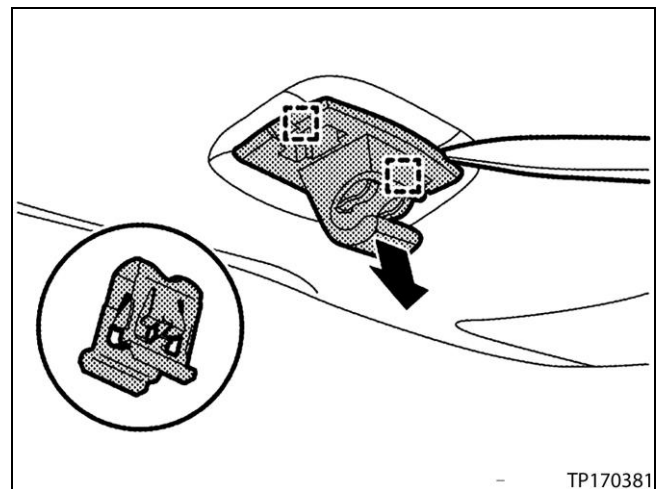
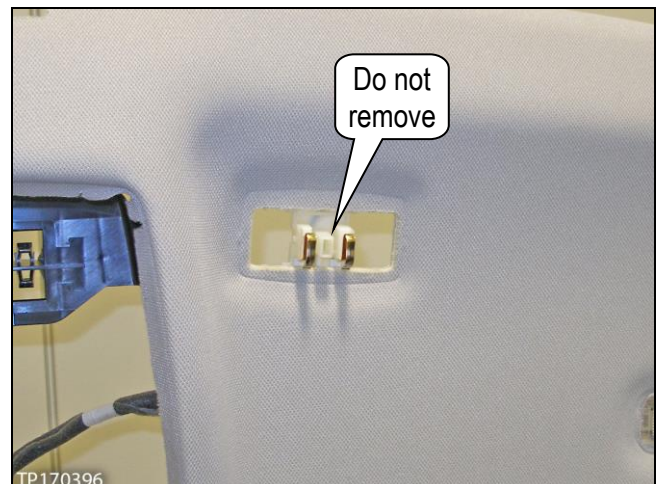
Figure 20

14. Carefully remove the metal clips, and then remove the sun visor holders.

NOTE: Do not remove the sun visor holder electrical contacts.

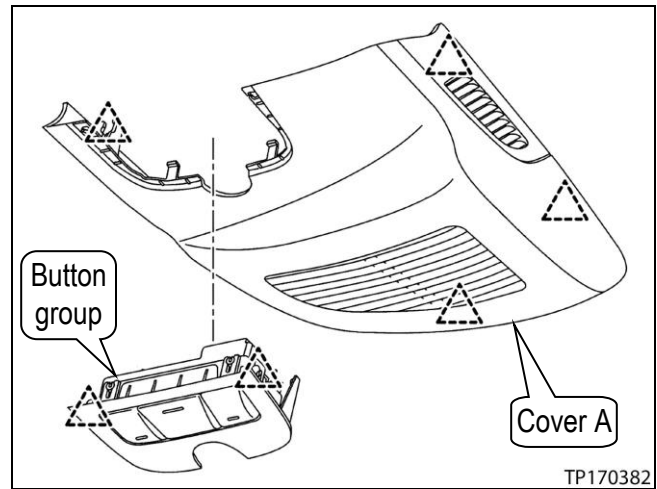
Figure 22

15. If equipped: Unfasten the anti-theft alarm system/emergency call system button group from the light & rain sensor cover A, and then unfasten/remove the light & rain sensor cover A.

- The anti-theft alarm system/emergency call system button group does not need to be disconnected/removed.

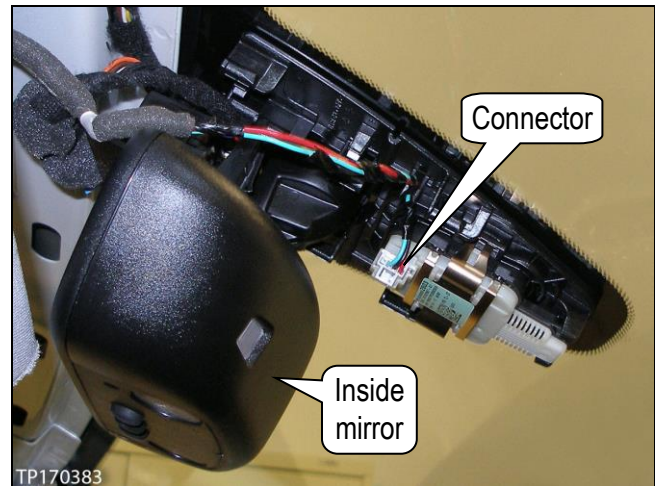
Figure 23

16. Disconnect the light & rain sensor electrical connector.

- This electrical harness is part of the headlining. It will be removed with the headlining.

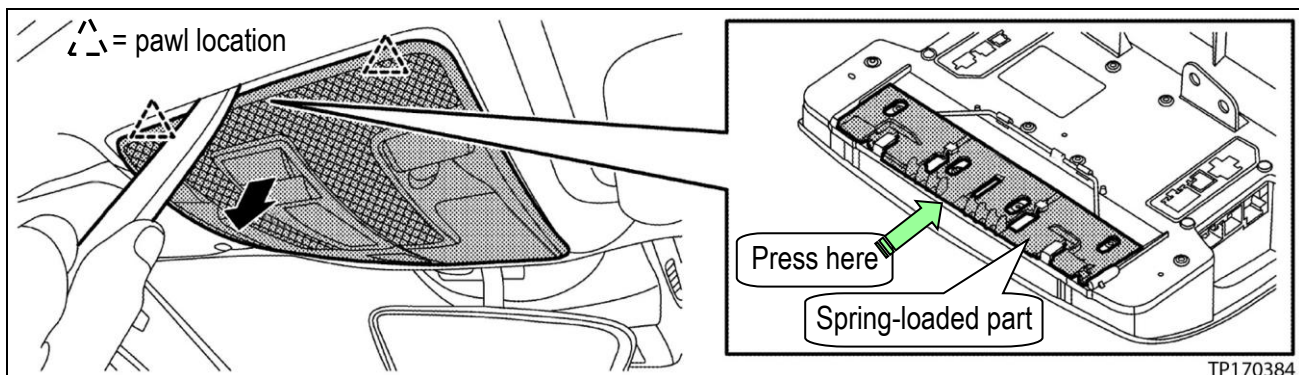
17. Unfasten the overhead control panel (see Figure 24 below).

- Insert a suitable plastic trim/pry tool, and then press on the spring loaded part.
- With the spring loaded part pressed inward, lower the “pry tool” side of the overhead control panel.
- Pull the overhead control panel toward the rear of the vehicle.
- Disconnect its electrical connectors, and then remove the overhead control panel.

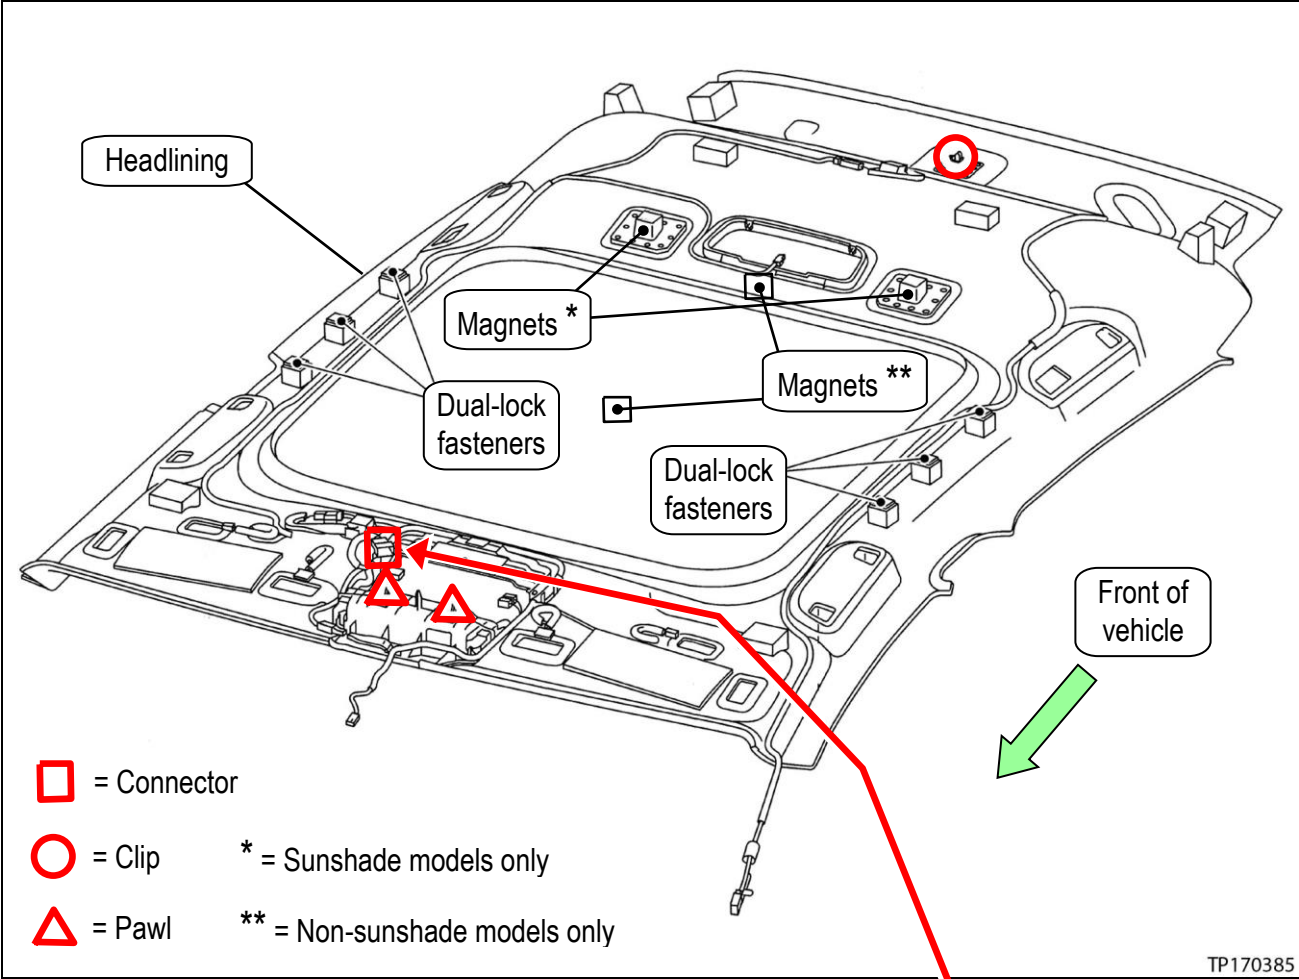
Figure 25

18. Unfasten the headlining's clip, pawls, and dual-lock fasteners from the roof.

21. Unfasten the magnets, and then carefully lower and remove the headlining through the back door opening.
 - See previous page, Figure 25, for magnets location.

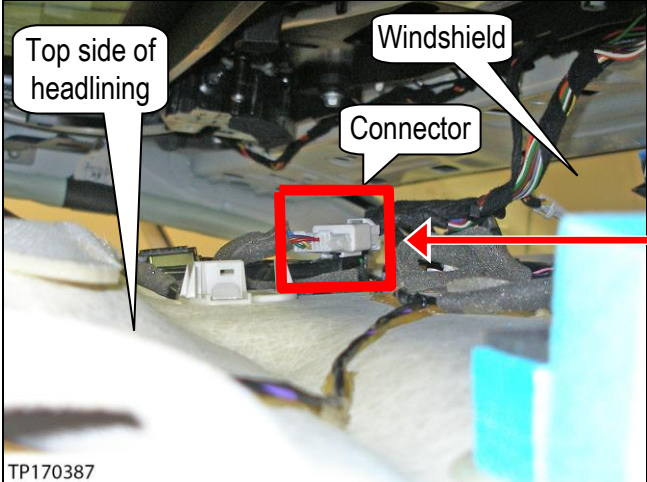
Figure 26

19. Disconnect the electrical connector located on the top side of the headlining.
- Access the electrical connector through the overhead control panel's opening.

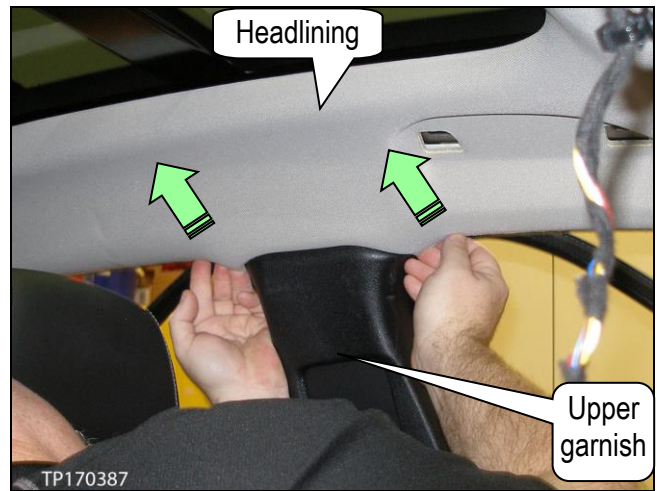
Figure 27

20. Carefully lift up the side of the headlining over the top edge of the center pillar upper garnish.
 - Perform the same procedure on the other side of the headlining.

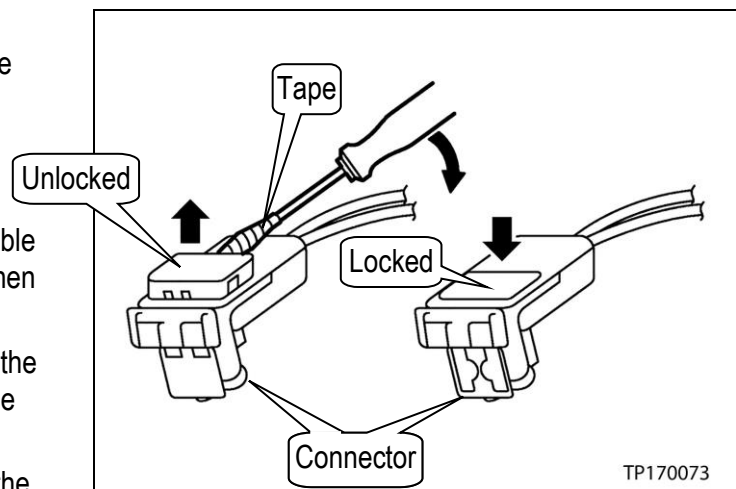
Figure 28

22. Disconnect the driver curtain air bag module electrical connector.

- When removing the driver curtain air bag module electrical connector, insert a suitable tool wrapped with tape, lift the lock, and then remove the connector.
- When installing, place the connector with the lock raised, and then push the lock into the connector.
- After installing the connector, make sure the lock is pushed in securely.

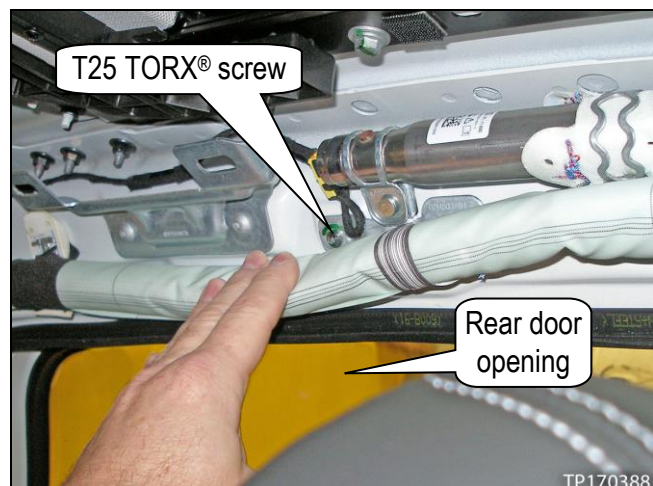
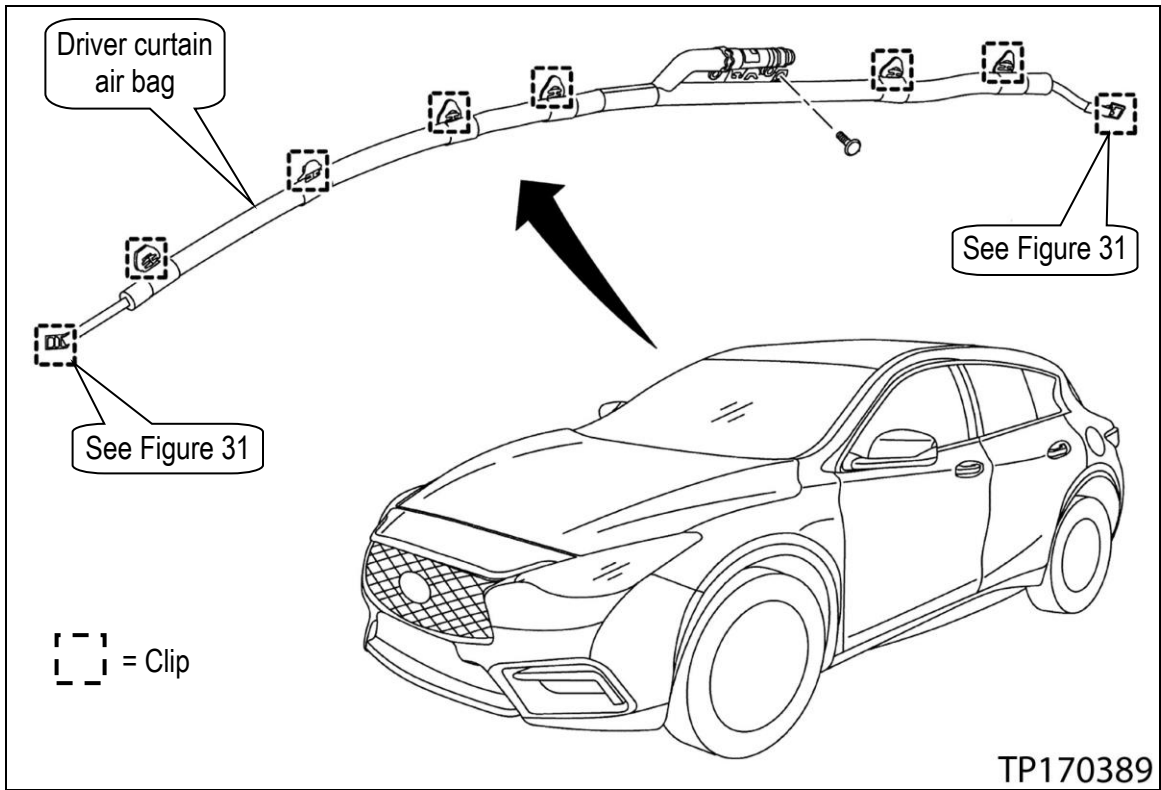
Figure 29

23. Remove the curtain air bag module T25 TORX® fixing screw.

- See **PARTS INFORMATION**.
- T25 TORX® fixing screw torque: 6.0 N•m (0.61 kg-m, **53 in lbs**)
- Make sure all harnesses and connectors are properly routed and placed.
- Reinstall the metal clips in the assist grips, sun visors, and sun visor holders before reinstalling them.

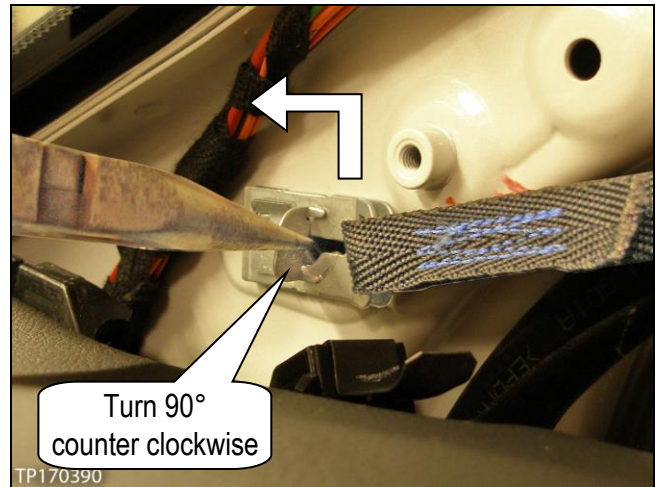
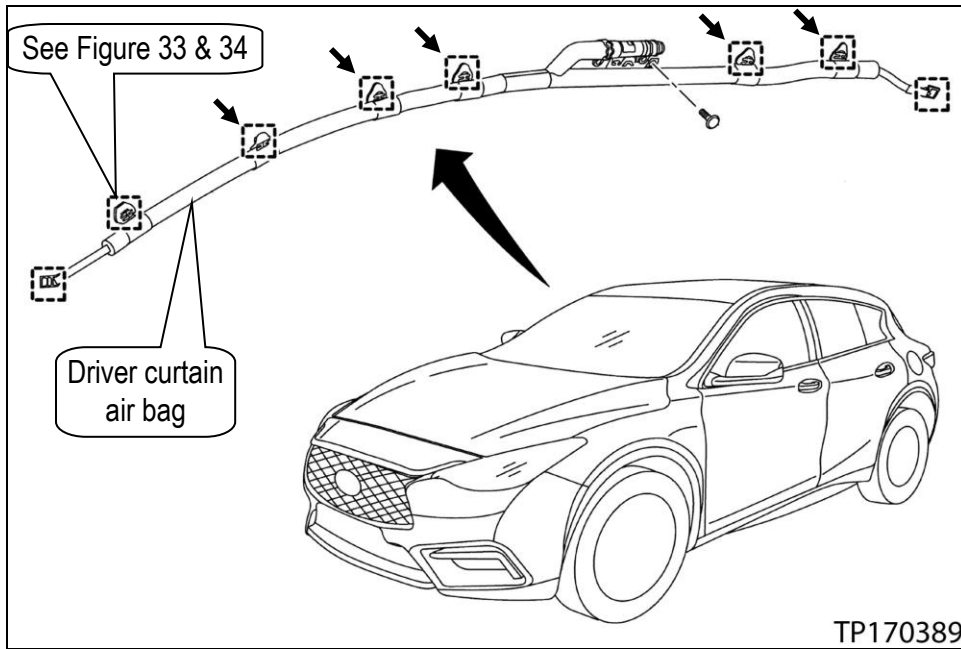
Figure 31

24. Unfasten the metal clip at each end of the driver curtain air bag by rotating 90° counter clockwise.

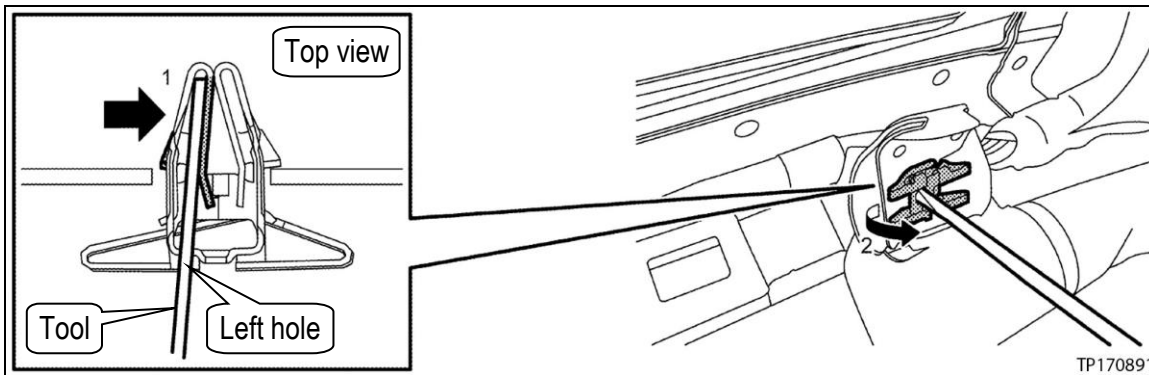
Figure 33

25. Unfasten the remaining clips.
 - a. Insert a suitable tool (such as a thin flat blade screwdriver) in the clip's left hole, press inward, and then partially pry out (see Figure 33).

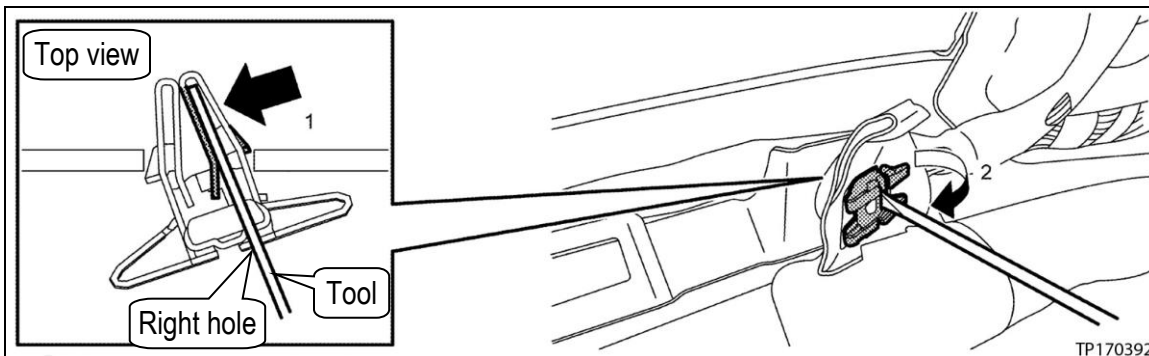
Figure 34

- b. Insert the suitable tool in the clip's right hole, press inward, and then pry out to fully release the clip (see Figure 34).

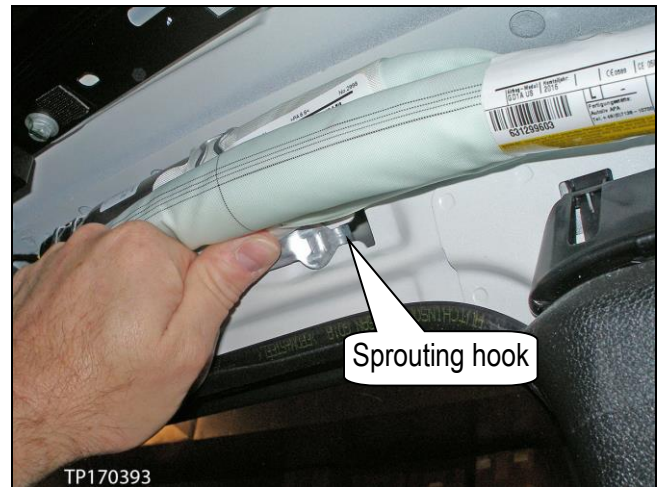
Figure 35

26. Unhook the bracket sprouting hook, and then remove the driver curtain air bag module.
