# Abnormal Buzz/Groan Noise at 20 - 30 mph From Front Transfer Case

YEAR(S)	MODEL(S)	ADDITIONAL INFORMATION
2019 - 2020	RAV4

Some 2019 – 2020 model year RAV4 Adventure and Limited grade AWD vehicles may exhibit an abnormal buzz/groan noise from the front transfer case at 20 – 30 mph when accelerating from a stop and/or at 20 – 13 mph on deceleration after driving the vehicle for 15 – 20 minutes or more. This condition occurs with Normal drive mode selected during disconnect/connect timing of the AWD system. Follow the procedures in this bulletin to address this condition.

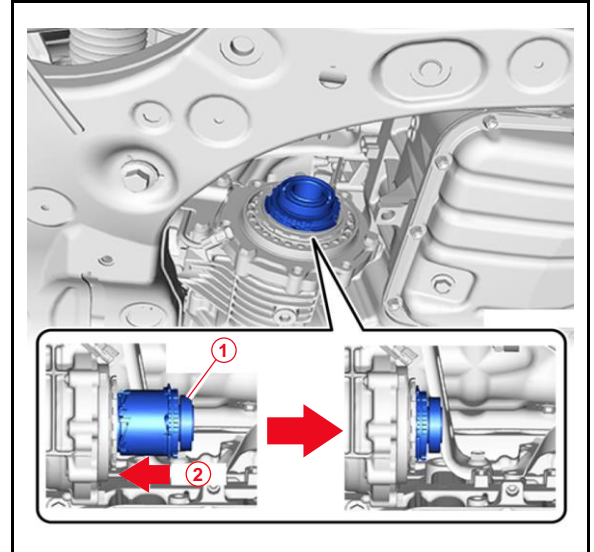
**Figure 5.**

- E. If the disconnect shaft is pulled out together with the electro-magnetic clutch cover, push it toward the vehicle inner side (automatic transaxle side).

Make sure to push the disconnect shaft back to its original position to ensure proper installation of the NEW electro-magnetic clutch.

<b>1</b>	<b>Shaft</b>
<b>2</b>	<b>Push</b>

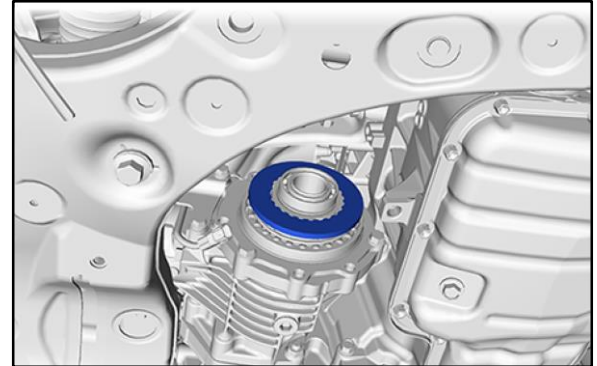
**Figure 13. Armature Plate Installed**

4. Install the NEW armature plate to the front transfer case with its metal surface facing the vehicle inner side (automatic transaxle side).

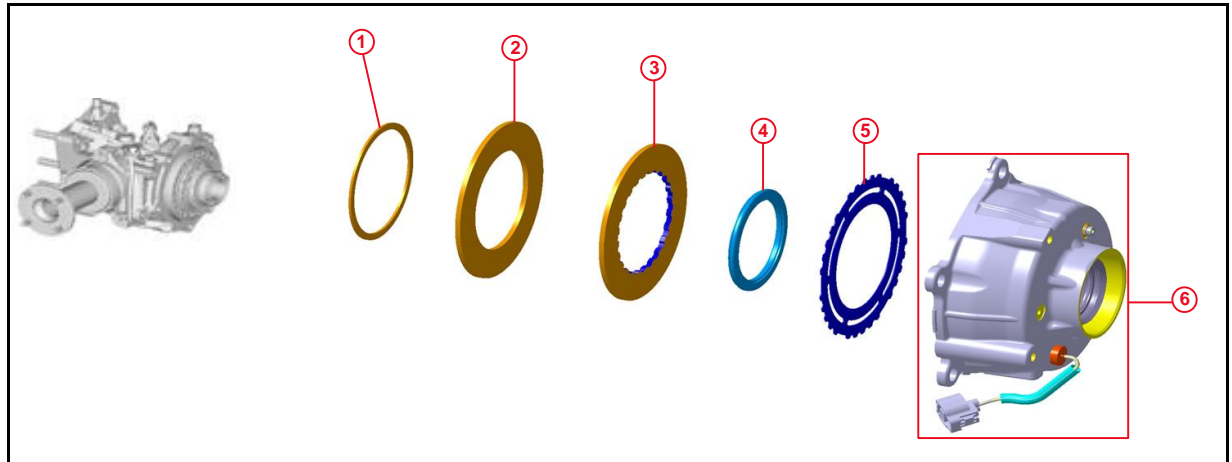
**Figure 19.**

<b>1</b>	<b>Shim</b>
<b>2</b>	<b>Damper Plate</b>
<b>3</b>	<b>Armature Plate</b>

<b>4</b>	<b>Thrust Roller Bearing (see Figure 20)</b>
<b>5</b>	<b>Outer Plate</b>
<b>6</b>	<b>Cover</b>

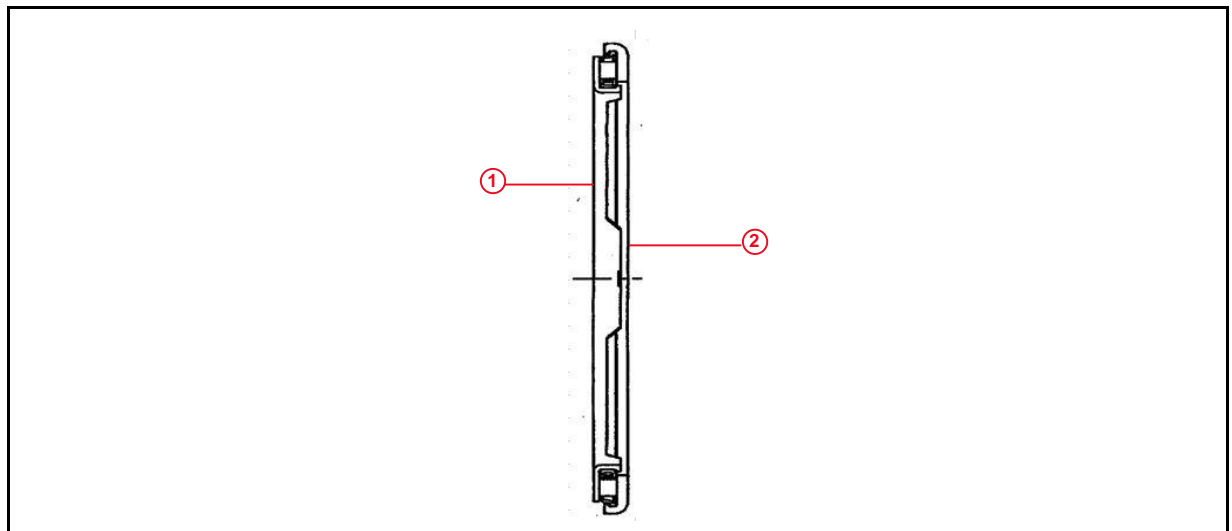
**Figure 20. Thrust Roller Bearing**

<b>1</b>	<b>Transfer Side</b>
----------	----------------------

<b>2</b>	<b>EMC Cover Side</b>
----------	-----------------------

Judge by the shape and assemble in the direction shown in Figure 20.

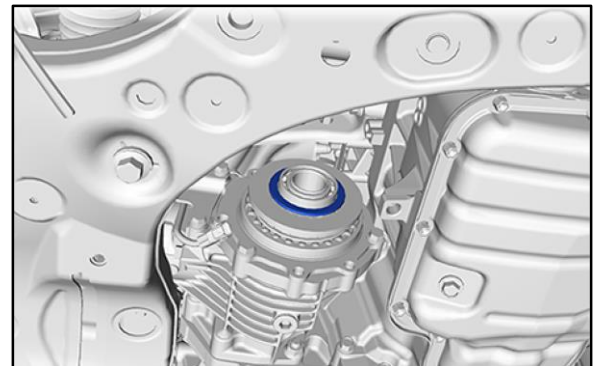
**Figure 24. Thrust Roller Bearing Installed**

5. Install the NEW thrust roller bearing to the front transfer case.
