# Sloshing or Splashing Noise From Inside One or More Door Panels

YEAR(S)	MODEL(S)	ADDITIONAL INFORMATION
2021 - 2022	RAV4 Prime	
2019 - 2022	RAV4, RAV4 HV

Some 2019 – 2022 model year RAV4 and RAV4 Hybrid, and 2021 – 2022 model year RAV4 Prime vehicles may exhibit a sloshing or splashing noise from inside one or more door panels when driving, opening and/or closing a door, and/or braking. This condition is caused by a cavity wax/debris/substance that may block door drain holes and restrict water from draining properly. Follow the Repair Procedure in this bulletin to address this condition.

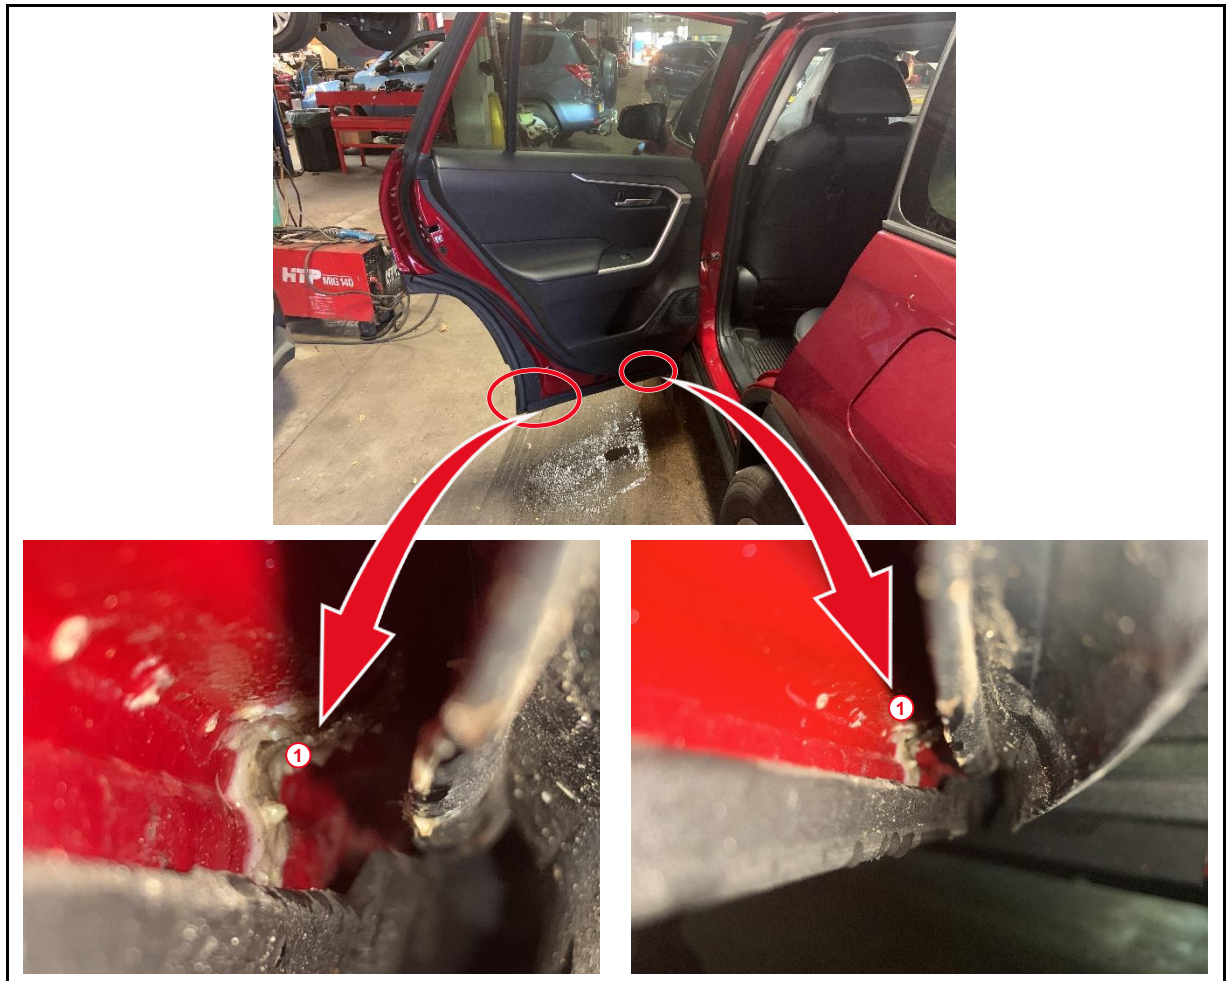
**Figure 1.**

Is there excessive cavity wax/debris/substance blocking the door drain holes and restricting water from draining properly?

<b>1</b>	<b>Wax-type Substance Blocking the Door Drain Holes</b>
----------	---

3. Remove the bottom door weatherstrip moulding from ALL four doors (front left, front right, rear left, and rear right).
  - A. Use the plastic clip removal tool to disengage the clips from the front doors and remove the front door No. 2 weatherstrip moulding.
  - B. Use the plastic clip removal tool to disengage the clips from the rear doors and remove the rear door No. 5 weatherstrip moulding.

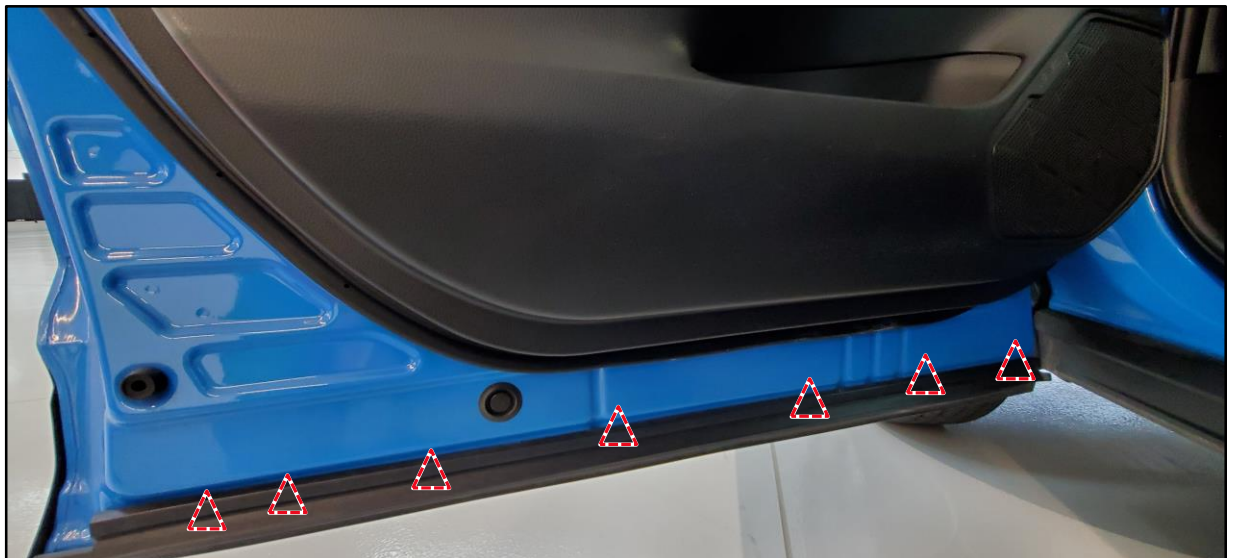
**Figure 2.**

Location of Clips Behind the Weatherstrip Moulding

Replace weatherstrip moulding if the clips are damaged during removal.

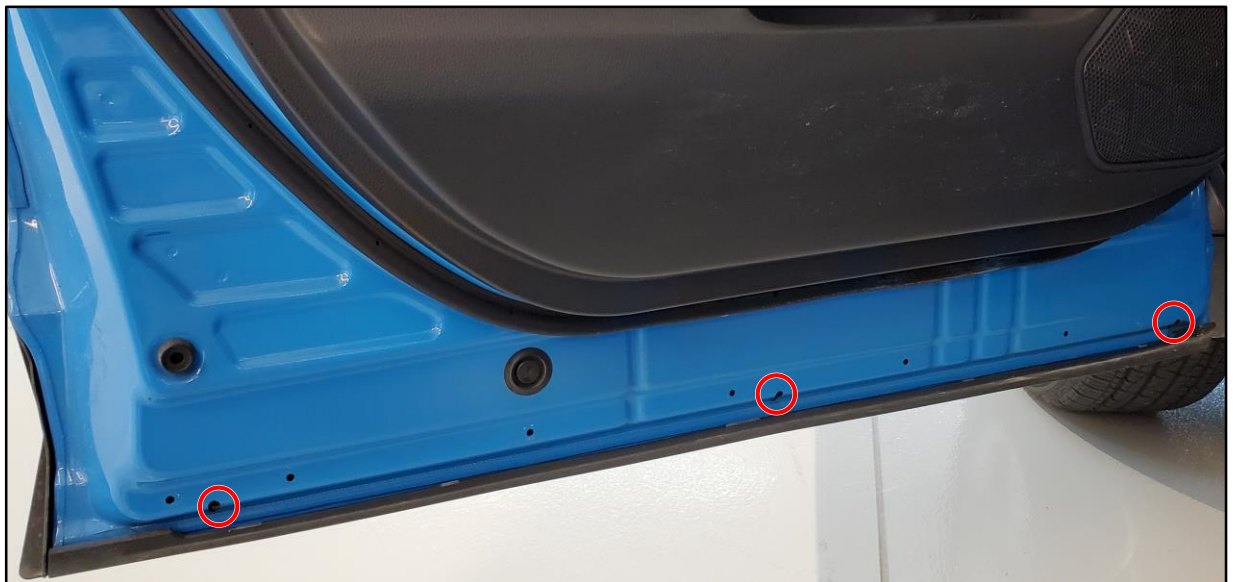
**Figure 3.**

- Use high pressure water to clean ALL debris from the weatherstrip mouldings and drain holes from ALL four doors.

○	Location of Drain Holes
---	-------------------------

Make sure all weatherstrip mouldings and drain holes on all doors are clean and free of road debris.

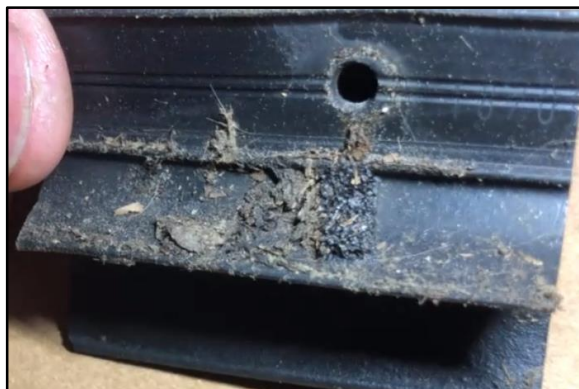
**Figure 4. Example of Debris on Weatherstrip Moulding**

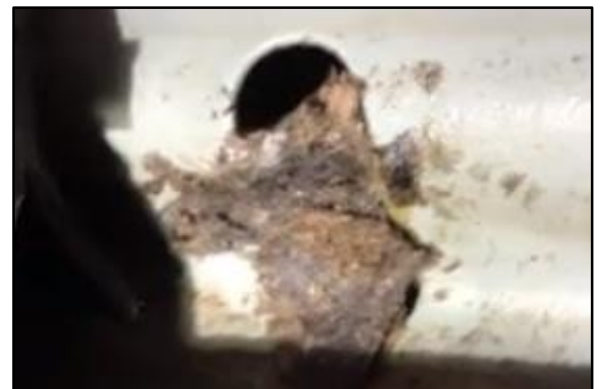
**Figure 5. Example of Debris on Drain Hole**

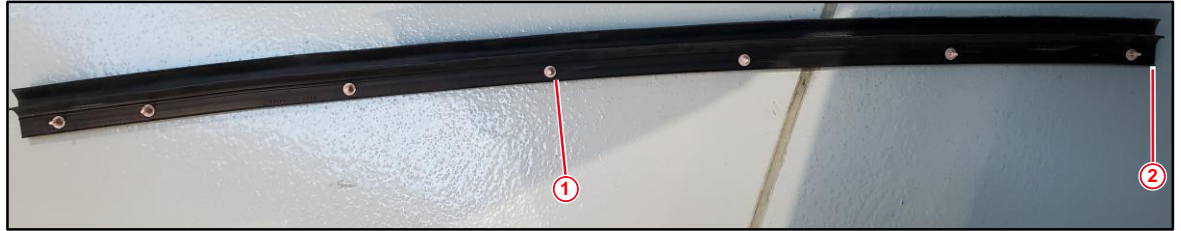
**Figure 6. Weatherstrip Moulding**

5. BEFORE reinstalling the front door weatherstrip mouldings trim the inner lip of the weatherstrip mouldings for ALL front doors to prevent debris build up in the future.
  - A. Measure 27 mm from clip No. 4 from the rear edge of the moulding (right).

<b>1</b>	Clip No. 4
<b>2</b>	Rear Edge of the Moulding

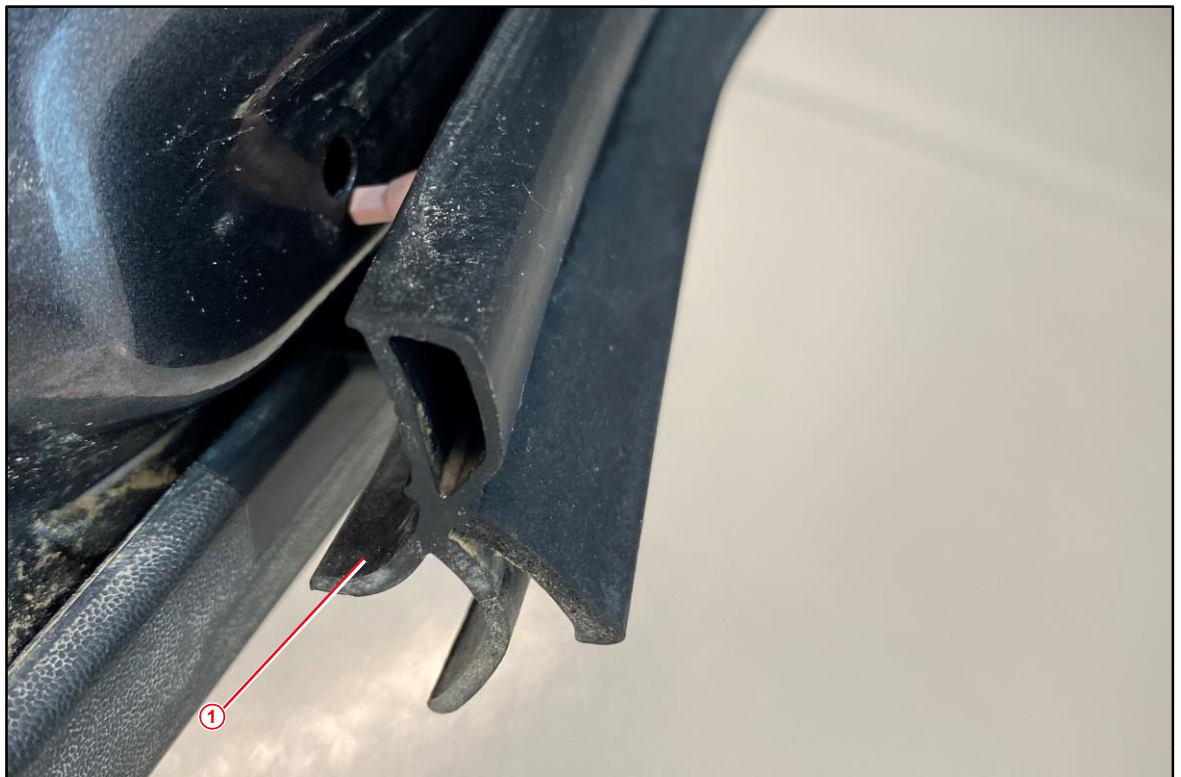
**Figure 7. Weatherstrip Moulding**

<b>1</b>	Inner Lip
----------	-----------

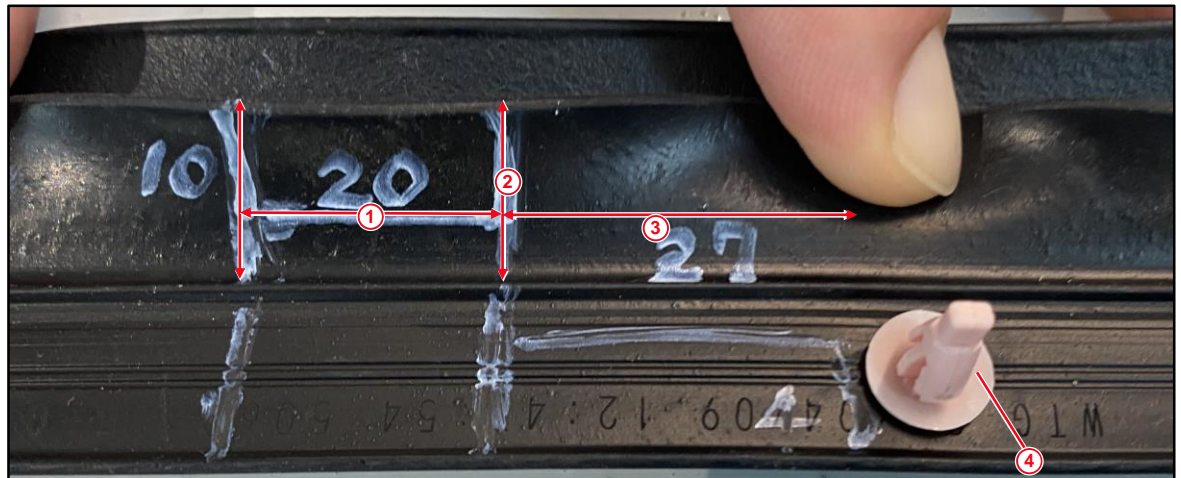
**Figure 8. Weatherstrip Moulding**

B. Cut the inner lip of the weatherstrip moulding with the following dimensions:

**Length: 20 mm**

**Height: 10 mm**

<b>1</b>	<b>Length of Cut: 20 mm</b>
<b>2</b>	<b>Height of Cut: 10 mm</b>
<b>3</b>	<b>Length Between Cut and Clip No. 4: 27 mm</b>
<b>4</b>	<b>Clip No. 4 (from rear edge of the molding)</b>

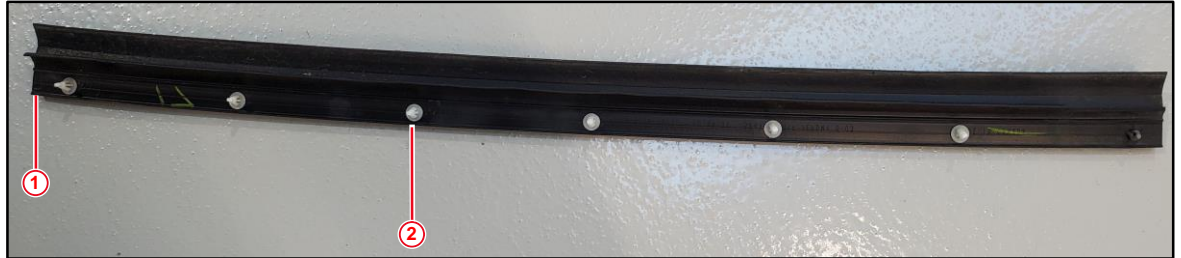
**Figure 9. Weatherstrip Moulding**

6. BEFORE reinstalling the rear door weatherstrip mouldings, trim the inner lip of the weatherstrip mouldings for ALL rear doors to prevent debris build up in the future.
  - A. Measure 37 mm from clip No. 3 from the front edge of the molding (left).

<b>1</b>	<b>Front Edge of the Moulding</b>
<b>2</b>	<b>Clip No. 3</b>

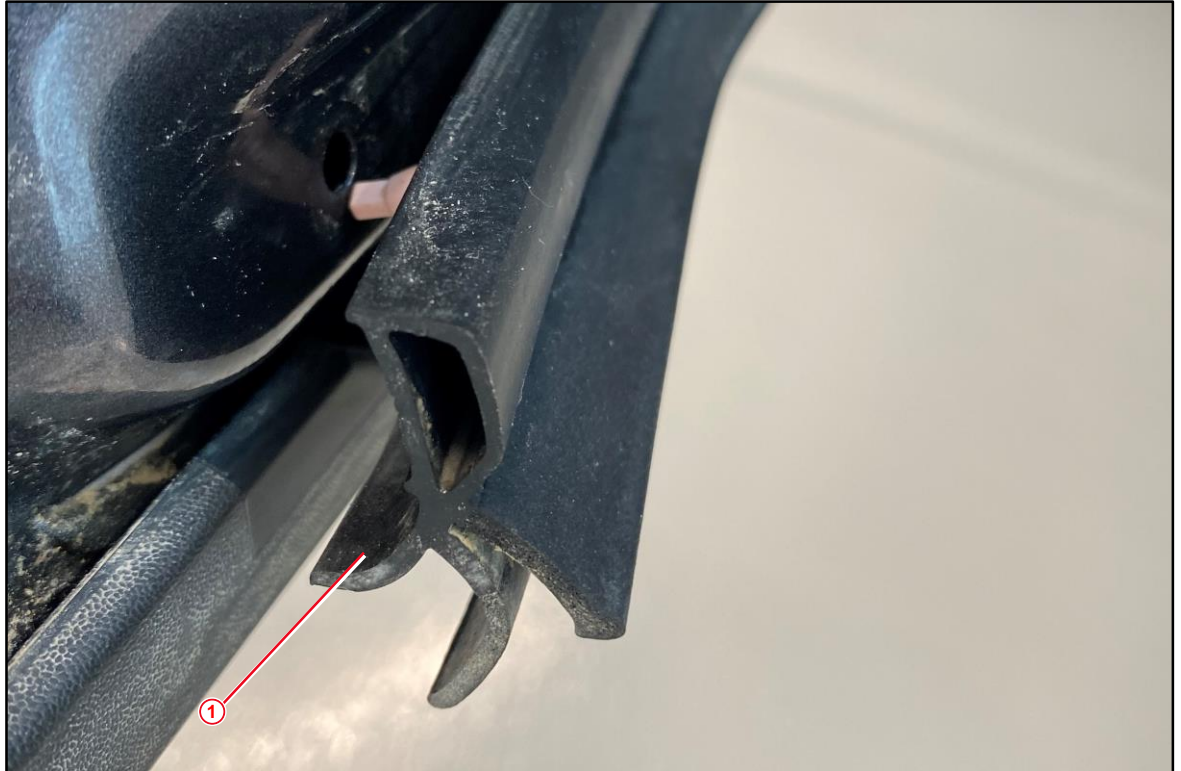
**Figure 10. Weatherstrip Moulding**

<b>1</b>	<b>Inner Lip</b>
----------	------------------

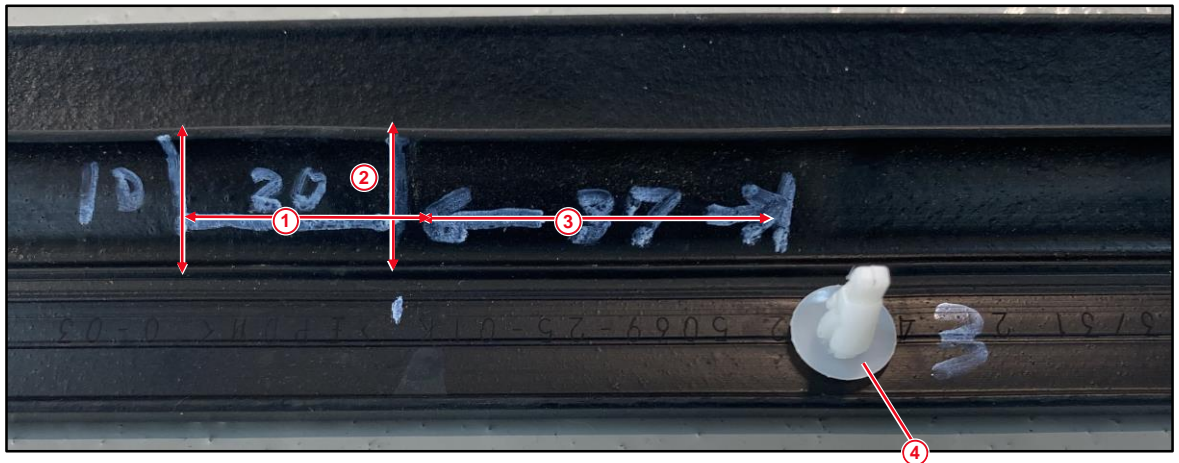
**Figure 11. Weatherstrip Moulding**

B. Cut the inner lip of the weatherstrip moulding with the following dimensions:

**Length: 20 mm**

**Height: 10 mm**

<b>1</b>	Length of Cut: 20 mm
<b>2</b>	Height of Cut: 10 mm
<b>3</b>	Length Between Cut and Clip No. 3: 37 mm
<b>4</b>	Clip No. 4

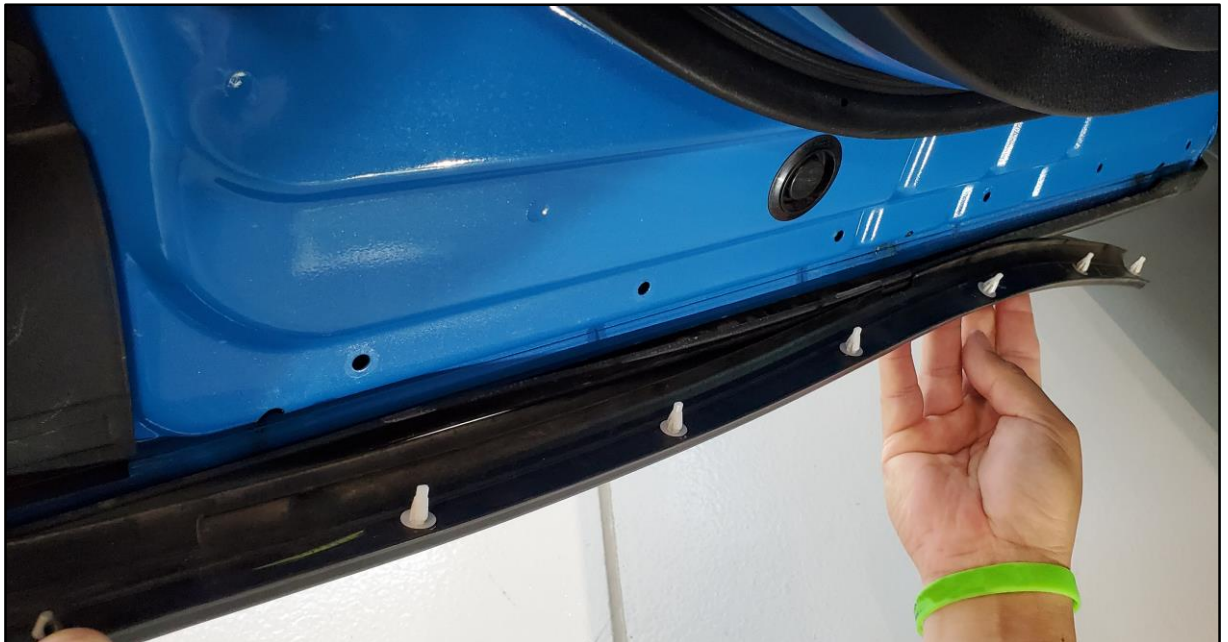
7. Reinstall the weatherstrip moulding back on ALL doors.
  - A. Reinstall the front door No. 2 weatherstrip mouldings by reinstalling the clips.
  - B. Reinstall the rear door No. 5 weatherstrip mouldings by reinstalling the clips.

**Figure 12. Reinstalling Weatherstrip Moulding to Door**

Replace weatherstrip moulding if the clips are damaged during removal.

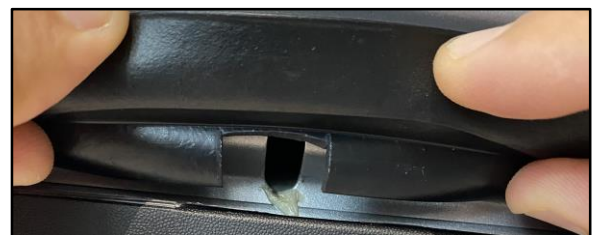
**Figure 13.**

8. Ensure the cut window on the weatherstrip moulding and the drain hole align properly.

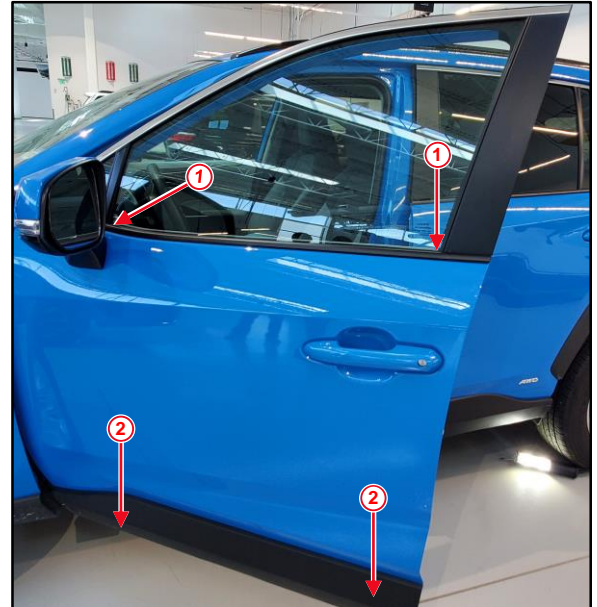
**Figure 14.**

9. Pour water into the repaired doors to confirm the drain holes are working properly.

<b>1</b>	<b>Pour Water Here</b>
<b>2</b>	<b>Check Water Drain</b>

10. Open and close the repaired doors and test-drive the vehicle to ensure the condition no longer exists.
