**SUBJECT:** **Customer Satisfaction Program 21B04 – Supplement #1**  
 Certain 2017 through 2020 Model Year F550 Equipped with Payload Plus Upgrade Package  
 Frame Rail Crack

In some of the affected vehicles certain second unit body (SUB) upfits could cause stress points on the frame rail. Over time this stress could cause a crack in the frame rail behind the cab.

## CERTAIN 2017-2020 MODEL YEAR F550 SUPERDUTY VEHICLES EQUIPPED WITH PAYLOAD PLUS UPGRADE PACKAGE — FRAME RAIL CRACKS

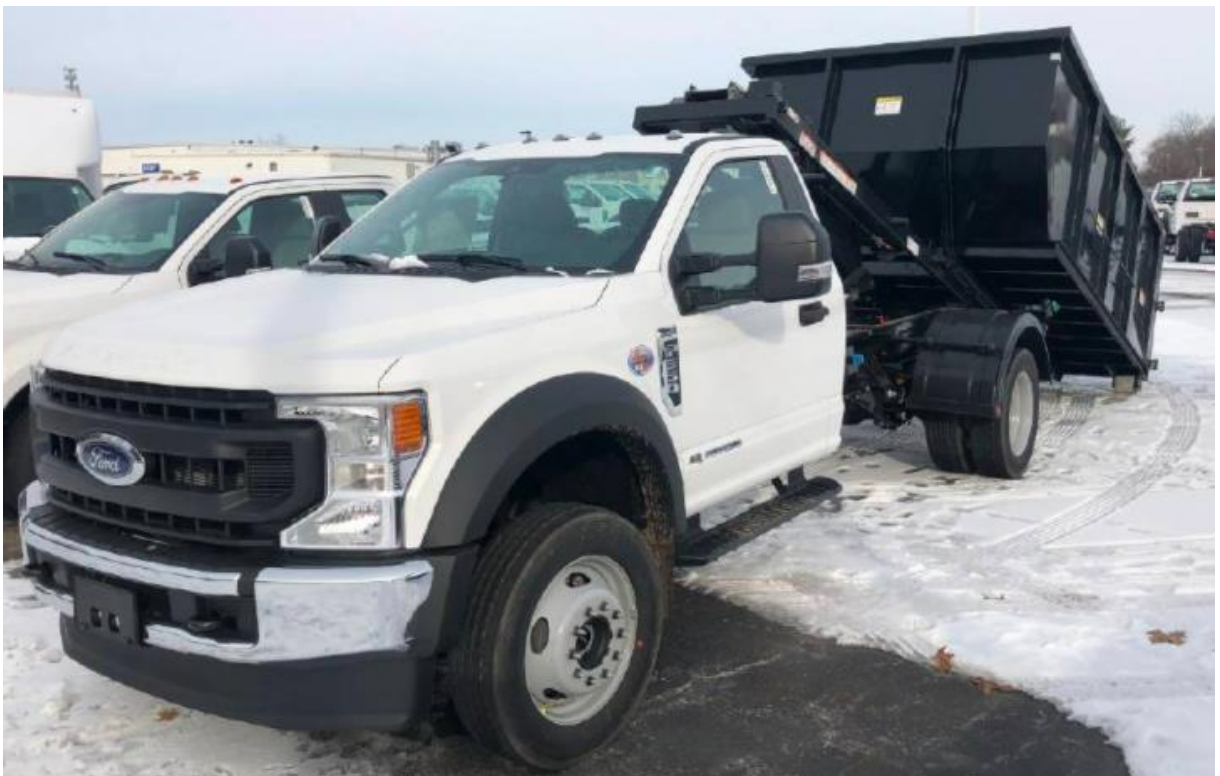
- **Upper and Lower Bracket Kit** - Roll-Off Wreckers, Waste Hauler Roll-Offs and Service Bodies with a Hoist. For questions and assistance, contact the Special Service Support Center (SSSC) via the SSSC Web Contact Site.

NOTE: To gain access to top of the frame with a service body installed it may have to be removed.

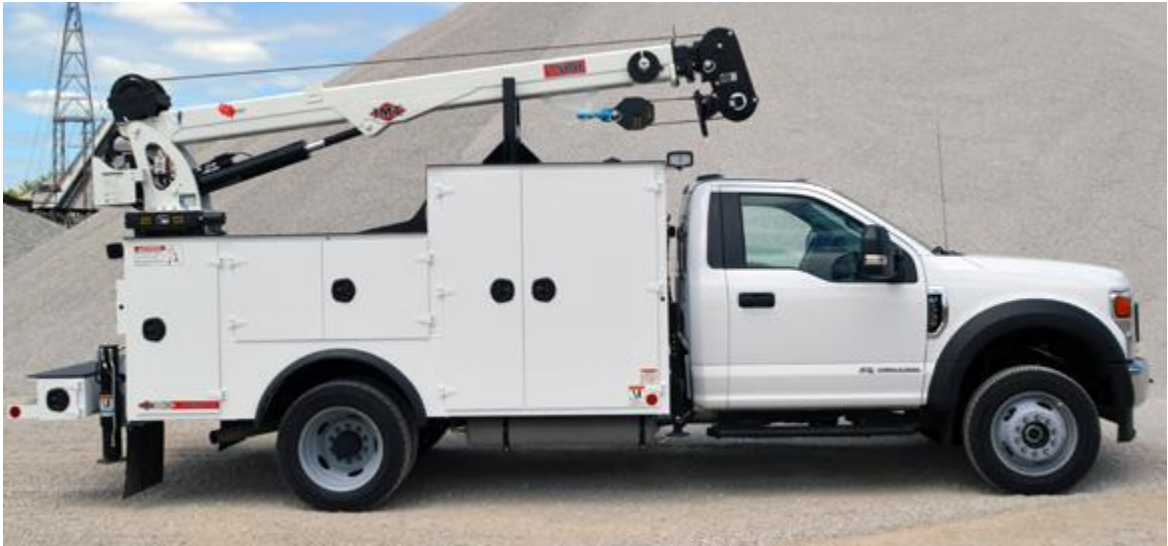
1. Identify and inspect the areas where the frame rail may exhibit signs of stress or a crack. Using compressed air, clear any debris that may be on the frame rails in the area of red dashed box. See Figure 1.

- Are there any signs of stress or cracks found on the frame rail?
  - Yes - Contact Special Service Support Center (SSSC).
  - No - Continue to procedure on Page 2.

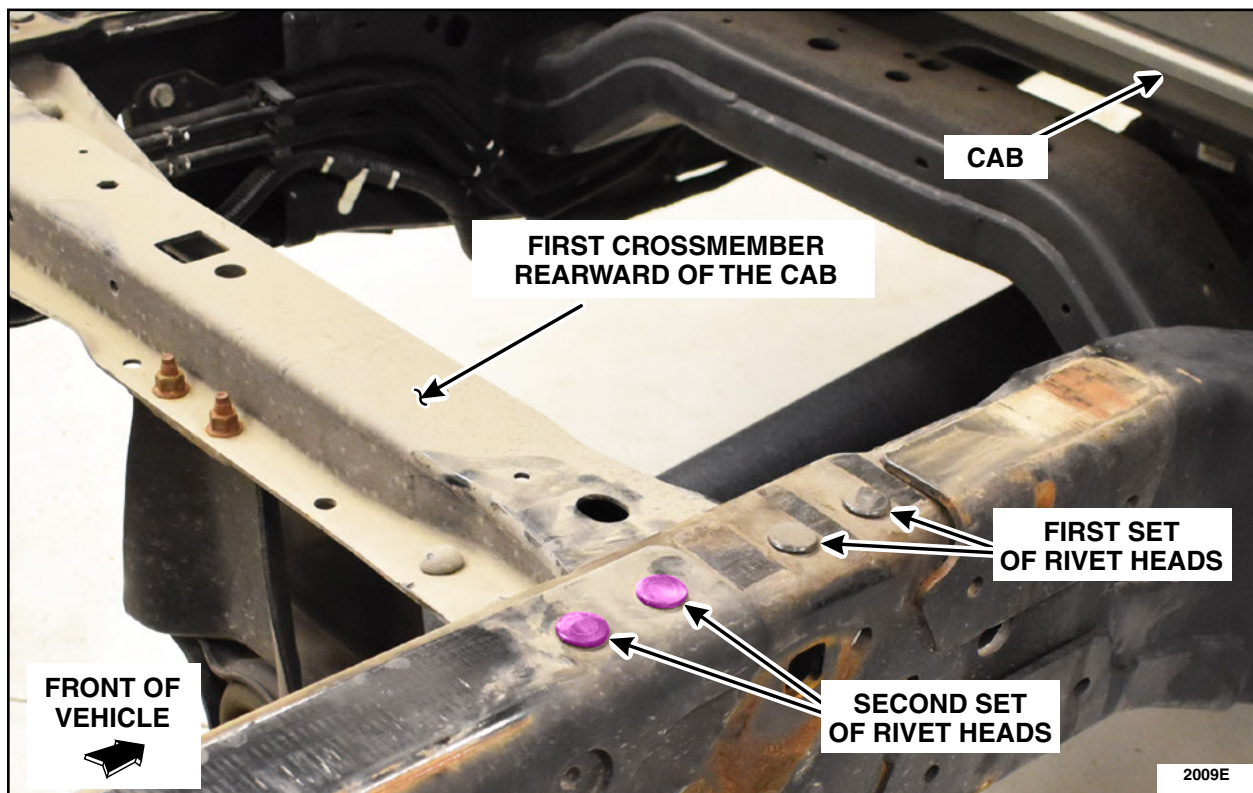
**FIGURE 2**

1. On the RH side frame rail, locate the second set of rivet heads, rearward of the cab. See Figure 2.

**NOTE:** Non-60CA frame shown, 60CA frame similar. The first crossmember rearward of the cab will be set further rearward on the 60CA frame.

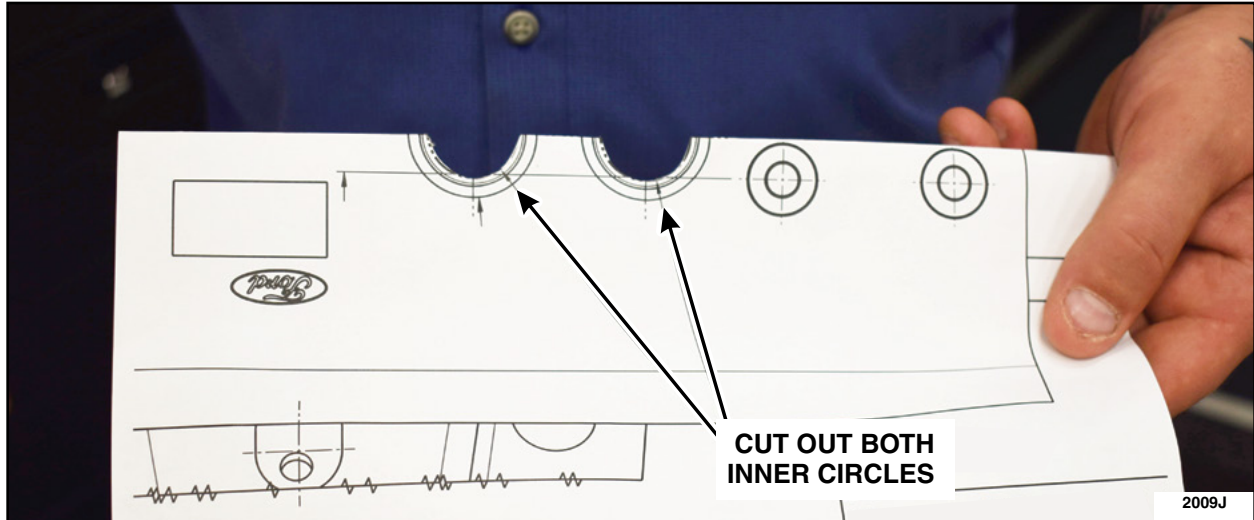
**FIGURE 3**

2. Print out the RH Upper Frame Rail Bracket Template (See Attachment IV) per the 60 CA and Non-60 CA. When printing the templates ensure that the printers Page Size is set to **'Actual size'** and Page Orientation set to **'Landscape'**.
3. Cut out the two (2) larger rivet heads on the template, cut out the inner most circle by slightly folding the template at the center line of the larger circles and cut out the half moon shape. See Figure 3.

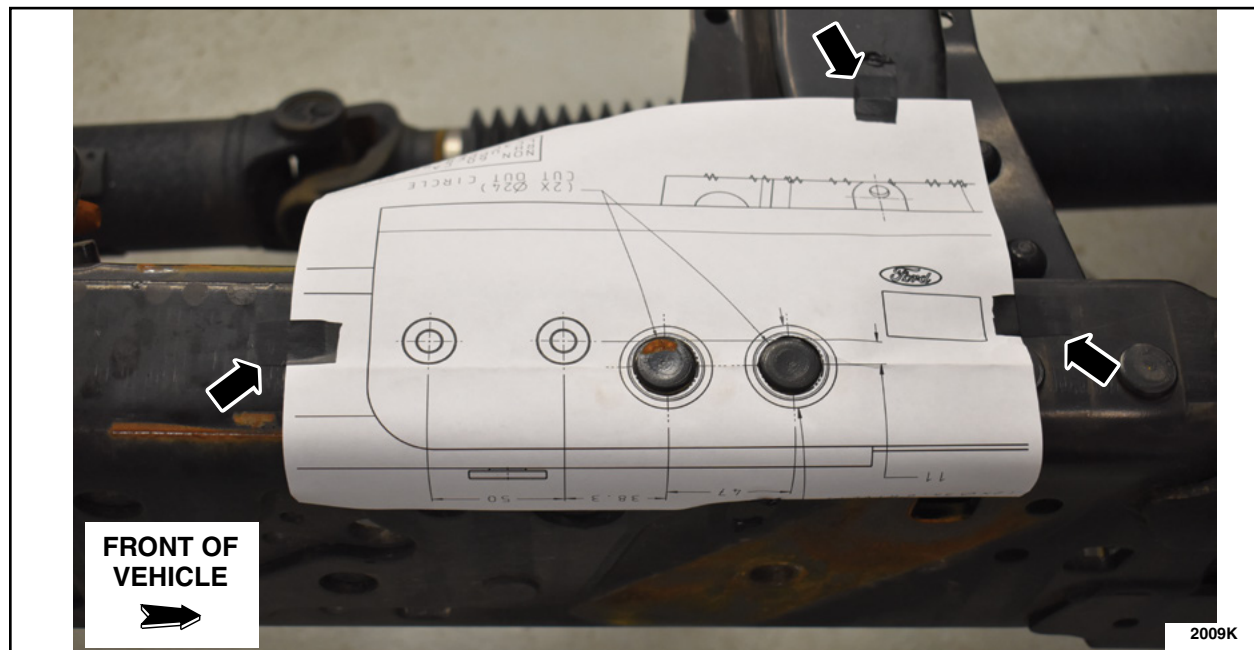
**FIGURE 4**

4. Place the template over the rivet heads, identified in Step 1, and secure the template to the frame with tape. See Figure 4.

**NOTE: Non-60CA frame shown, 60CA frame similar. The first crossmember rearward of the cab will be set further rearward on the 60CA frame.**

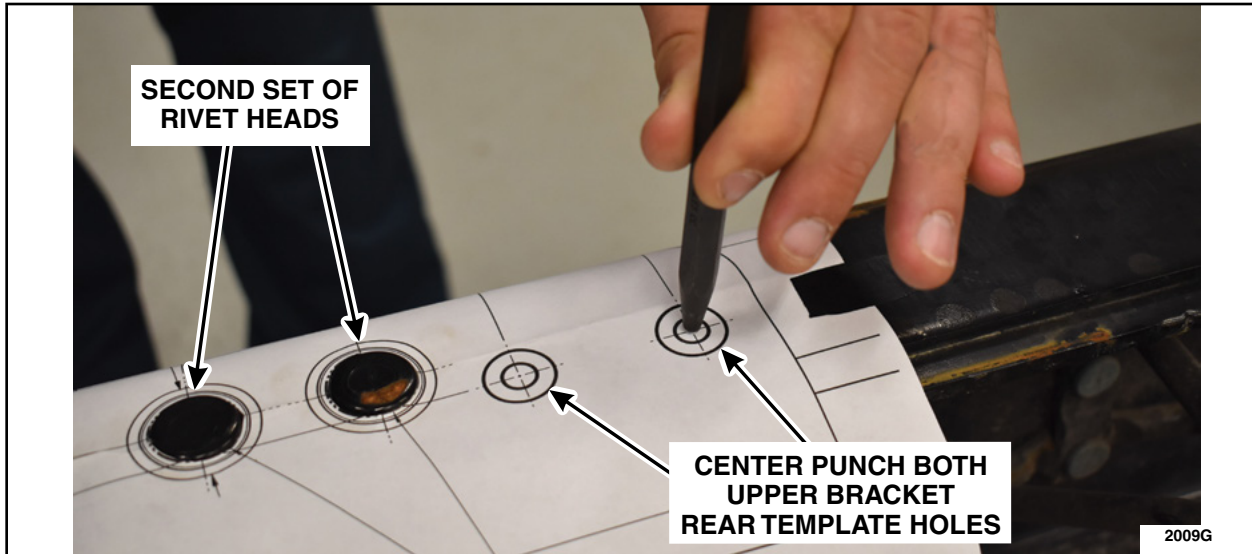
FIGURE 5

5. Using a center punch, mark the center of the smaller diameter circles. See Figure 5.

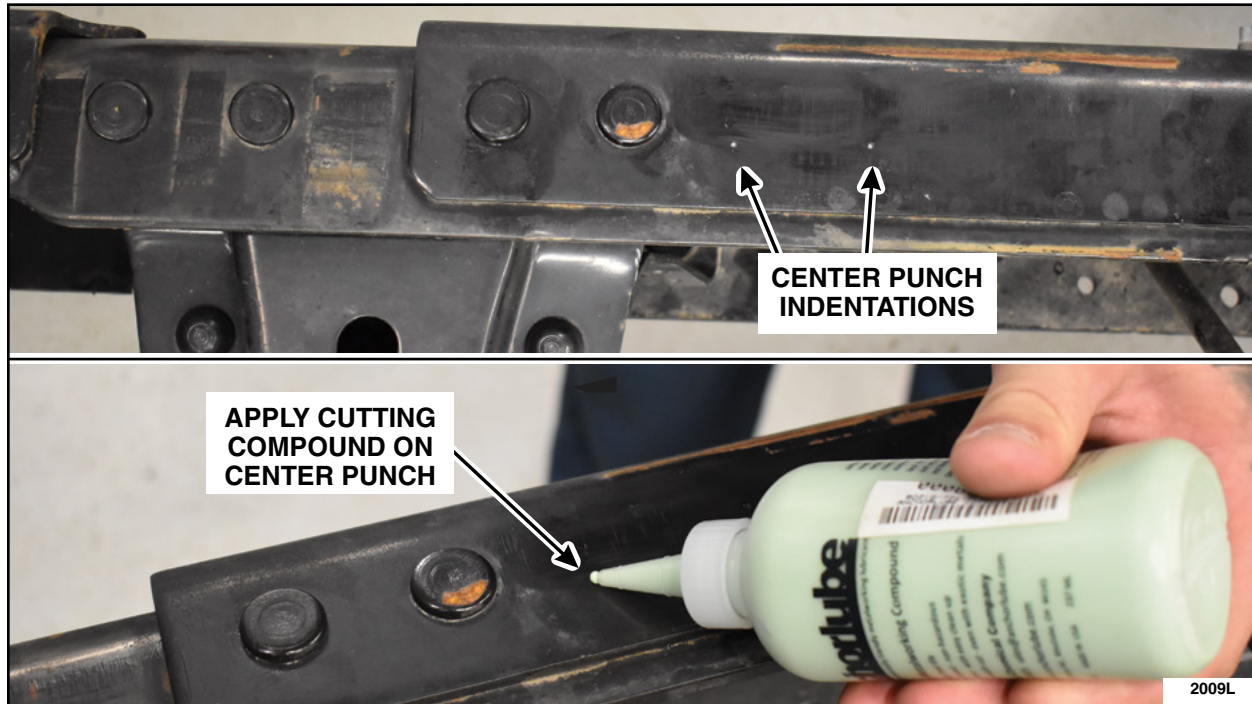
FIGURE 6

6. Remove the template from the frame and apply a bead of Anchorlube G771 or equivalent. See Figure 6.

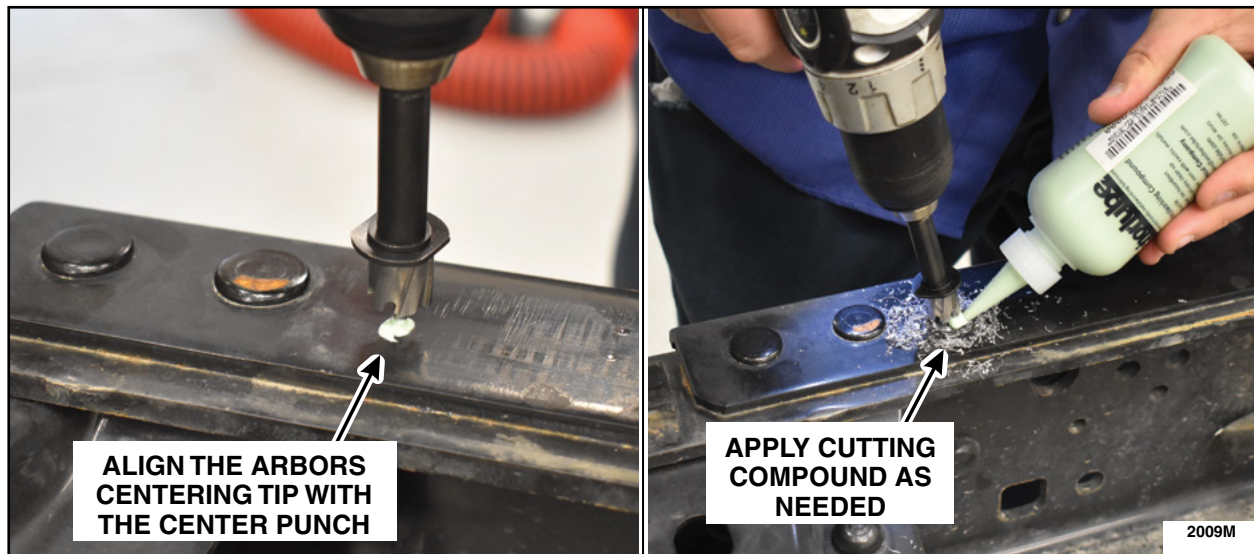
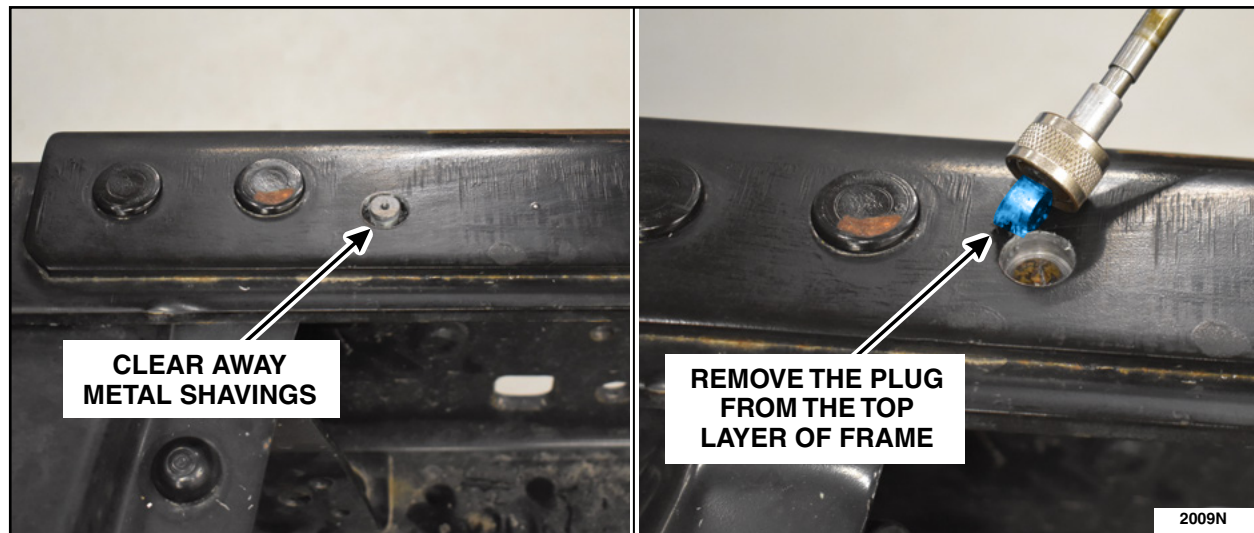
**NOTE:** On dual layer frame drilling, once the drill bit has cut through the upper layer you will need to stop and clear away any shavings and remove the loose piece of the upper frame in order to continue drilling through the lower layer. See Figures 7 and 8.

**NOTE:** One RotaBroach bit, with proper use of cutting fluid, will be able to drill holes on several trucks before needing replaced.

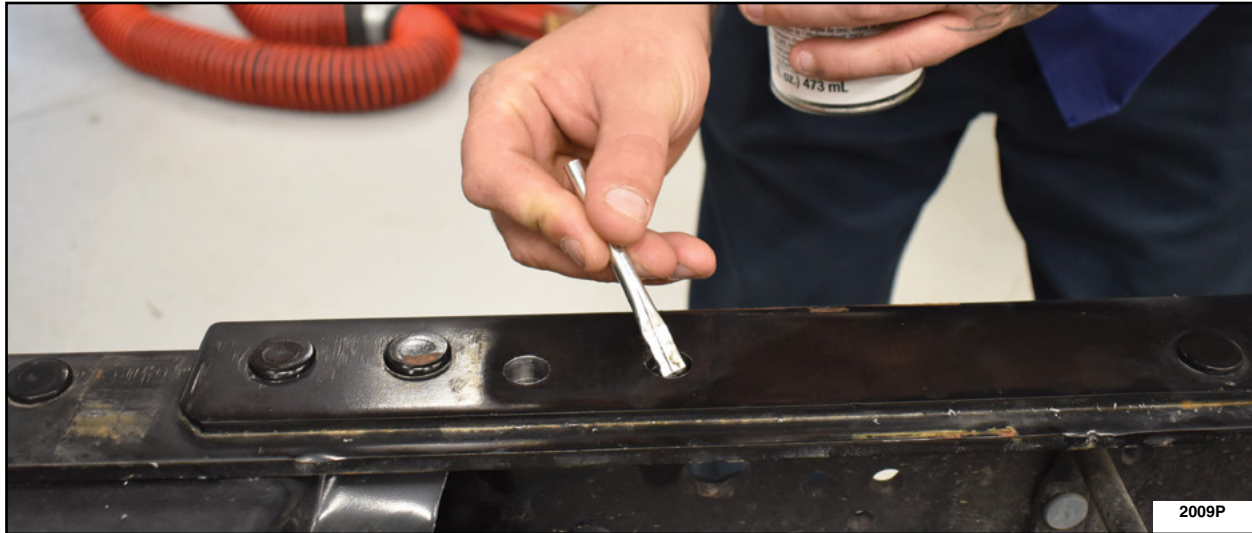
**FIGURE 9**

8. Clear away any shavings and clean the drilled holes and the frame around them, using rubbing alcohol and a clean shop towel.
9. Using a small brush and Motorcraft® High Temperature Anti-Corrosion Coating (PM-13-A), apply the coating in and around the holes that were just drilled, to cover any bare metal present from the drilling of the holes. See Figure 9.

- Clear away any shavings and clean the drilled holes and the frame around them, using rubbing alcohol and a clean shop towel.
- Using a small brush and Motorcraft® High Temperature Anti-Corrosion Coating (PM-13-A), apply the coating in and around the holes that were just drilled, to cover any bare metal present from the drilling of the holes. See Figure 9.

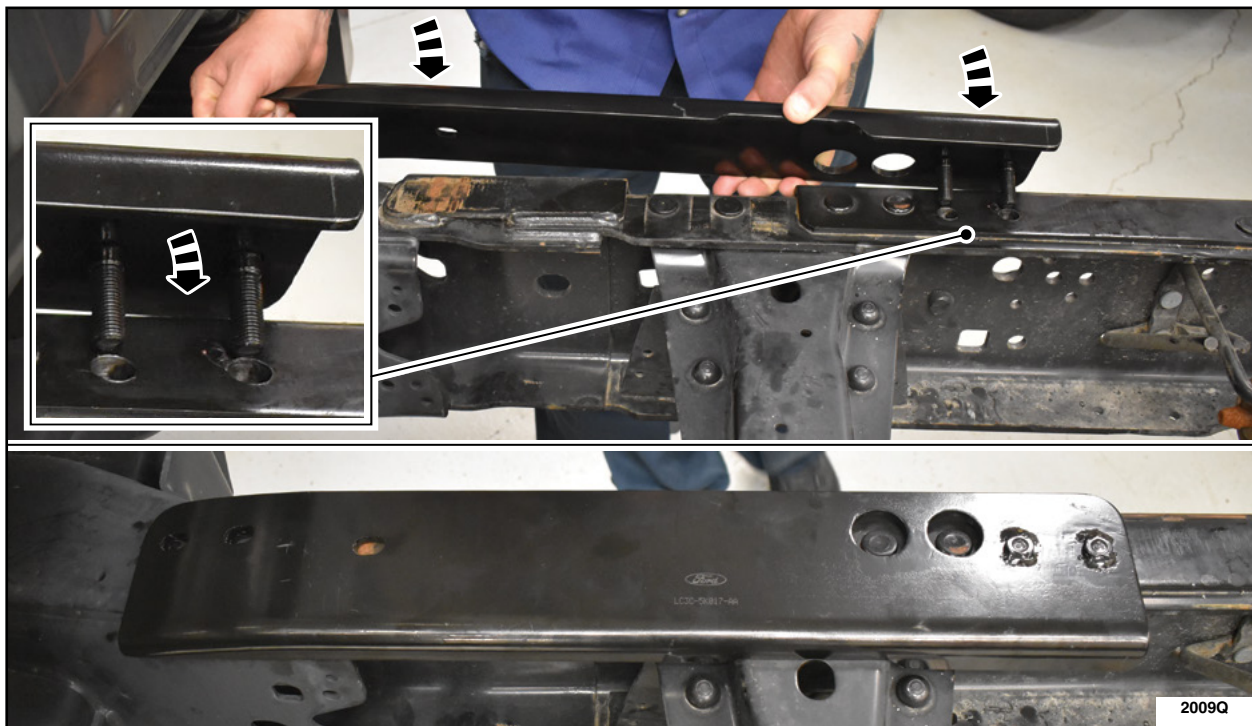
**FIGURE 10**

10. Position the upper bracket on the frame and seat the two (2) rear studs into the drilled holes. See Figure 10.

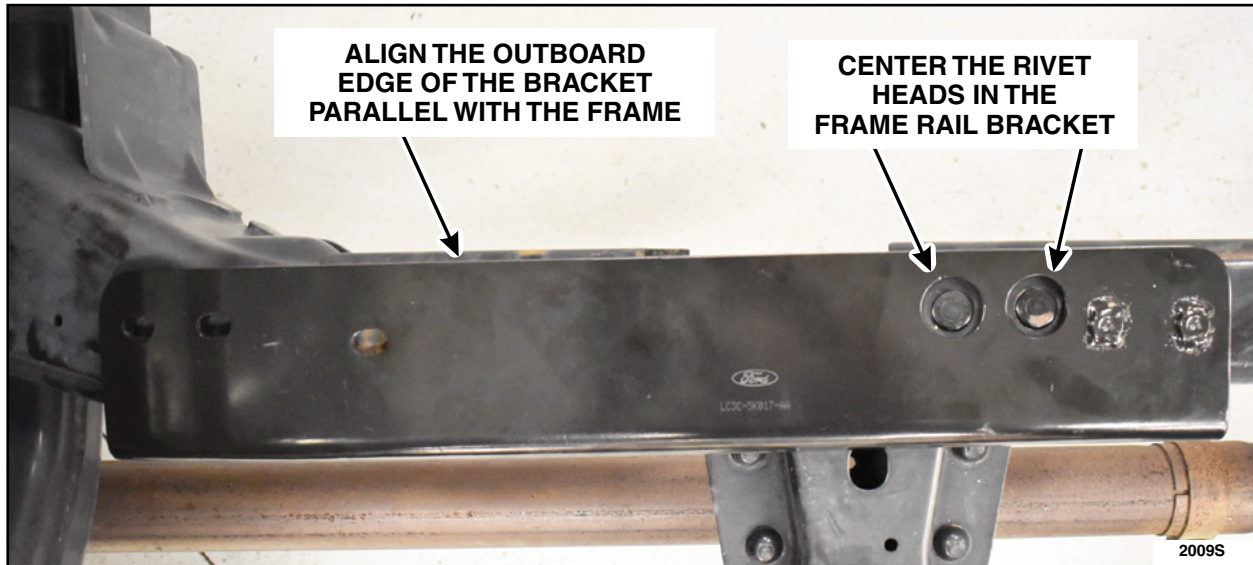
FIGURE 11

11. Use the bracket as a template to mark the front drill hole locations by;

- a. Centering the two (2) rivet heads in the bracket rivet holes. See Figure 11.
- b. Ensuring that the outboard edge of the bracket is flush with the frame. See Figure 11.
- c. Clamp the bracket to the frame and center punch the front two (2) holes. See Figures 12 and 13.

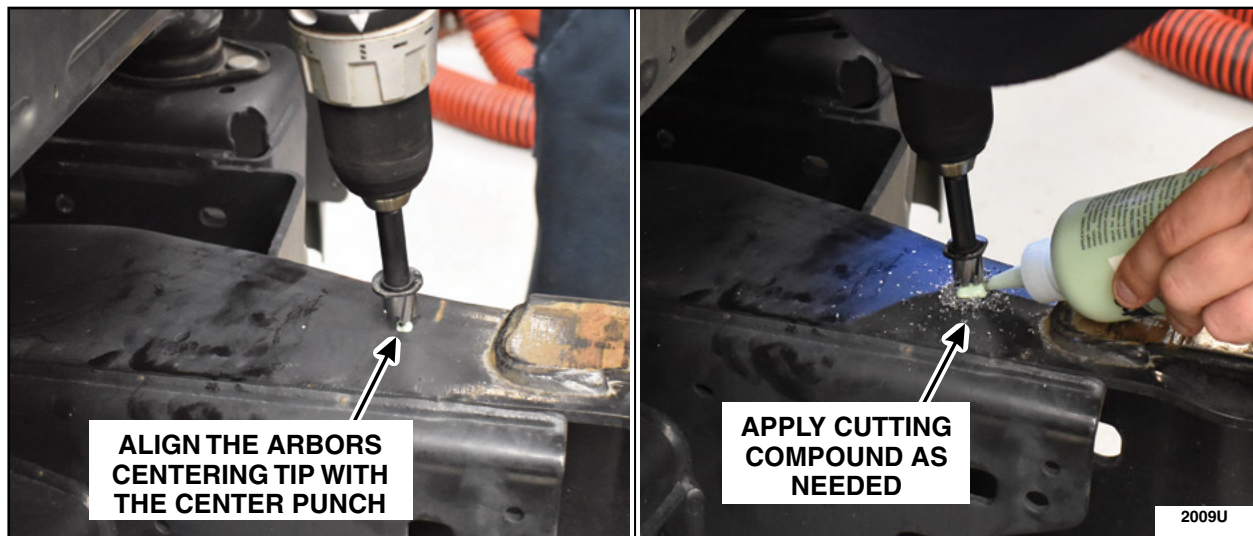
**FIGURE 14**

**NOTE:** Cutting fluid, such as Anchorlube G771, will need to be applied several times during the cutting out of these holes.

**NOTE:** One RotaBroach bit, with proper use of cutting fluid, will be able to drill holes on several trucks before needing replaced.

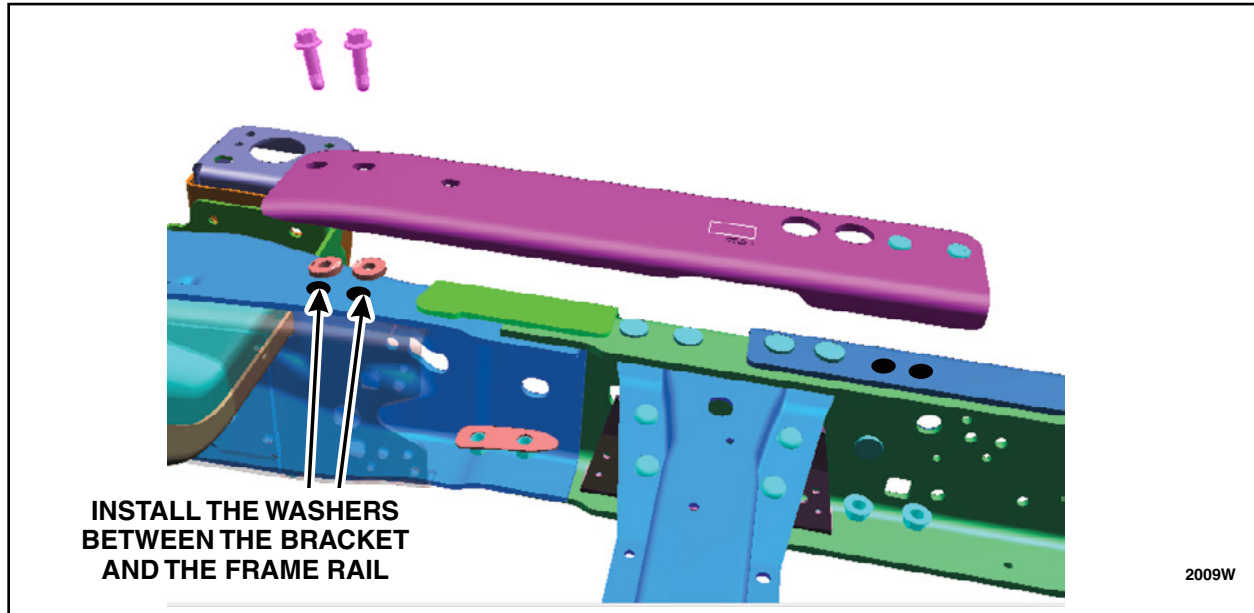
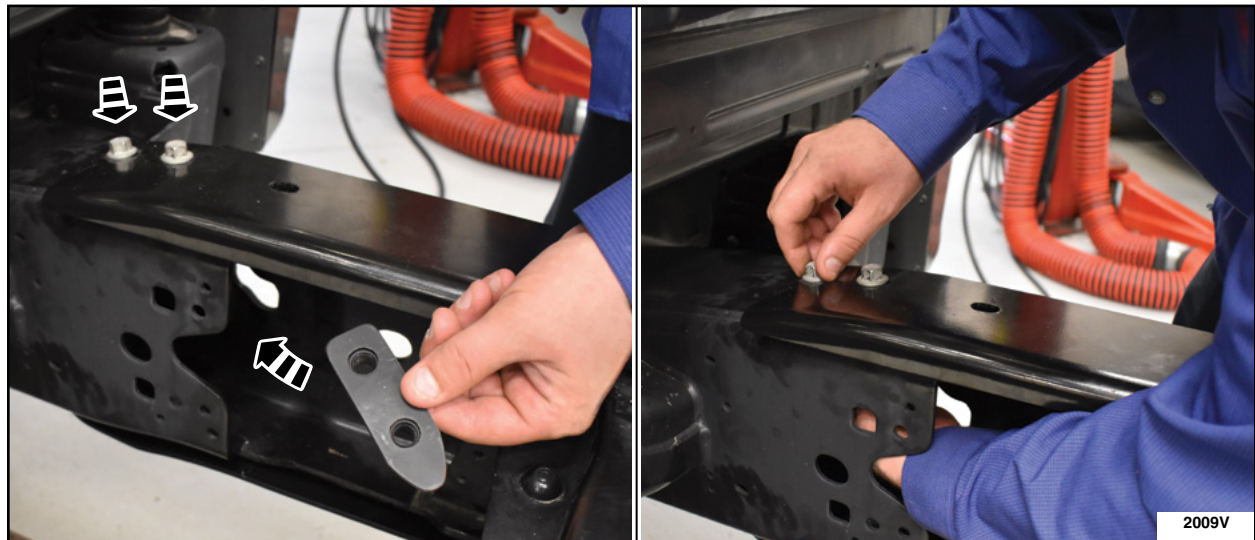
17. Install a spacer, Part Number LC3C-5113-CA, between the upper bracket and the frame rail, one for each bolt, then install front bracket to frame bolts in the front two holes and position the front nut plate in the frame and start the bolts into the nut plate. See Figures 15 and 16.

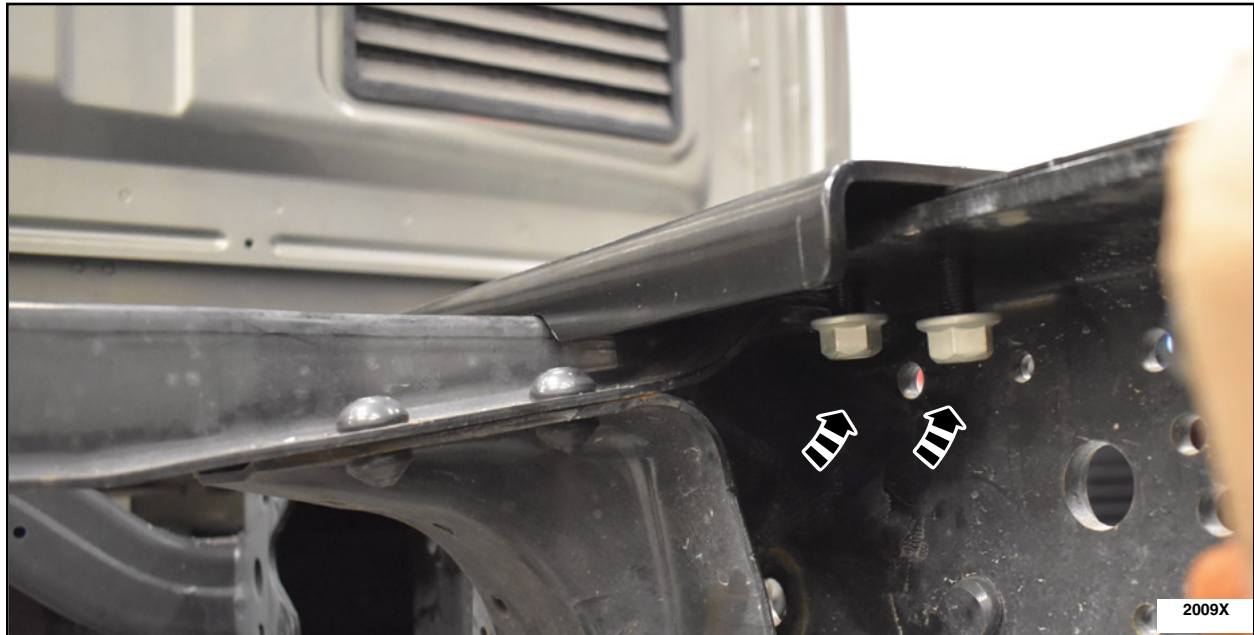
**FIGURE 17**

18. Install the rear nuts, onto the bracket rear studs, finger tight at this time. See Figure 17.

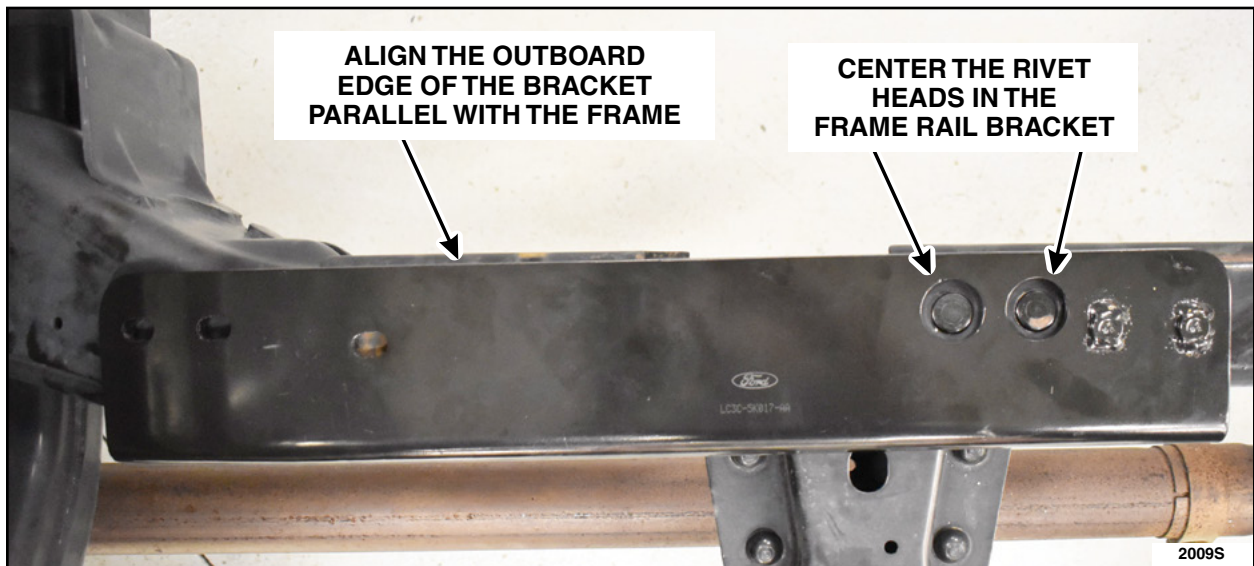
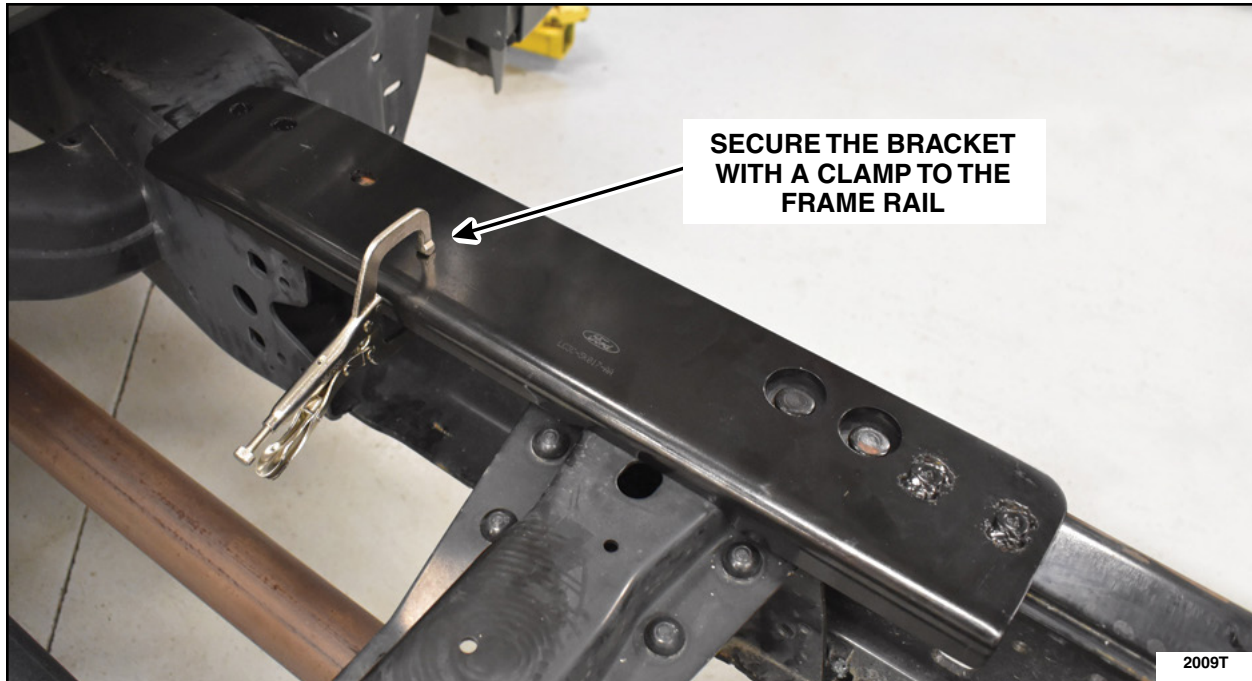
20. With the bracket setting flush against the top of the frame, ensure that the outboard edge is flush with the frame and the rivet heads are centered in the bracket openings. Secure the bracket to the frame rail with a clamp. See Figures 18 and 19.

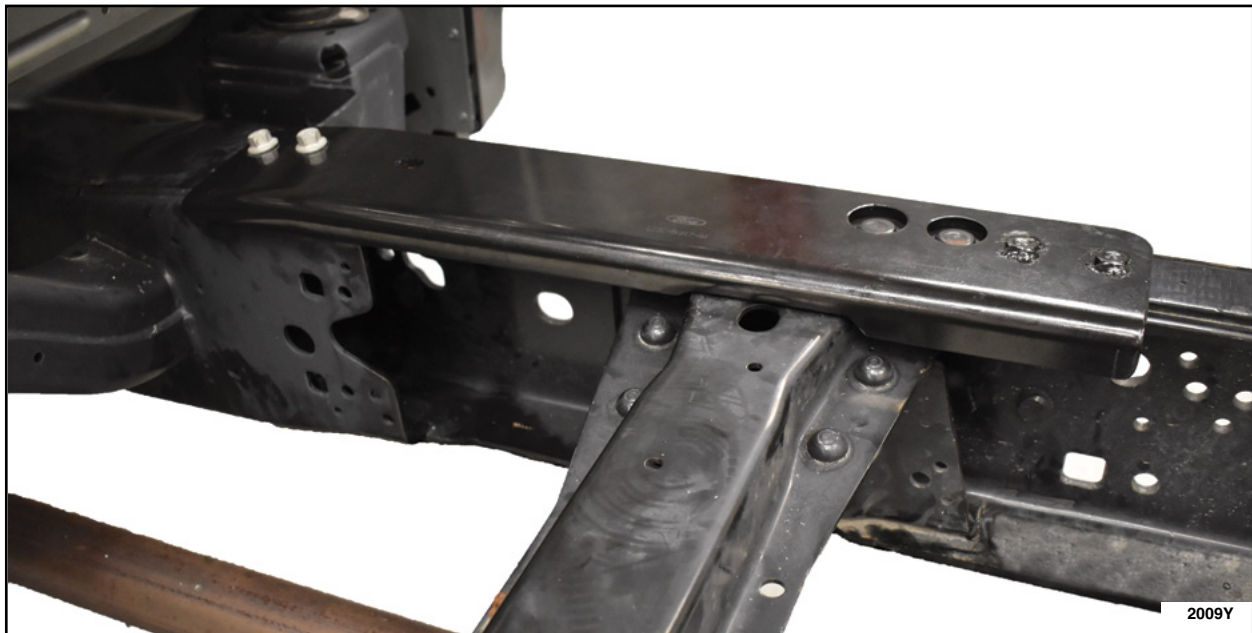
**FIGURE 20**

21. Tighten both front bolts and both rear nuts. Then remove the clamp. Figure 20 shows a fully installed upper RH bracket

- Tighten to: 59 lb. ft (80 Nm).

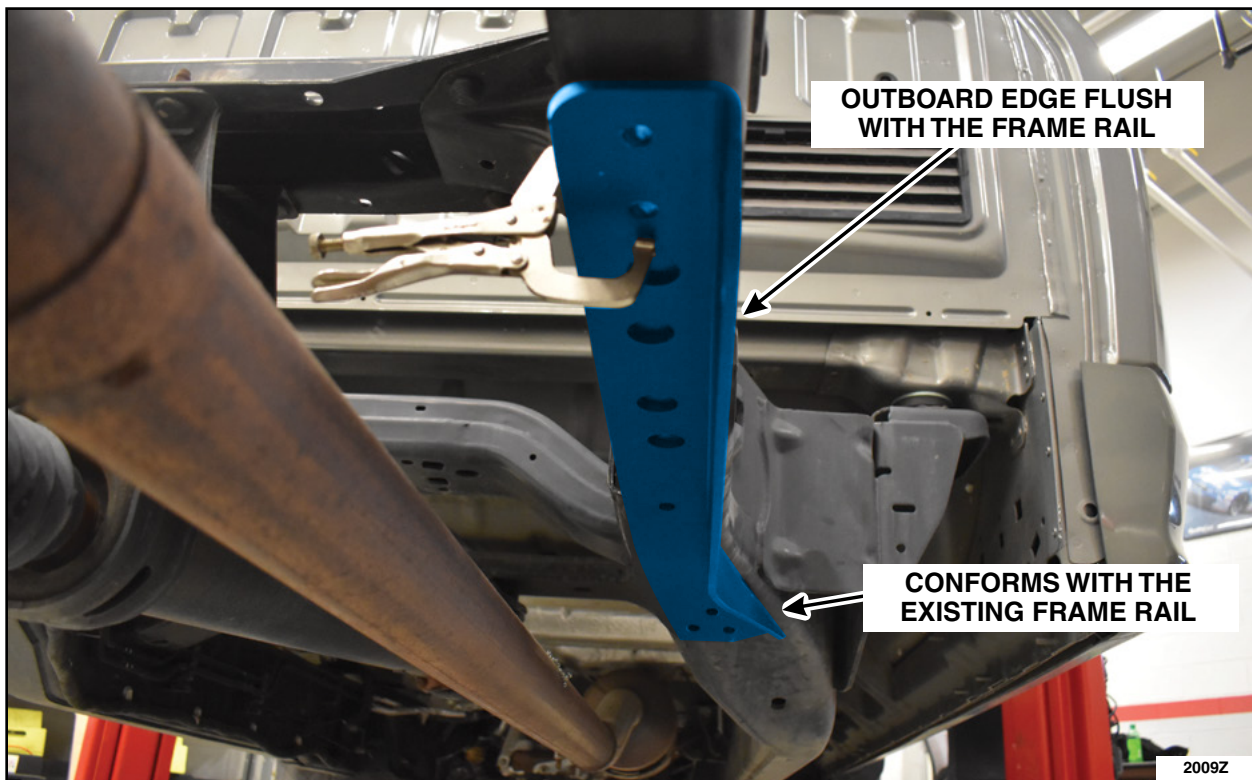
**FIGURE 21**

1. Using the help of an assistant, Position the lower bracket in place, up against the lower frame rail as shown in Figure 21. Align the bracket to the contour of the frame.
  - a. Ensure that the outboard edge is flush with the outboard side of the frame rail.
  - b. Clamp the bracket to the frame.

**NOTE:** Non-60CA frame shown, 60CA frame similar. The first crossmember rearward of the cab will be set further rearward on the 60CA frame.

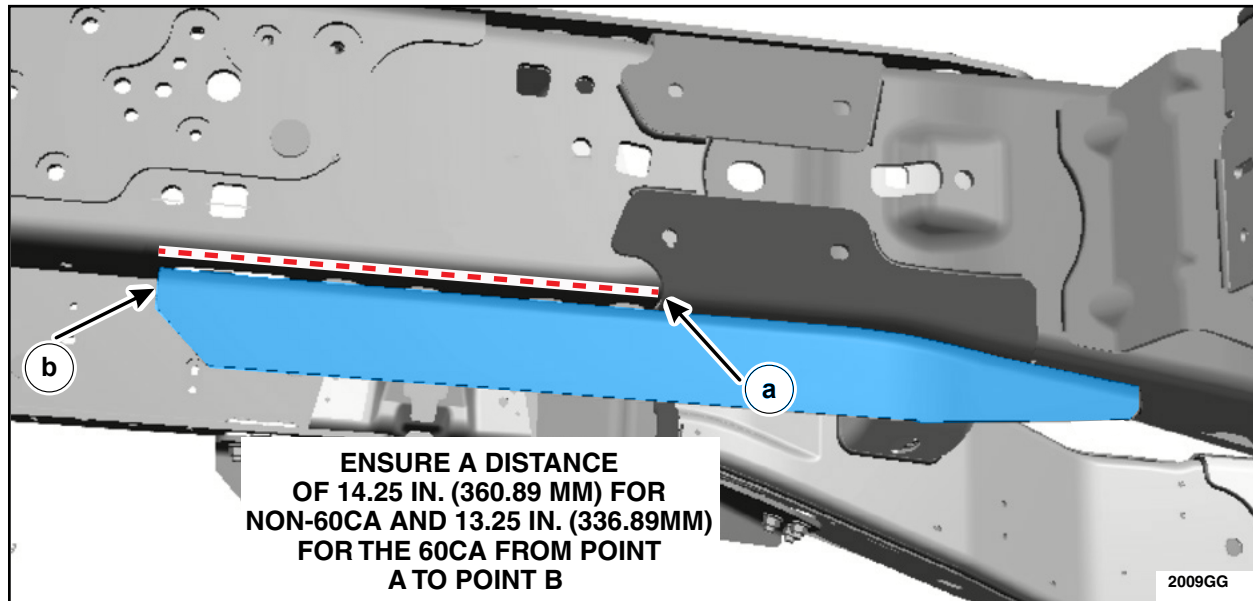
**FIGURE 22**

**NOTE:** Non-60CA frame shown, 60CA frame similar.

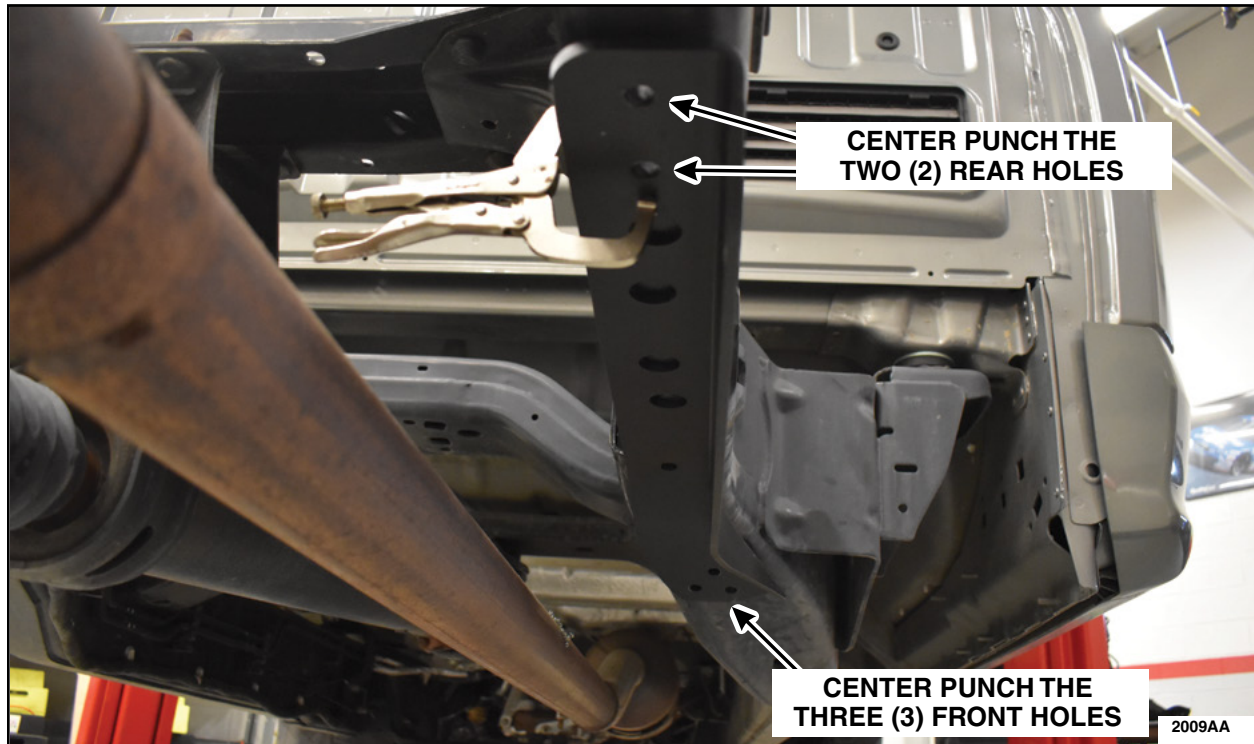
FIGURE 23

**NOTE:** The lower bracket on the 60CA frames will utilize only one (1) rear hole, not two (2) like the Non-60CA. These bracket will use a single fastener at the rear of the bracket and will use a single flag stud to attach the bracket to the frame.

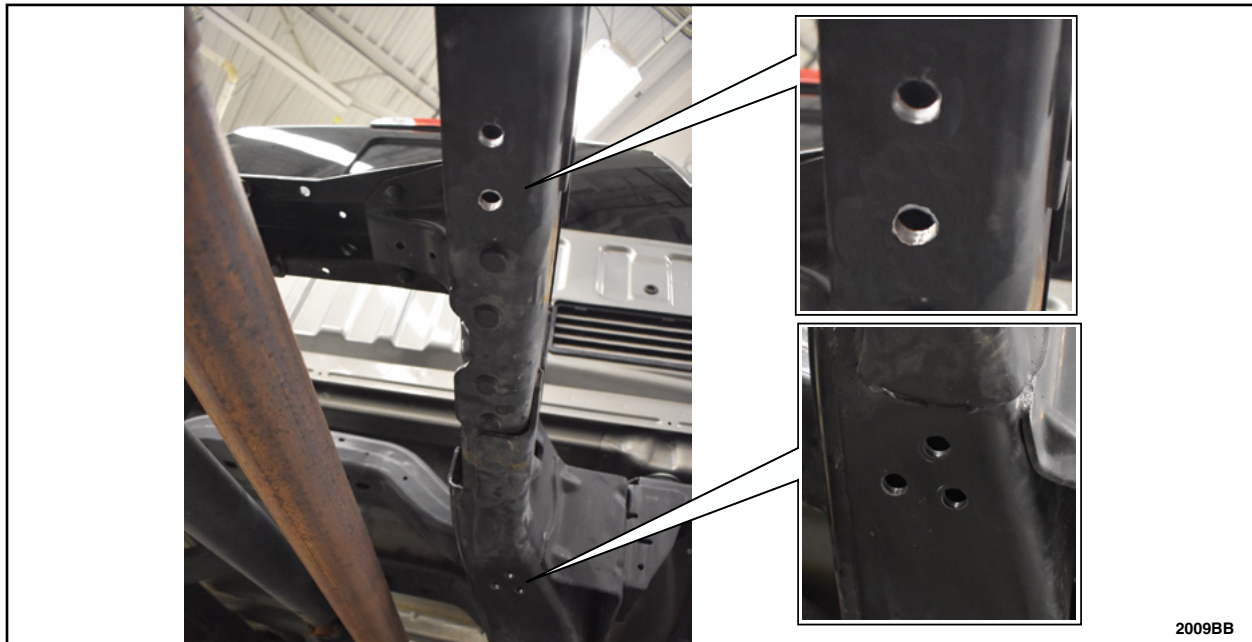
**FIGURE 24**

**NOTE:** The lower bracket on the 60CA frames will utilize only one (1) rear hole, not two (2) like the Non-60CA, to secure the rear of the bracket to the frame.

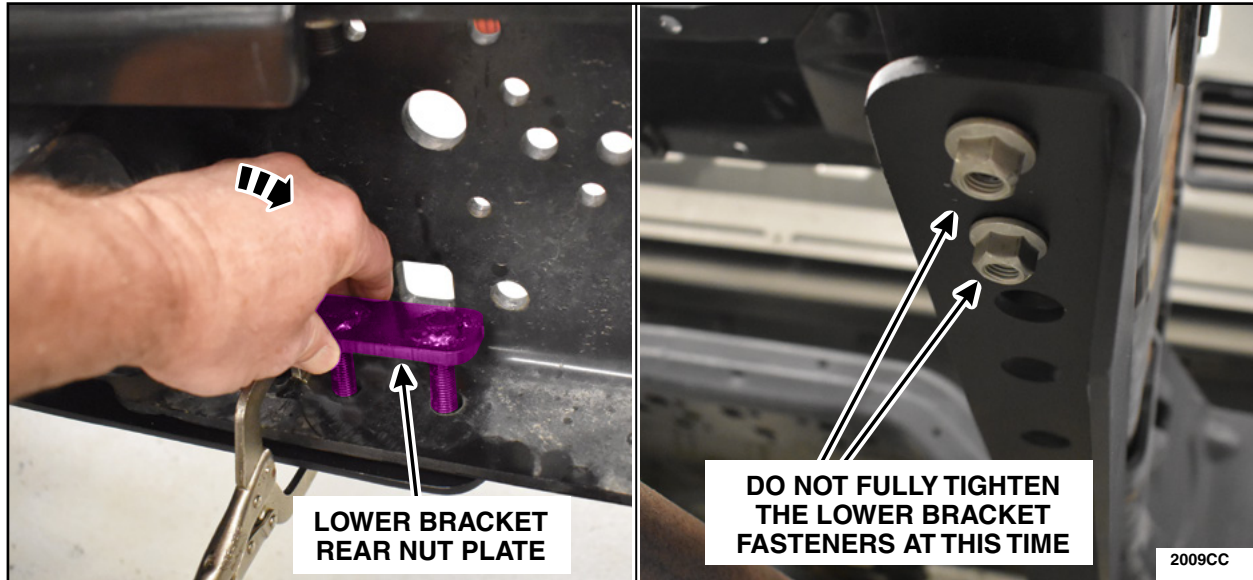
FIGURE 25

7. Position the lower bracket back in place with the rear two (2) holes aligned for Non-60CA and the four (4) holes aligned for the 60CA, and clamp the bracket to the frame. Install the rear nut plate and the two (2) rear fasteners as shown in Figure 25. Do Not fully tighten the fasteners at this time.

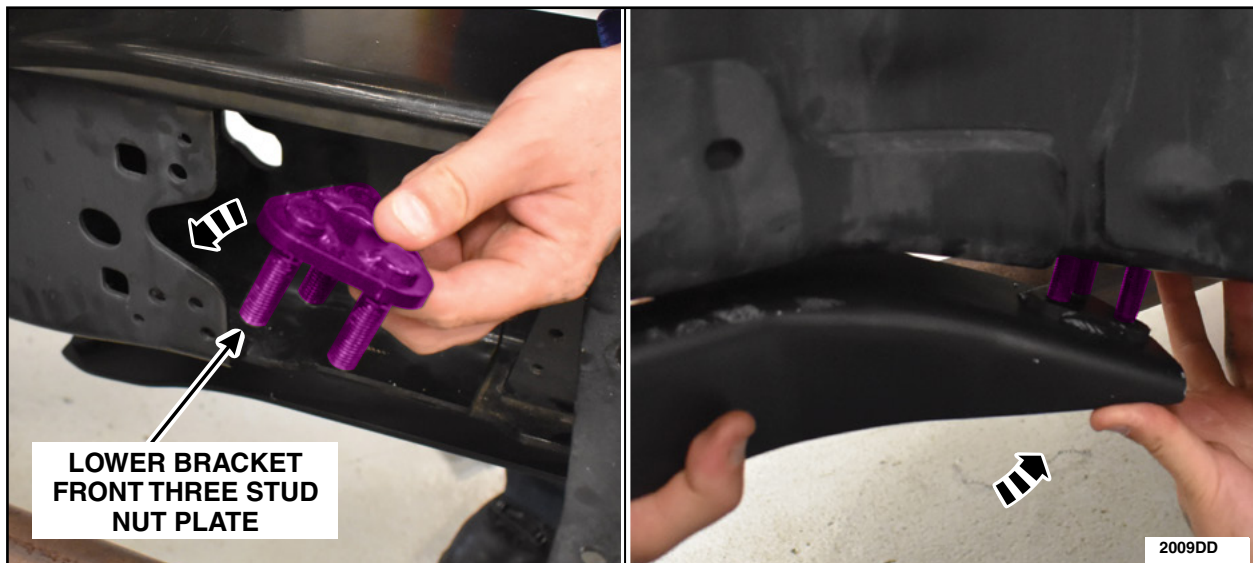
FIGURE 26

8. Install the lower bracket front three stud nut plate, with the three studs facing downward. (To aid in installing the lower bracket three stud nut plate in boxed portion of frame, a magnet pick up tool can be used to place into position.) Push the bracket upward and install all three (3) nuts. Even with the lower bracket rear stud nuts loose, the front nut plate will still need to be worked into the lower bracket holes, once through the frame. See Figure 26.

**NOTE:** The lower bracket front nut plate can be installed in any position. It is normal for the front portion of the lower bracket to sag until all fasteners have been fully tightened.

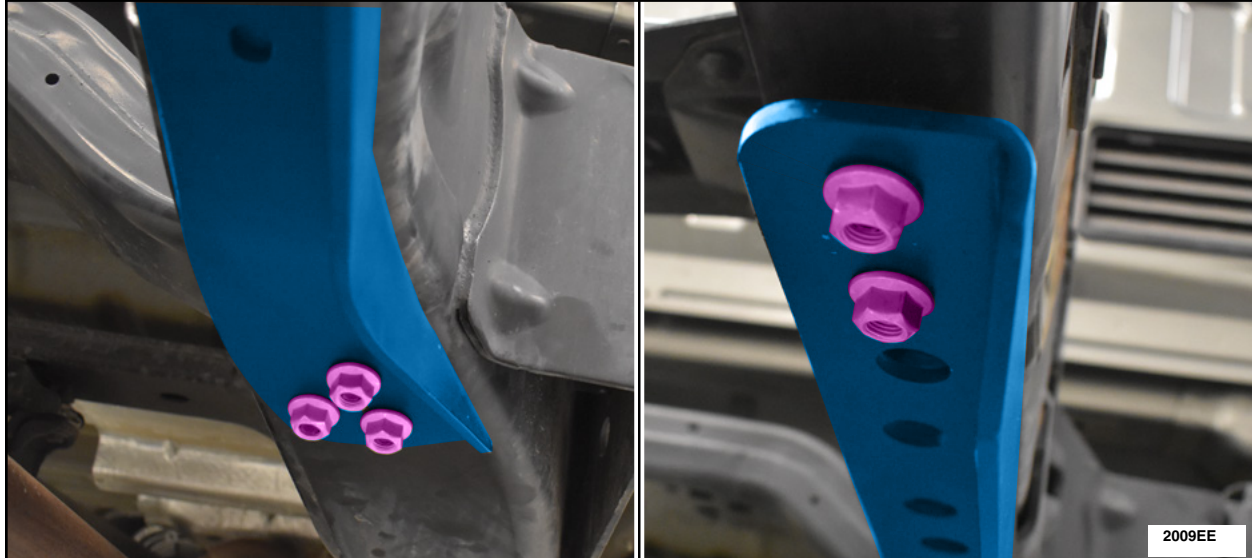
**FIGURE 27**

- Tighten to: 59 lb. ft (80 Nm).

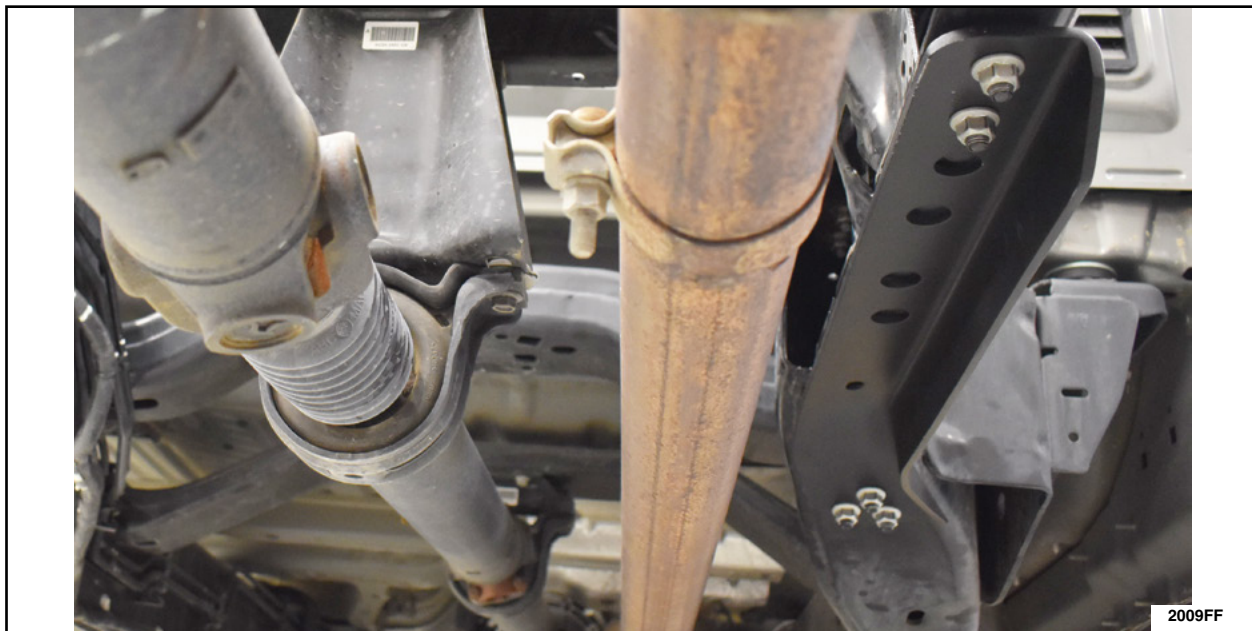
**FIGURE 28**

10. Figure 28 shows the fully installed right lower Frame Rail Bracket.
