**SUBJECT:** **Customer Satisfaction Program 21B04 – Supplement #1**  
 Certain 2017 through 2020 Model Year F550 Equipped with Payload Plus Upgrade Package  
 Frame Rail Crack

In some of the affected vehicles certain second unit body (SUB) upfits could cause stress points on the frame rail. Over time this stress could cause a crack in the frame rail behind the cab.

## CERTAIN 2017-2020 MODEL YEAR F550 SUPERDUTY VEHICLES EQUIPPED WITH PAYLOAD PLUS UPGRADE PACKAGE — FRAME RAIL CRACKS

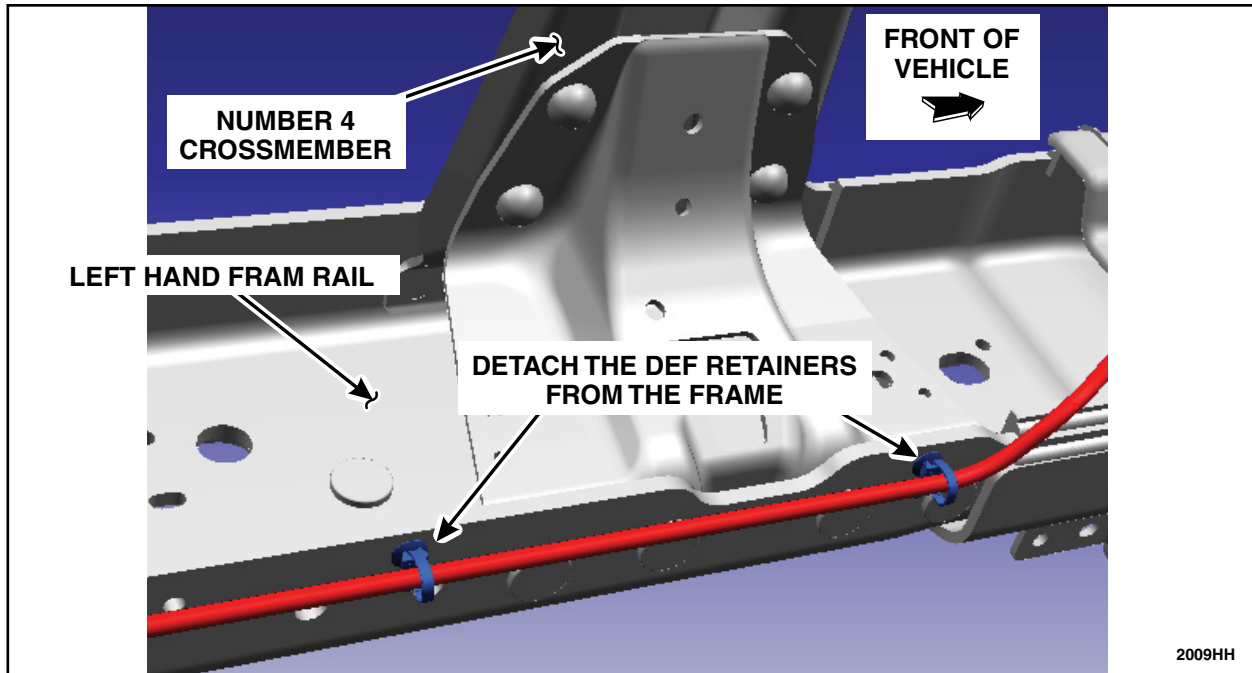
**FIGURE 29**

**NOTE:** The DEF pressure line is shown in the factory installed position.

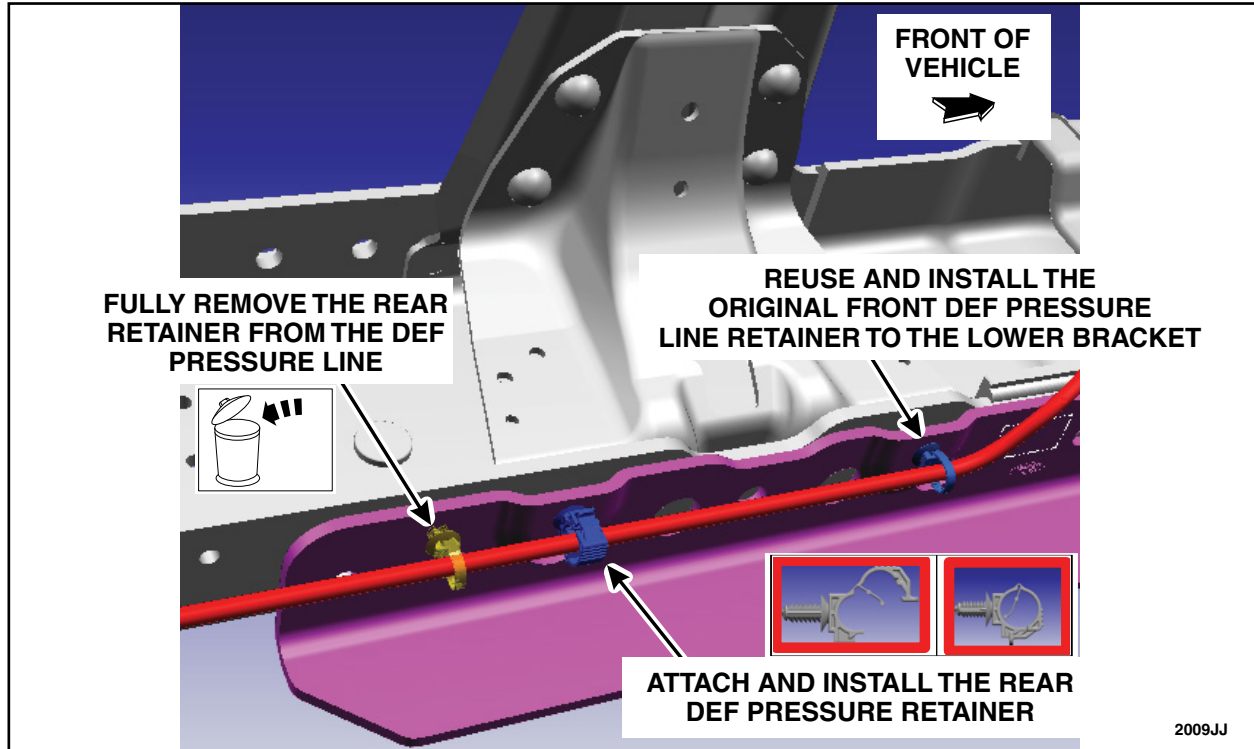
**FIGURE 30**

2. Once the LH side lower bracket has been installed, position back the DEF pressure line and attach the existing front line to frame retainer to the lower bracket as shown in Figure 30. Then, remove and discard the original rear line to frame retainer from the DEF pressure line. Then, attach the supplied clasp retainer to the DEF pressure line and install into the rear lower bracket retainer hole as shown in Figure 30.

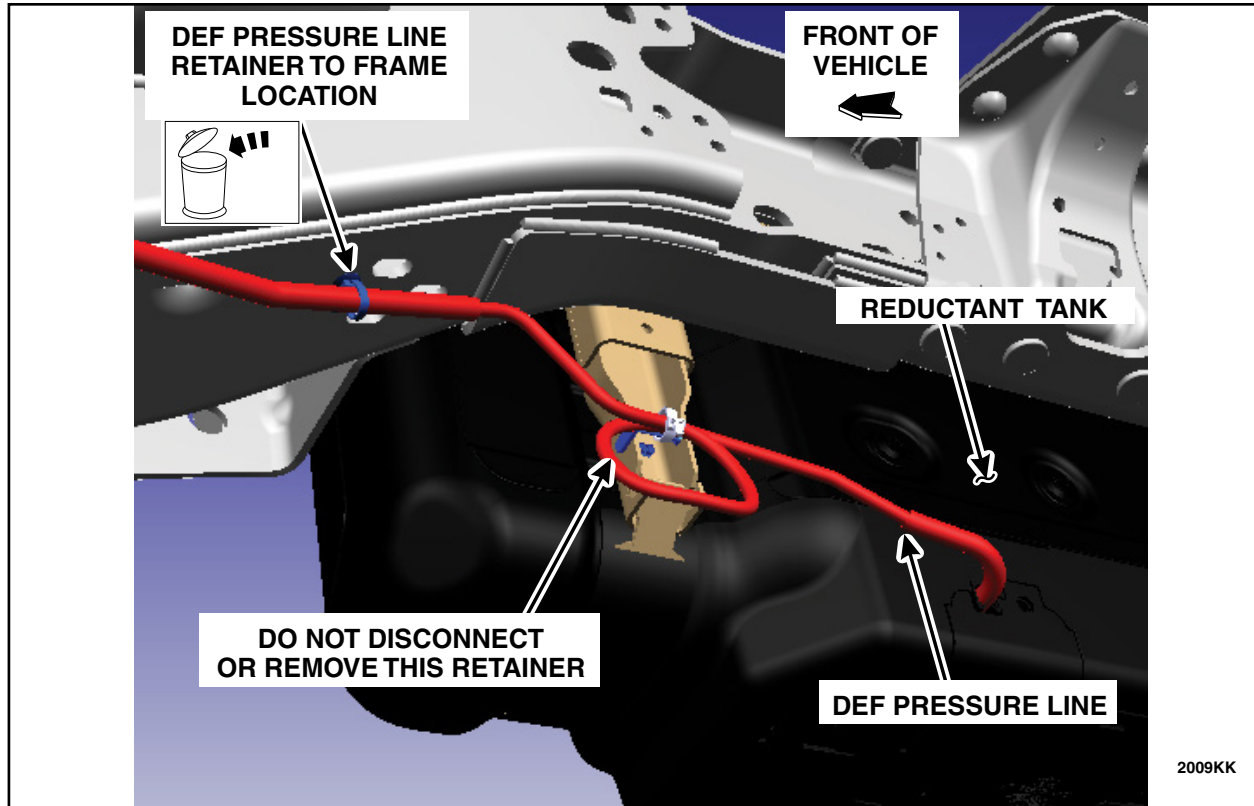
**FIGURE 31**

1. Detach the single DEF pressure line retainer from the RH lower frame as shown in Figure 31. Then, completely remove and discard the retainer from the DEF pressure line.

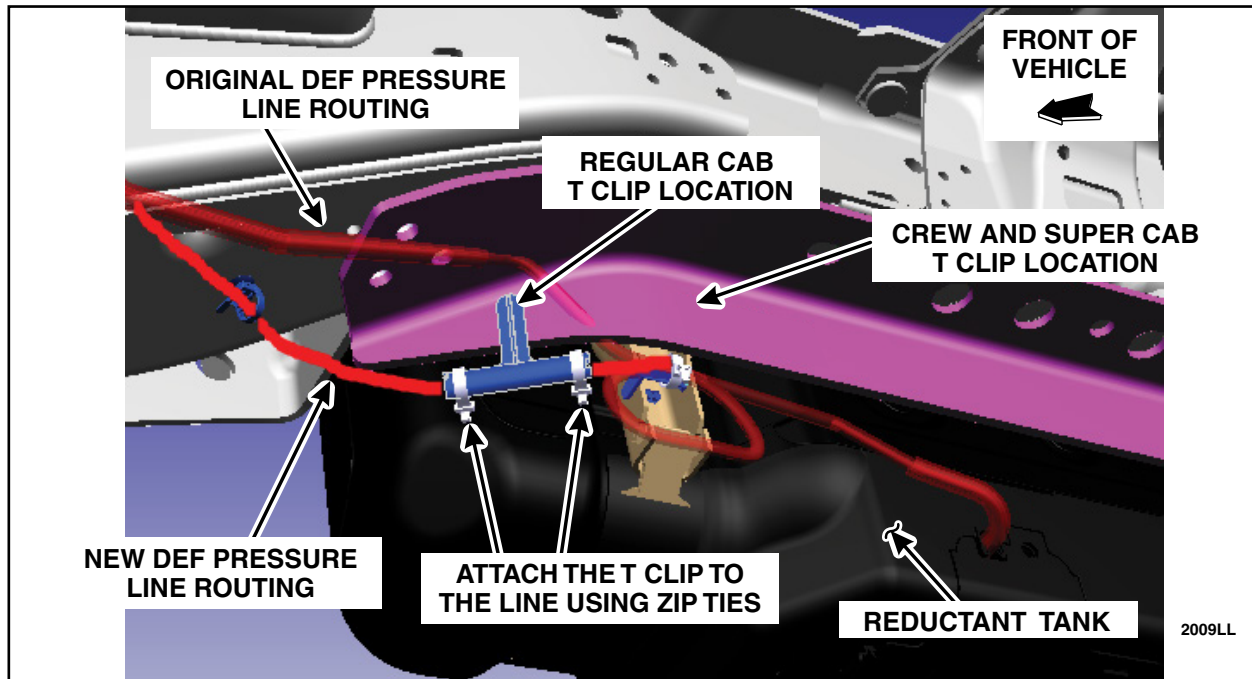
FIGURE 32

**NOTE:** Figure 32 shows the different T clip locations for between the regular cab vehicles and Crew and Super Cab vehicles. Holes are pre drilled on bracket for T clip, will need to drill new hole for routing clip.

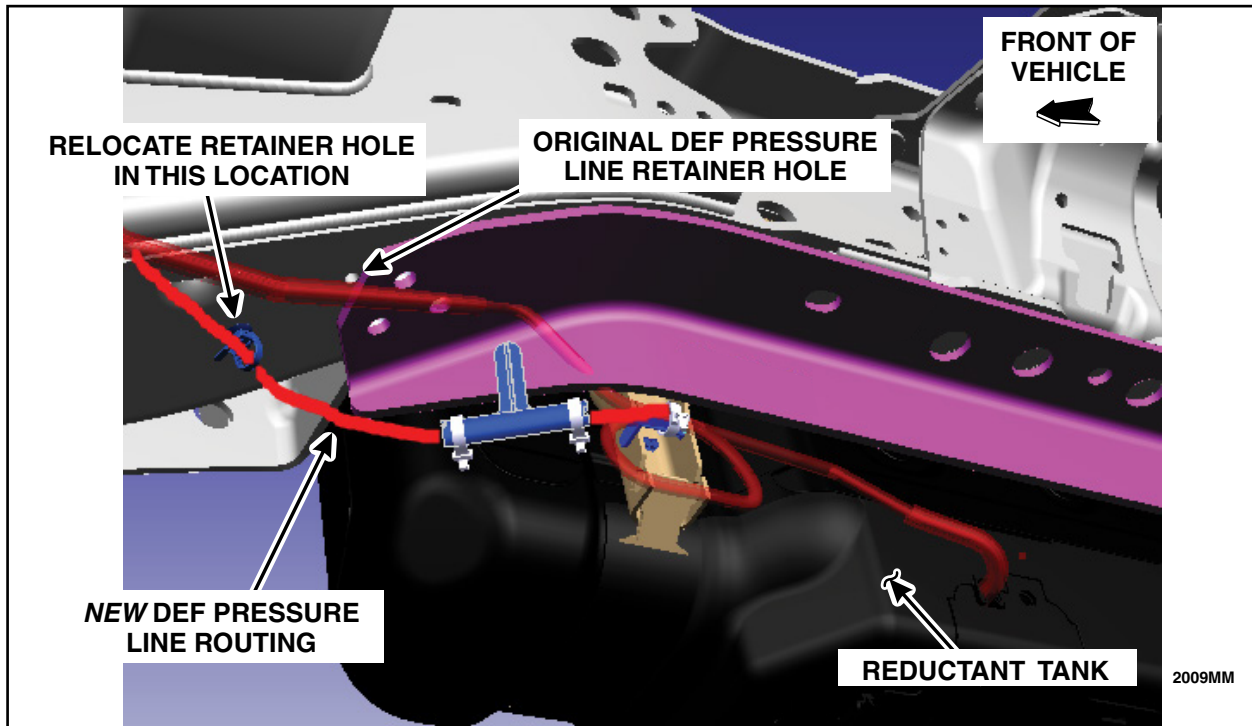
**FIGURE 33**

**NOTE:** The *new* drill hole location should be determined by positioning the DEF pressure line in its natural relaxed position toward the frame and marking a location for the *new* drill hole, forward of the *new* reinforcement bracket as shown in Figure 33.

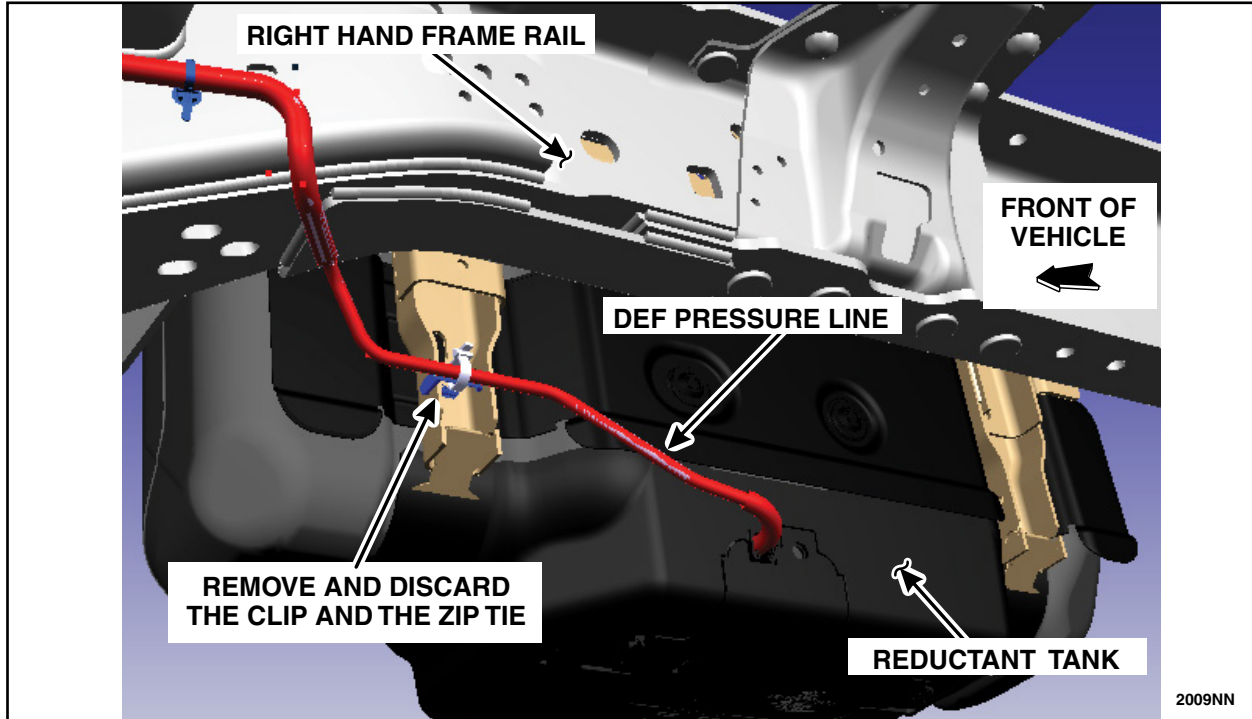
**FIGURE 34**

1. Remove and discard the clip and zip tie from the area shown in Figure 34.

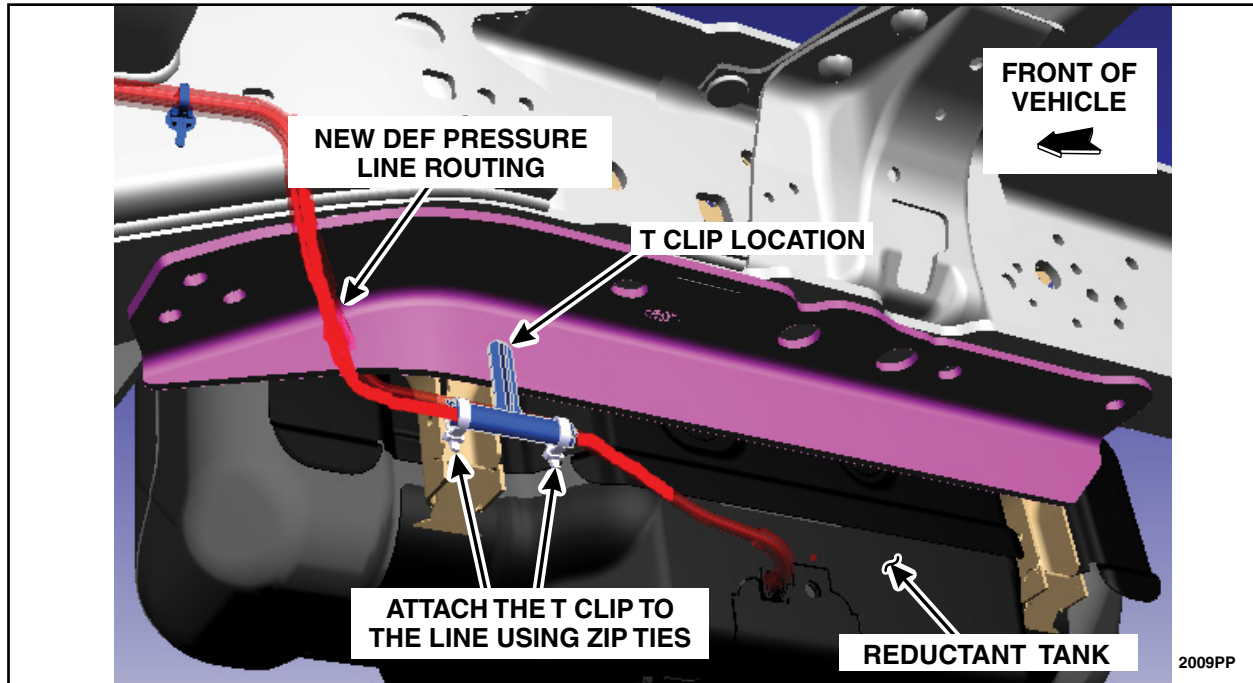
**FIGURE 35**

2. Once the RH side lower bracket has been installed, install the supplied T clip to the existing hole in the lower reinforcement bracket and route the DEF pressure line toward the T clip and attach the T clip to the DEF pressure line with two (2) of the supplied zip ties as shown in Figure 35.

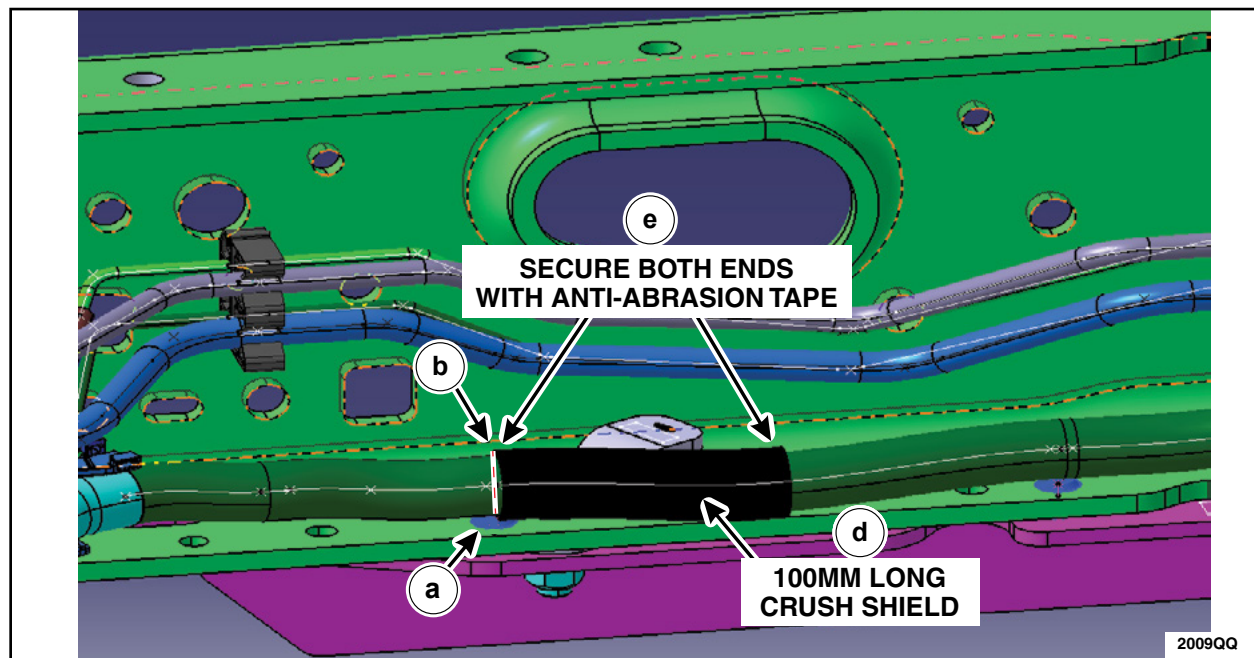
**FIGURE 36**

- Remove the tie strap push pin (a) from the hole indicated in Figure 36.
- Mark the location of the push pin on the harness (b).
- Cut off the existing push pin from the harness removed in sub-step a.
- Install the provided crush shield (d) on the harness with the rear edge of the shield aligning the mark made in second bullet point (above). See Figure 36.
- Secure both ends of the crush shield with the supplied Coroplast Tape (e).
- Install the supplied push pin zip tie in same location as the previously marked (original) location on the harness (b).

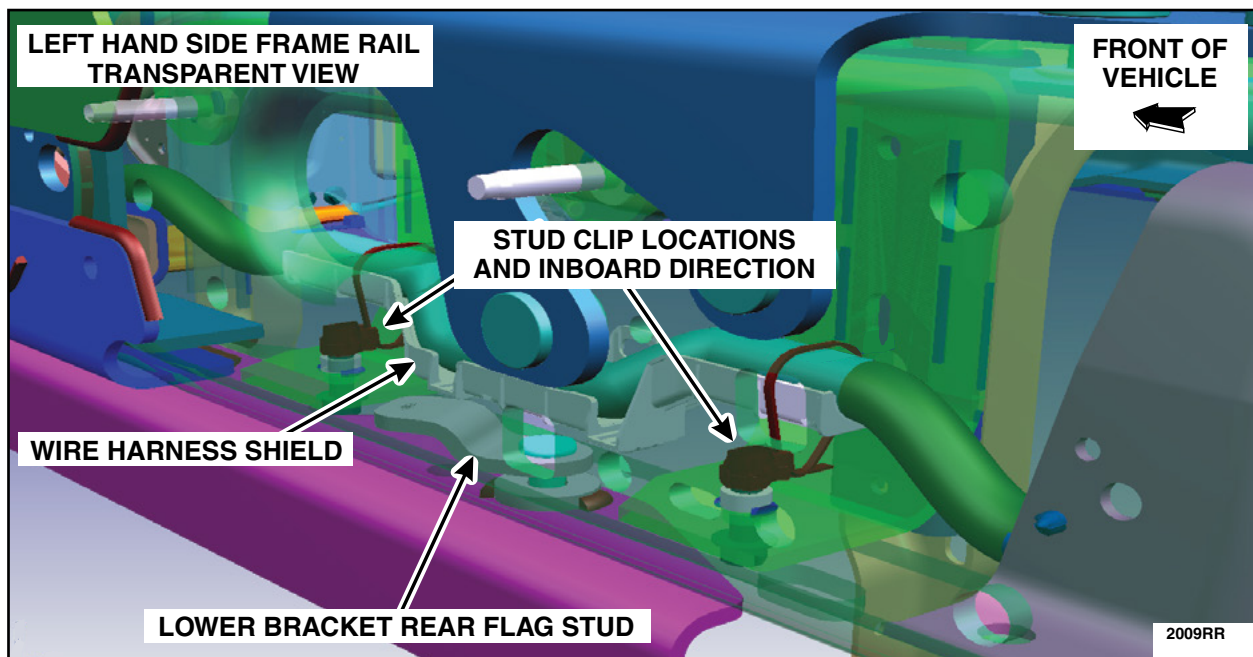
**FIGURE 37**

- Position the supplied stud clips onto the studs with the zip ties side facing inboard as shown in Figure 37.
- Secure the harness to the stud clips with the zip ties.
- Ensure that the harness shield is positioned above the flag stud and the stud clips are fully seated on the studs.

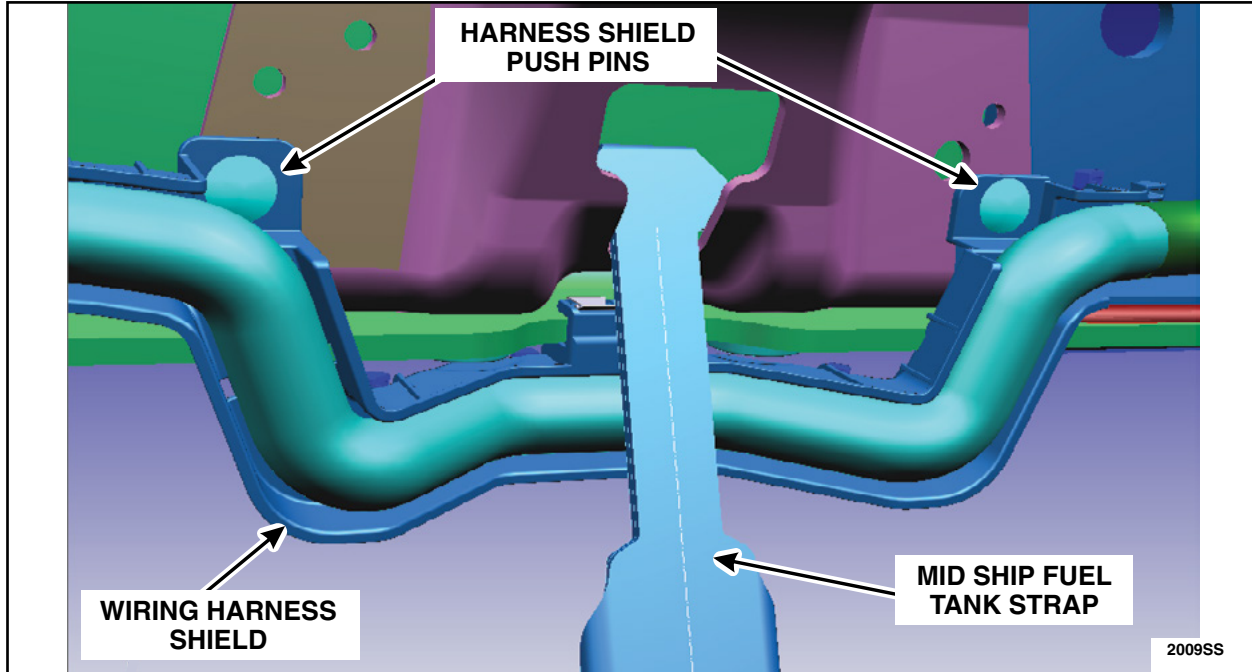
**FIGURE 38**

1. From the left hand side lower frame rail, remove the harness shield push pins as shown in Figure 38.

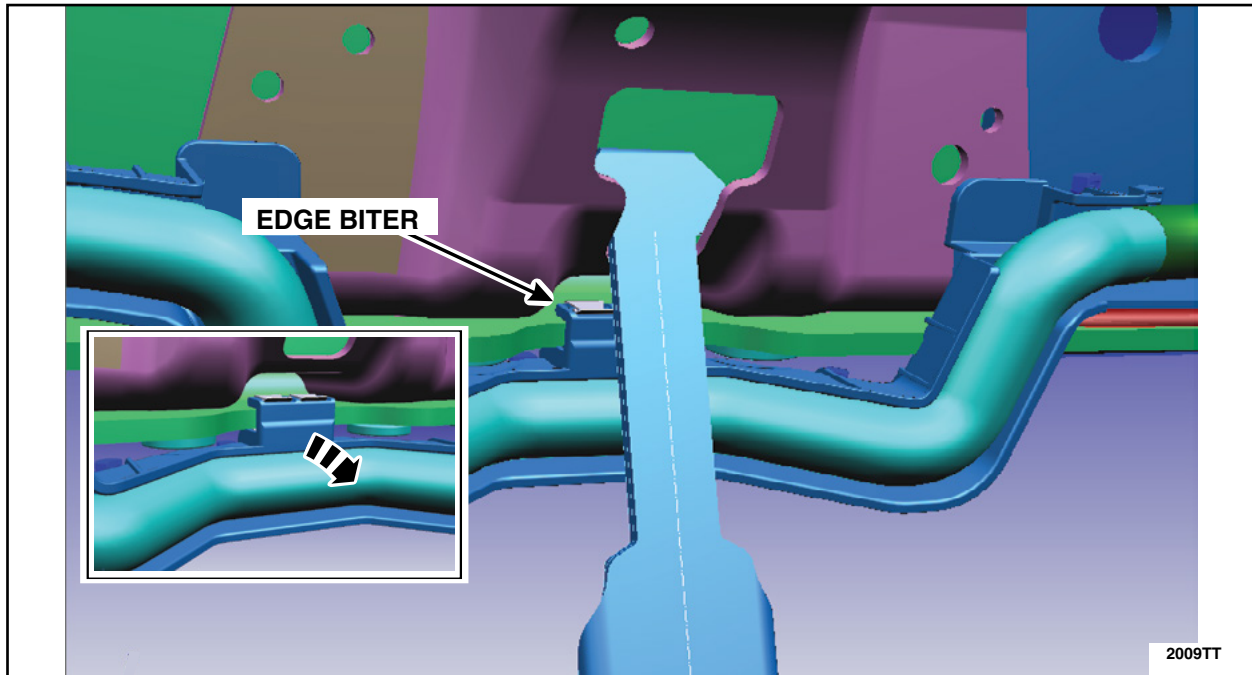
**FIGURE 39**

2. Detach the edge biter clip from the frames lower flange as shown in Figure 39.

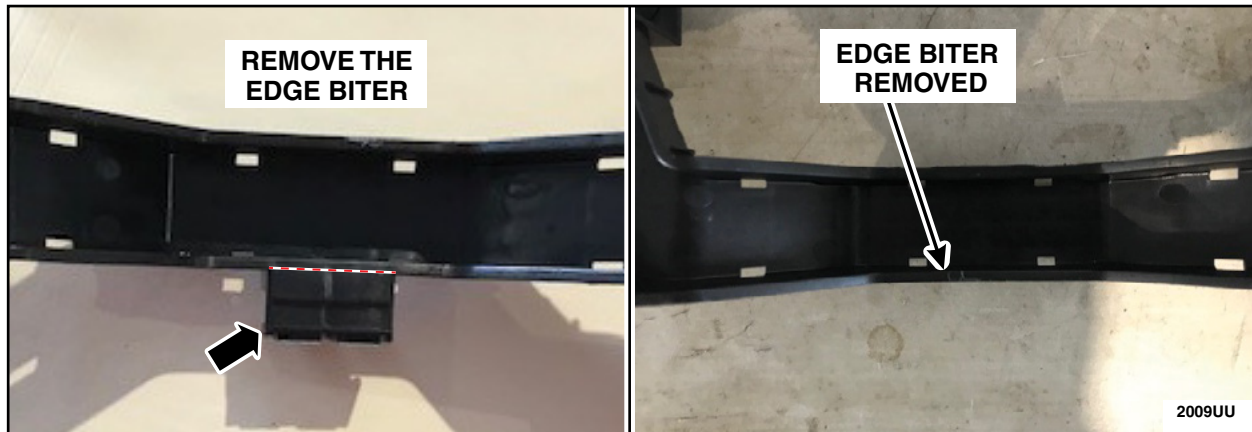
**FIGURE 40**

4. Using a suitable cutting tool, remove the edge biter clip flush with the surface of the harness shield as shown in Figure 40.

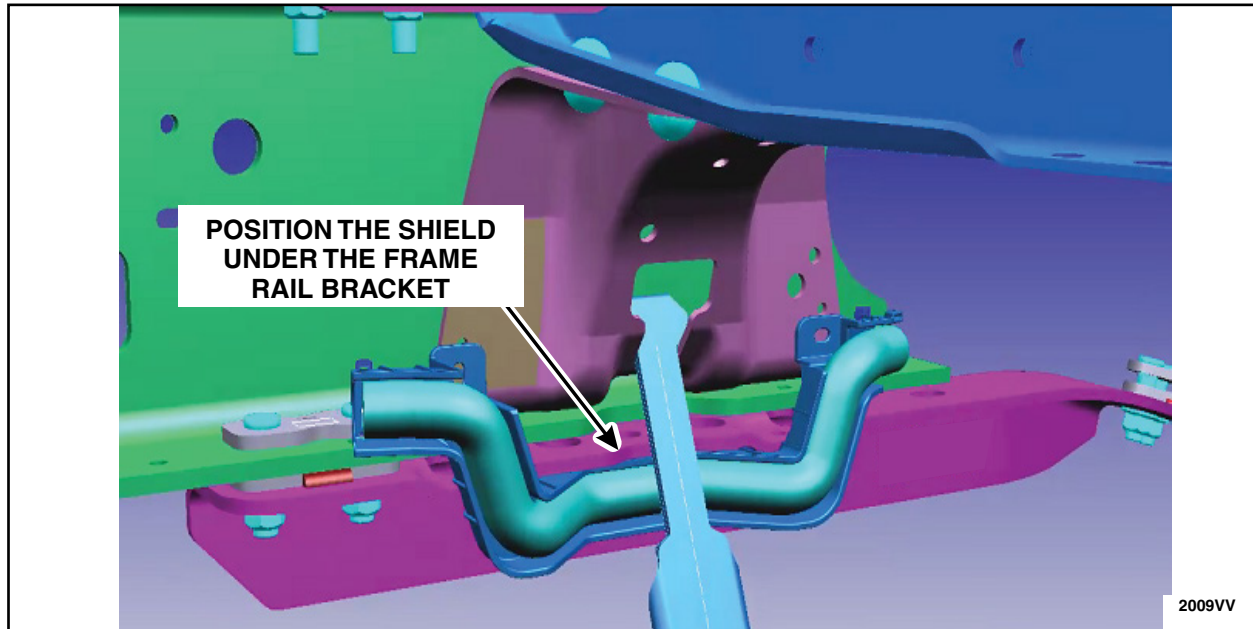
**FIGURE 41**

5. Reattach the shield to the harness, in the same locations as they were removed from in Step 3, using seven (7) of the similar supplied tie straps.
6. Once the frame rail bracket has been installed, position the middle of the harness shield under the frame rail bracket as shown in Figure 41. Then, using two (2) of the supplied tie straps, secure the harness shield in the same location as the push pins were removed from in Step 1.

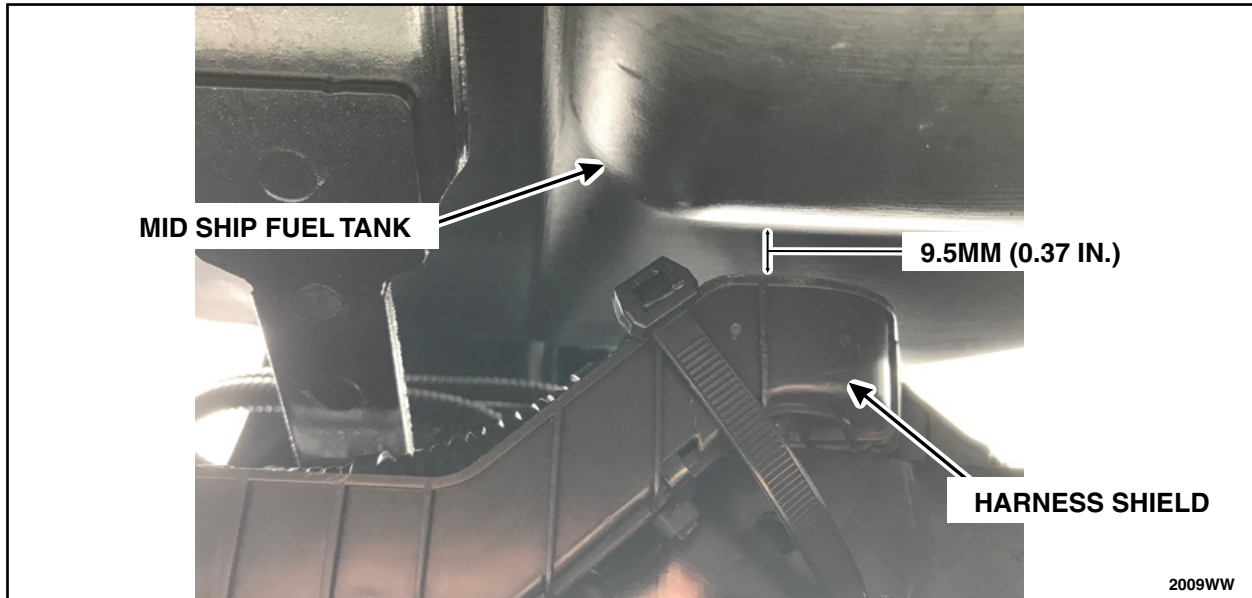
**FIGURE 42**

7. Using two (2) of the larger supplied tie straps, secure the harness shield to the reinforcement bracket using the existing holes in the reinforcement bracket.
8. Ensure that the wiring harness shield has at least 9.5mm (0.37 in.) of clearance from any contact to the mid ship fuel tank. See Figure 42.

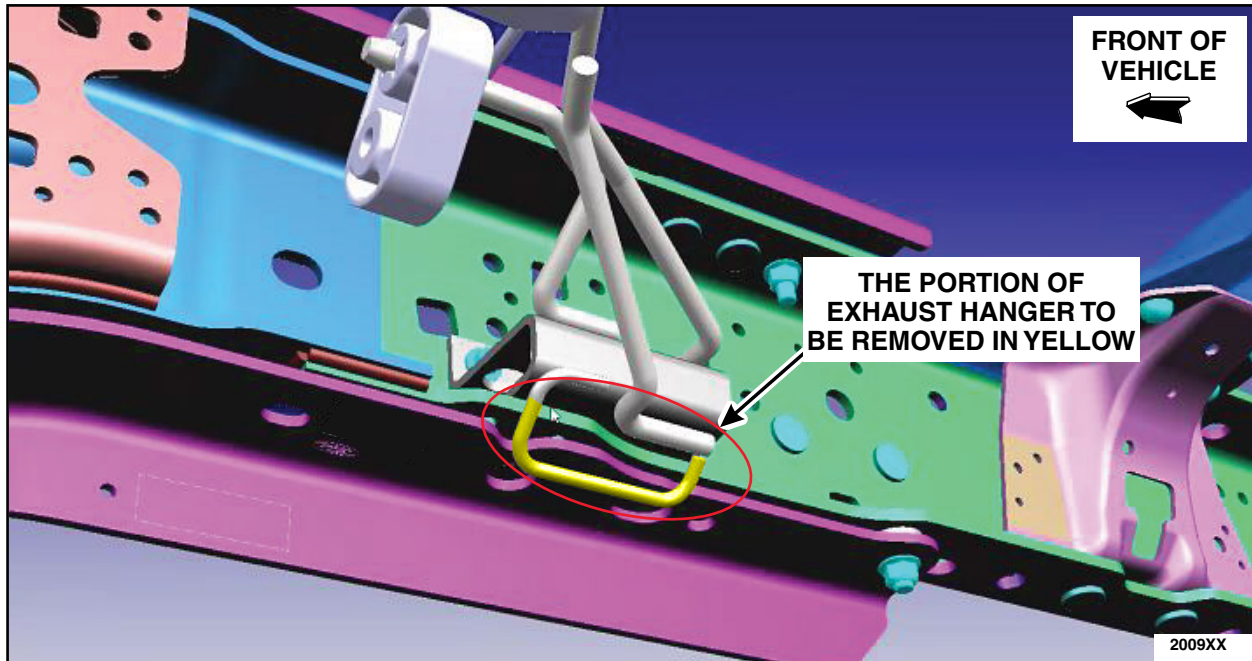
**FIGURE 43**

1. The right hand side exhaust hanger will interfere with right hand side lower reinforcement bracket.  
Figure 43 shows the portion of the exhaust hanger that will be removed in order to obtain the clearance needed.

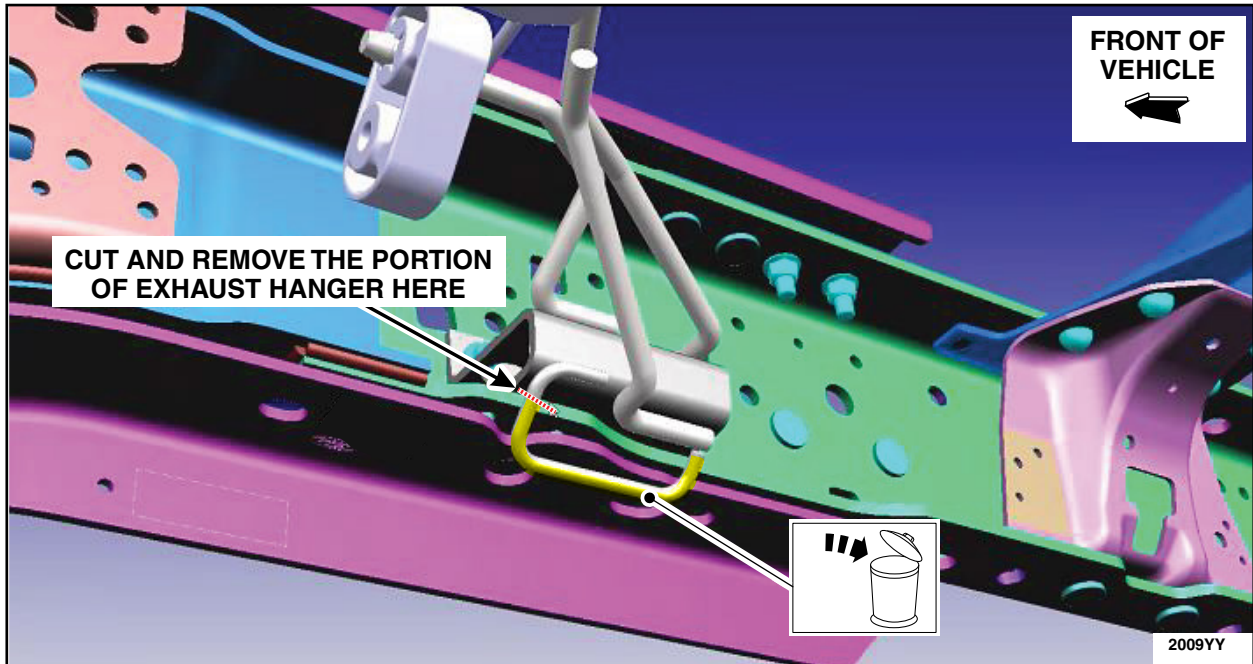
FIGURE 44

2. Using a suitable cutting tool, cut the exhaust hanger in the location shown in Figure 44. Remove and discard the cut off portion of exhaust hanger. See Figure 44.

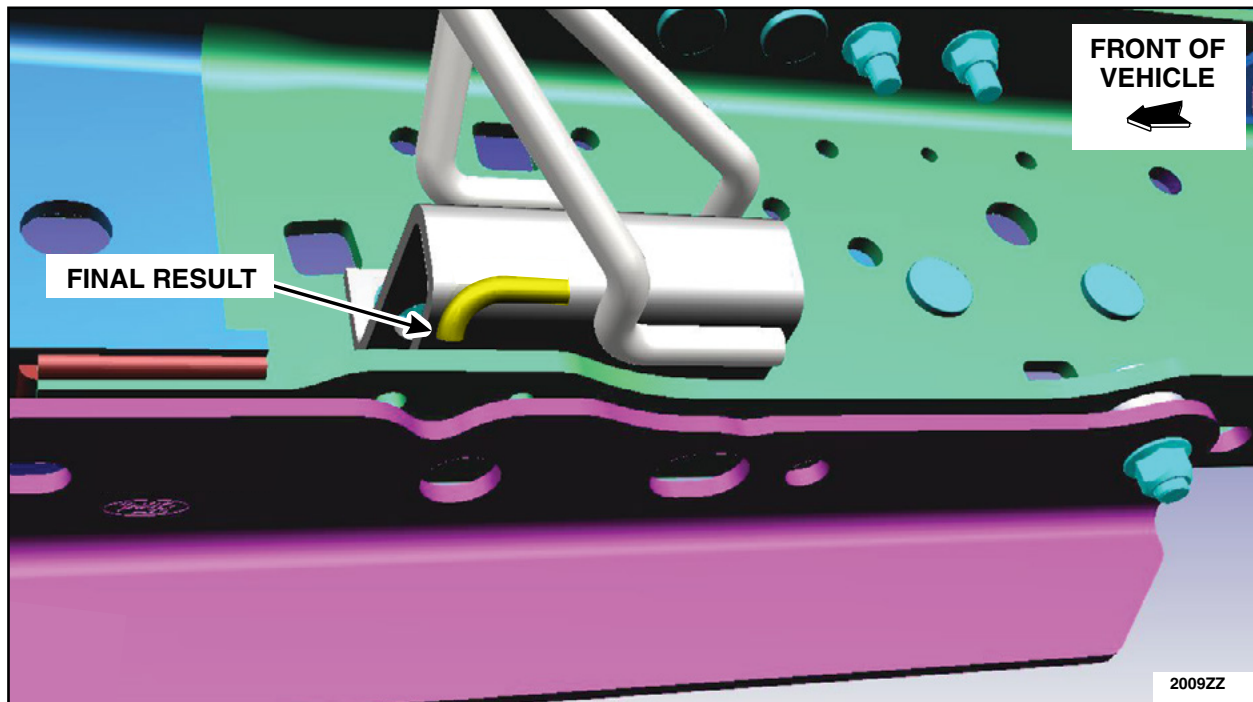
FIGURE 45

3. Figure 45 shows the final result once the exhaust hanger portion is removed.
