# Technical product information

## New Continental GT/GTC and New Flying Spur

DTC's C10BCF6 - 160000 and/or C12E2F2 with symptom code 59744 stored in address 0003 - Parking brake warning in DIP

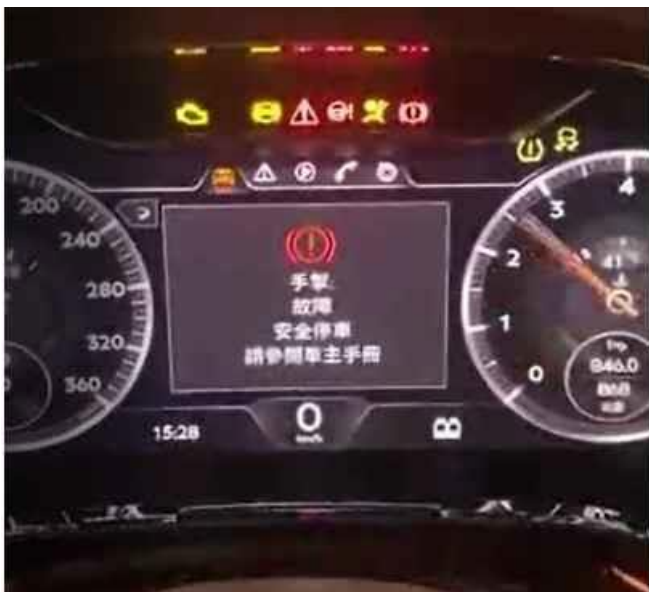
Figure 1

Parking brake warning light evident within the DIP (See example shown in Figure 1)

- 1) Referring to the applicable Rep.Gr - Remove the rear brake drums
- 2) Carry out an inspection of the rear (Electronic Parking Brake EPB) actuators and system

As part of visual inspection - consider dirt and debris in system.

- 3) Using a suitable cleaning agent - Remove any brake dust ensuring all parking brake components are free of dust/debris

5) Referring to the applicable wiring diagram - Conduct an inspection and check the electrical integrity of the (EPB) connections and wiring to the relevant/applicable actuator (Right and or Left hand side)

8) In the event that no other issues have been found - Replace the defective actuator - Rep.Gr 46
