# Technical Service Bulletin

## 97 Vehicle ignition cannot be turned on or vehicle does not start

97 21 81 2064805/1 November 3, 2021.

Model(s)	Year	VIN Range	Vehicle-Specific Equipment
Q5, SQ5	2018 - 2022	All	Not Applicable
Q5 PHEV	2020 - 2022	All	Not Applicable
Q5 sportback, SQ5 sportback	2021 - 2022	All	Not Applicable

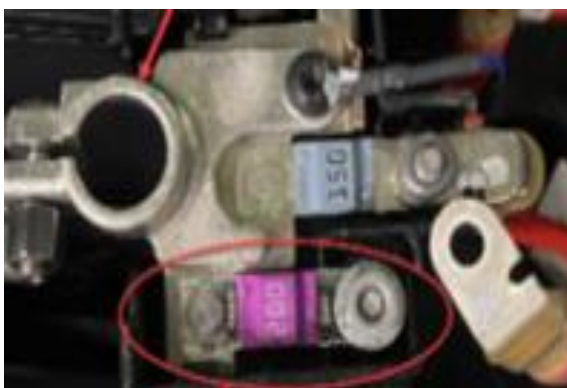
*Figure 1. Fuse S164 circled in red.*

1. Fuse S164 is located on the distribution block at the B+ post of the battery (Figure 1).

This fuse is not replaceable separately, part number **80A 915 459** is needed.

For this reason, the short circuit must be located and repaired **BEFORE** the fuse assembly is replaced.

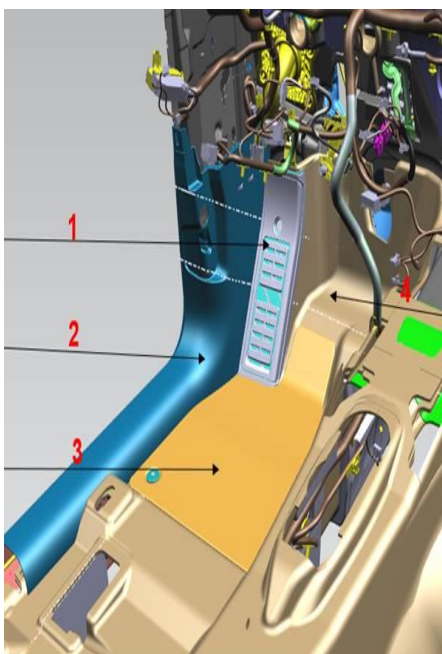
*Figure 2. Driver side footwell.*

2. Gain access to the fuse holder underneath the drivers' footrest.

Remove the driver's seat, footrest cover (Figure 2, position 1), lower A-pillar trim (Figure 2, position 2), and floor mat (Figure 2, position 3).

Fold the carpet (Figure 2, position 4) towards the center console to expose the fuse box behind the footrest.

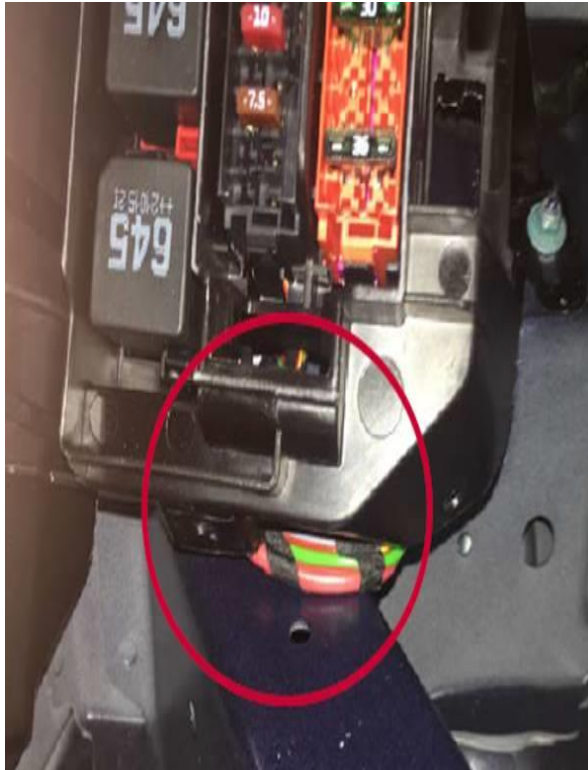
3. Check the red wire leading to J329 (terminal 30) and the black wire on J329 (terminal 15) for damage (Figure 3).

**Figure 3.** Area to inspect for chaffing.

4. If any wire is damaged, repair it using VAS 1978B.

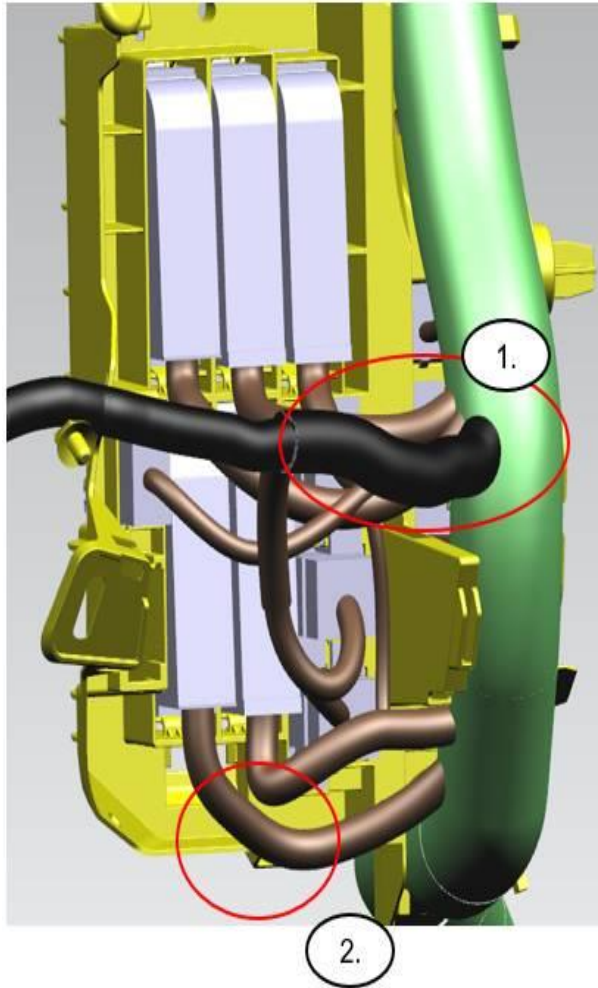
**Figure 4.** Location 1 for harness tape, location 2 for cable tie.

Using harness tape N 107 290 02, wrap the 30mm harness section shown in point 1 of Figures 4 and 5.

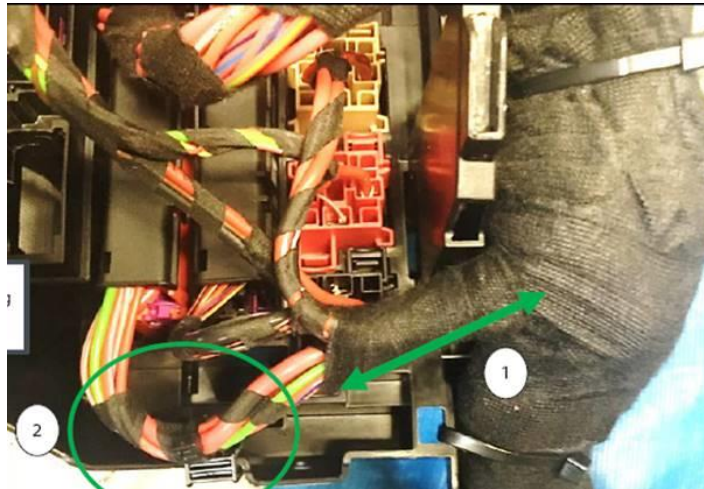
**Figure 5.** Location 1 for harness tape, location 2 for cable tie.

- Route the harness to prevent any further chafing. Fit cable tie **5M0 971 838** in the area of point 2 in Figures 4 and 5.
