Technical Service Bulletin

19J1 UPDATE – 4.0 I Quality Package (NVLW)

November 13, 2013

Model(s)	Year	VIN Range	Vehicle-Specific Equipment
S6, S7, A8, and S8	2013 - 2014	See Campaign/Action screen in ElsaWeb	None

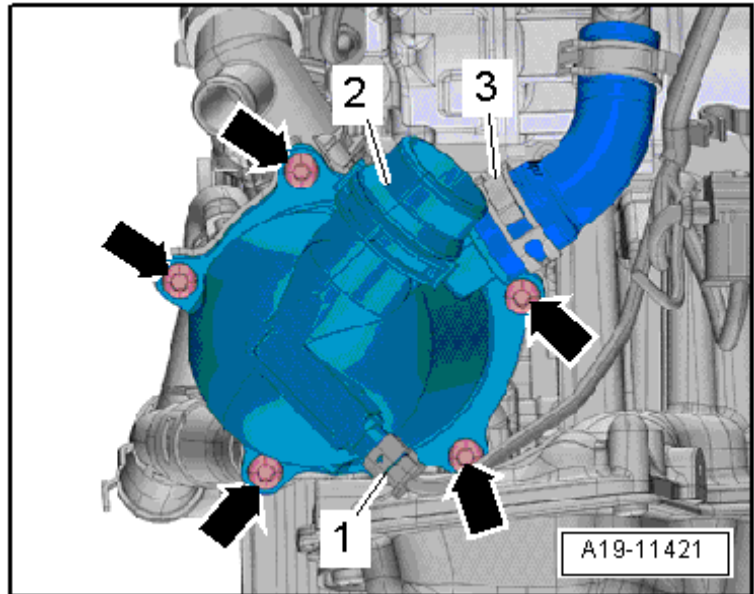
Figure 1. Coolant thermostat (2).

1. Replace the coolant thermostat and the quick release coupling by following the instructions in *ElsaWeb >> Repair Manual >> Engine >> Engine Mechanical >> 19 Cooling System >> Removal and Installation >> Map Controlled Engine Cooling Thermostat -F265-* (Figure 1 and Figure 2).

Tip: The quick release coupling is located directly on the coolant thermostat. It is removed together with the coolant thermostat when the coolant thermostat is replaced. However, the coolant thermostat does not have to be removed when the quick release coupling is replaced (Figure 1 and Figure 2).

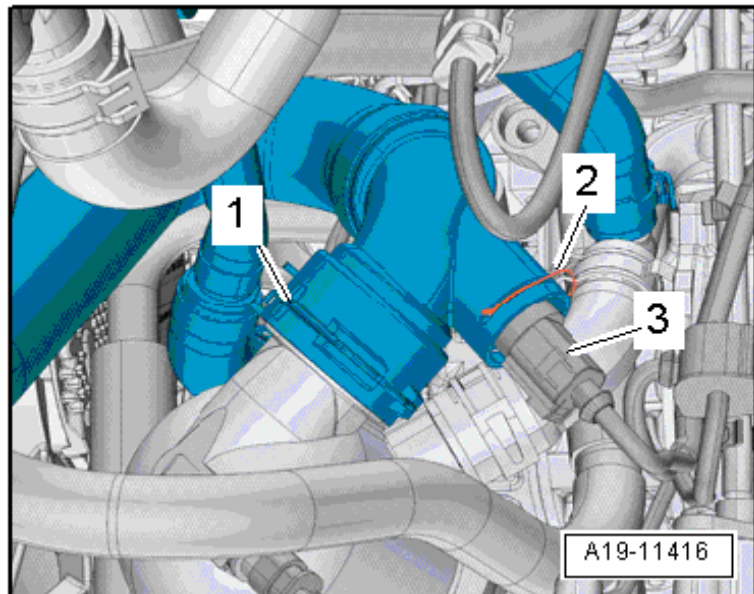
Figure 2. Quick release coupling (1).

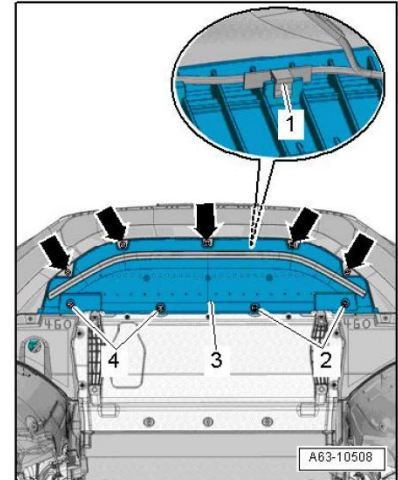
Figure 3. Closure plate for bumper cover (3).

1. Remove closure plate for bumper cover (Figure 3)

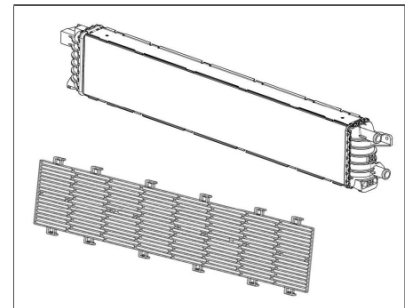
Figure 4. Fit protective grille onto radiator.

2. Fit protective grille onto radiator (Figure 4) and secure with nine retaining clips (Figure 5).

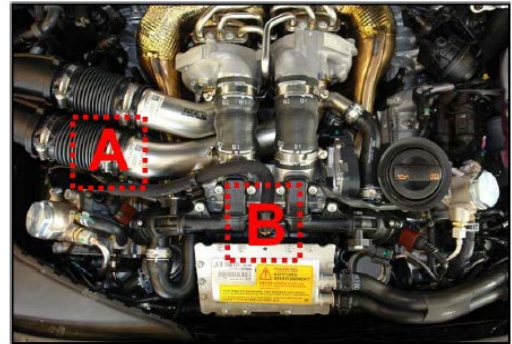
Figure 6. Location of ACF hose (A).

1. Replace ACF hose (Figure 6 and Figure 7). The hose clip can be re-used.

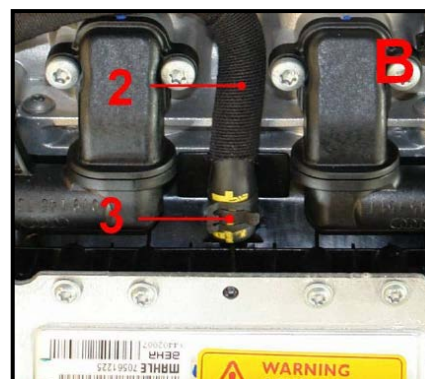
Figure 8. Hose clip (3).

2. Replace hose clip (Figure 8).

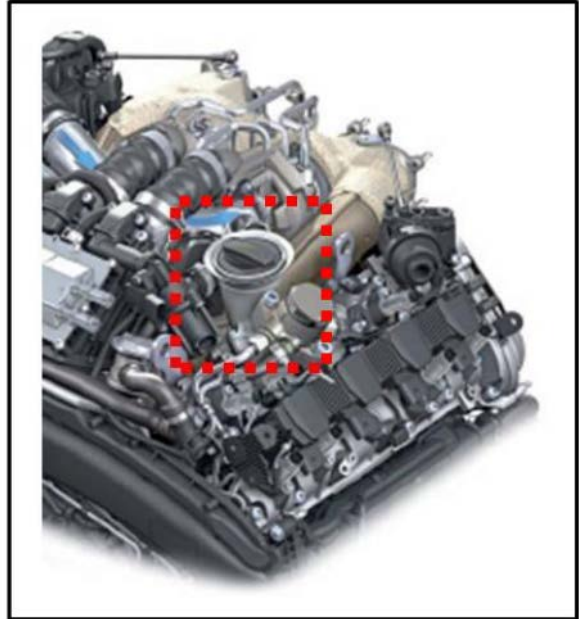
Figure 9. Oil filler neck.

Replace oil filler neck (Figure 9).

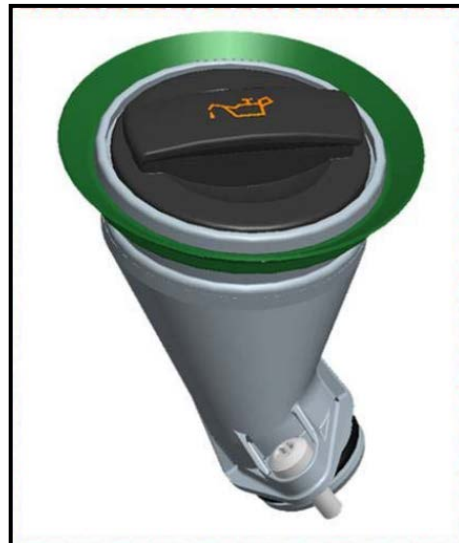
Figure 10. Torque bolt to 9 Nm.

Torque bolt to 9 Nm (Figure 10).
