## Field campaign

Topic	Bentayga Hybrid - Left hand rear jacking block replacement and coolant pipe check (SC 21/38)
Market area	China 796 VW Import Comp. Ltd (Vico), Beijing (6796), Germany E02 Bentley rest Europe (6E02), Japan E03 Bentley Japan (6E03), United Kingdom E01 Bentley UK (6E01), United States E05 Bentley USA and rest America (6E05)
Brand	Bentley
Transaction No.	2064824/3
Campaign number	EC21
Note	
Type	
US code

### Bentayga Hybrid

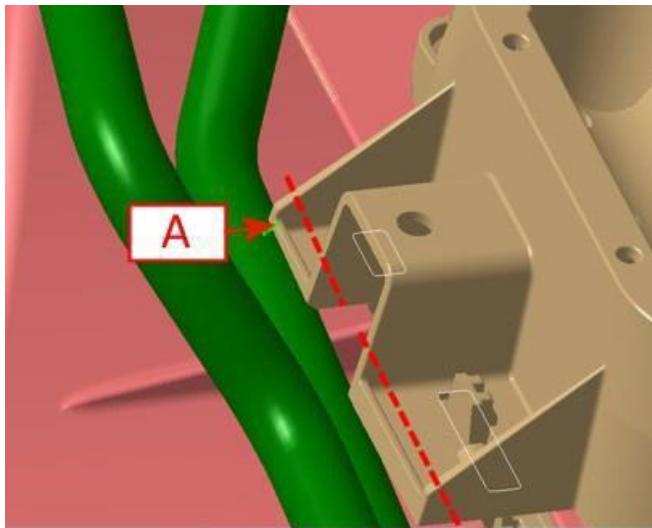
Due to possible a clash condition between the high voltage system coolant pipe and the left hand rear jack block - Figure 1 (point A) the original left hand rear jack block must be replaced

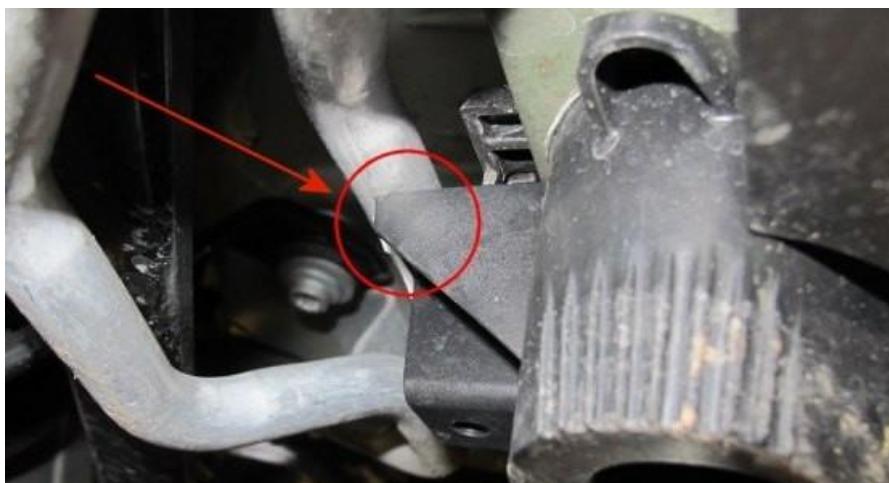
Figure 2 shows the clash condition looking from the underside towards the left hand rear jack block and pipe (circled)

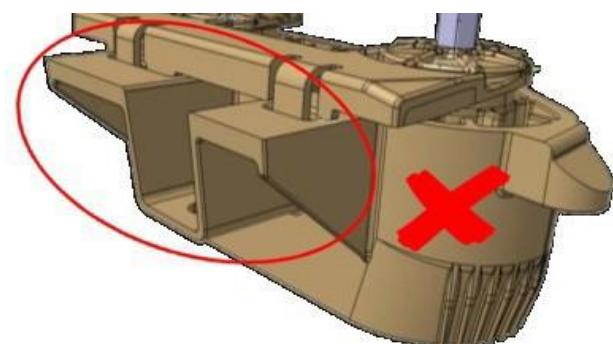
- Figure 3 shows the original jack block NOTE: The area (circled) shows excess material which can clash with the pipe

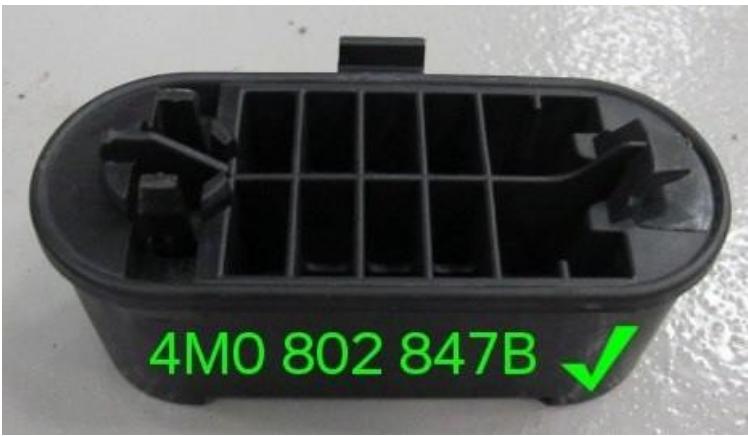
- Figure 4 shows the replacement jack block 4M0 802 847B

- The lefthand jack block requires replacement
- A visual inspection of the high voltage system coolant pipe (situated adjacent to the left hand jack block) is required

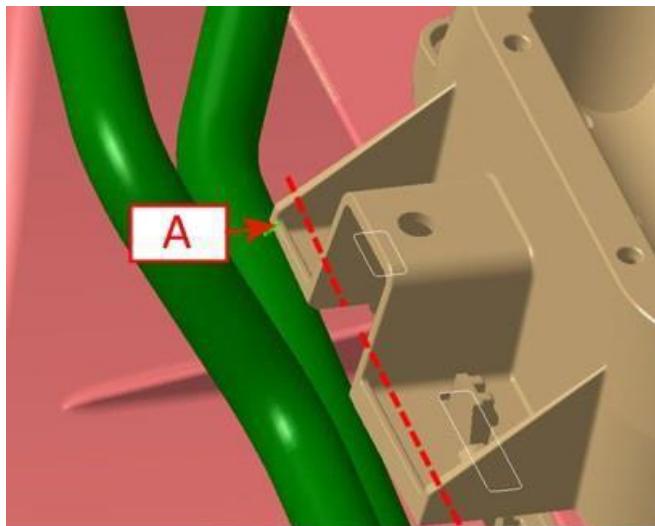
Due to possible a clash condition between the high voltage system coolant pipe and the left hand rear jack block - Figure 1 (point A) the original left hand rear jack block must be replaced

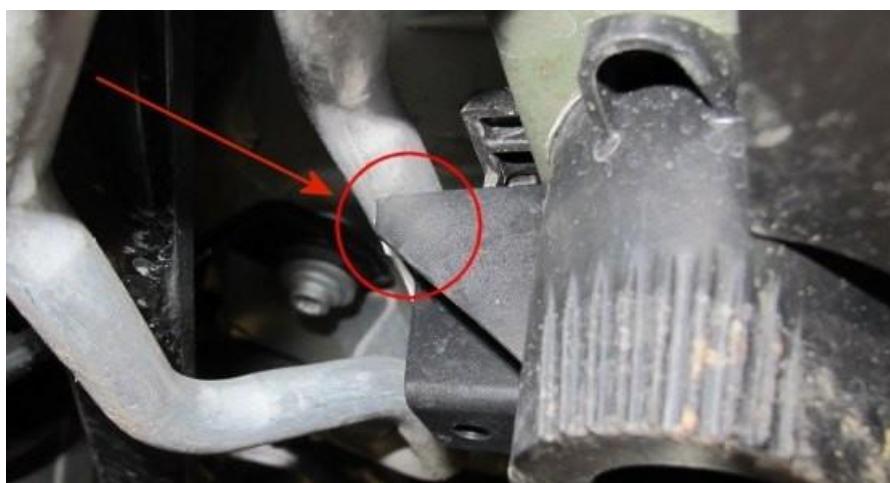
Figure 2 shows the clash condition looking from the underside towards the left hand rear jack block and pipe (circled)

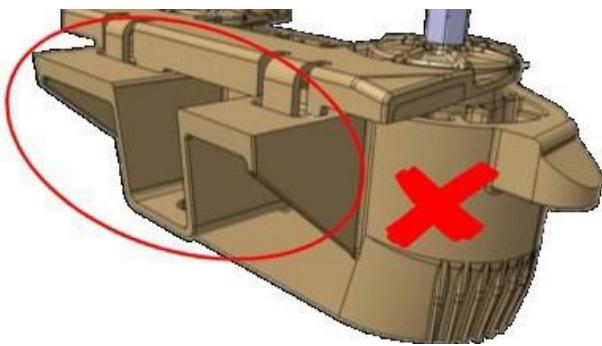
- Figure 3 shows the original jack block NOTE: The area (circled) shows excess material which can clash with the pipe

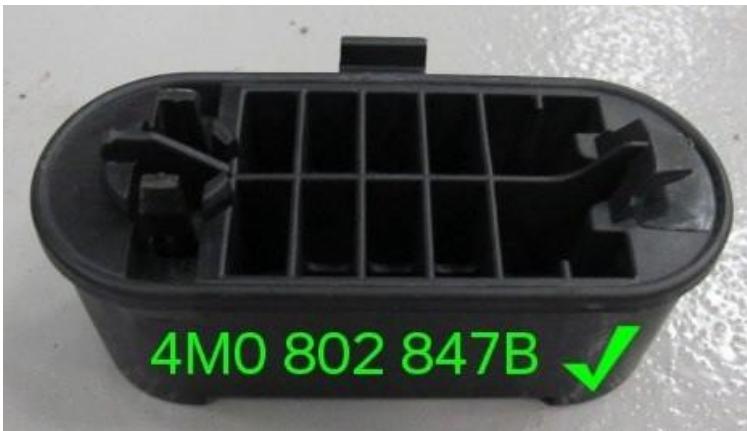
- Figure 4 shows the replacement jack block 4M0 802 847B

4) Should no issues be evident regarding the coolant pipe the operative must fit the replacement left hand jack block - 4M0 802 847B as per the applicable Maintenance chapter (Elsa Pro)

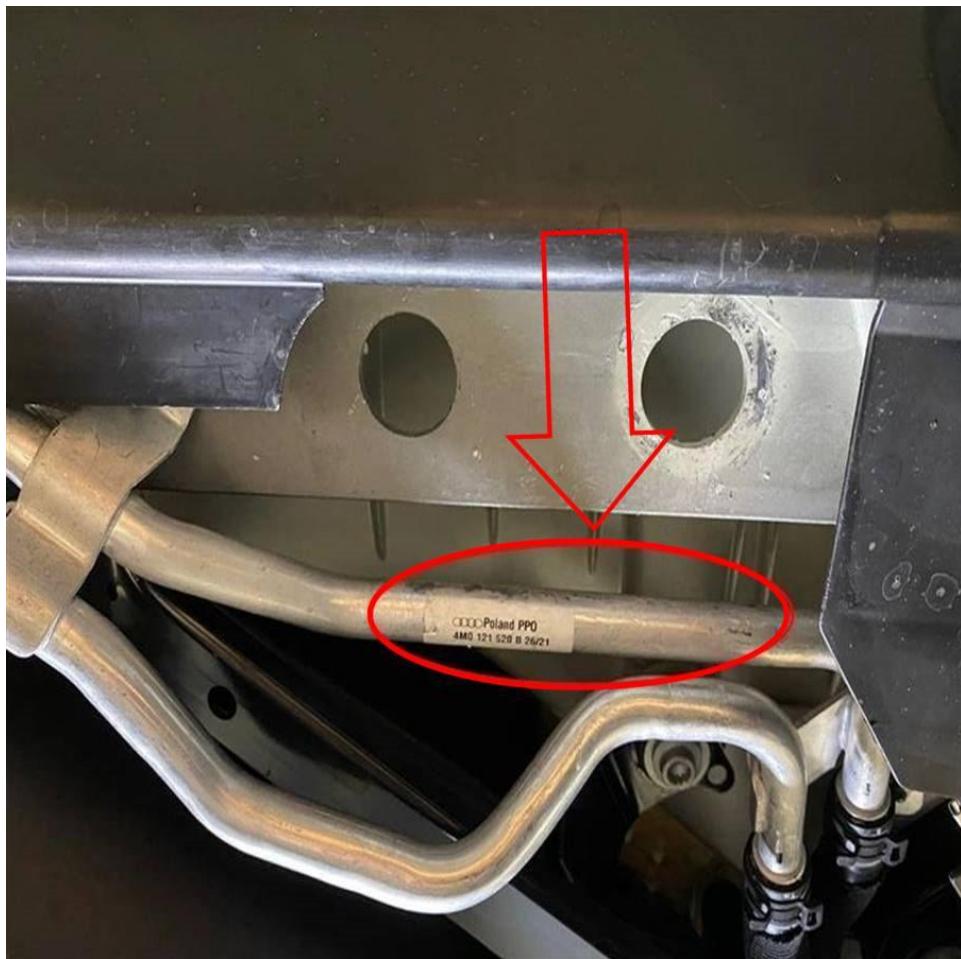
Figure 6

NOTE: In the event the coolant pipe has no signs of a clash condition

IMPORTANT: In the event the coolant pipe has signs of damage for example:

- Damage to the pipe is clearly visible
- The pipe is dented or distorted
- The pipe is worn/chaffed or has signs of rubbing

3) Conduct a thorough inspection of the coolant pipe (Figure 6)

IMPORTANT: Should any of the afore mentioned issues be applicable the operative MUST conduct Section 2 to completion

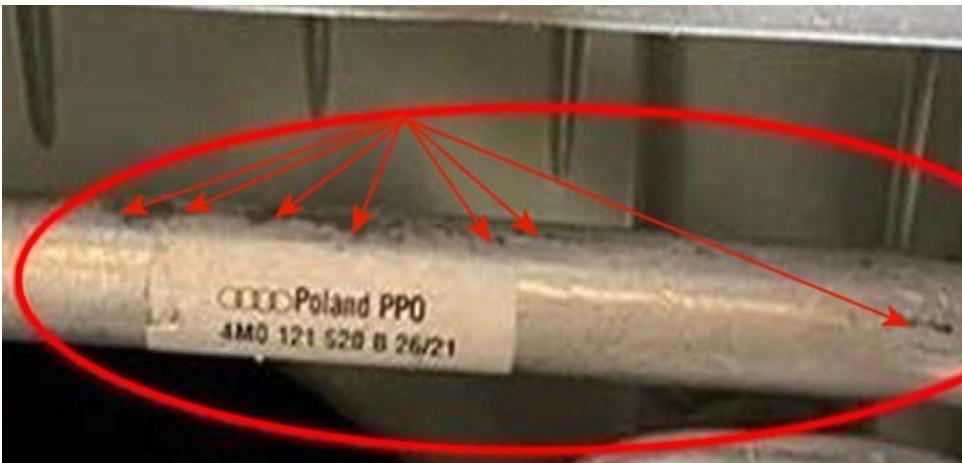
Has very light scratches due to minimal contact between the jack block and coolant pipe (as shown in Figure 7 - Arrows) - No further action is required - Carry out Section 1 (step 4)
