## ΤΟΥΟΤΑ

### Tech Tip T-TT-0672-21

#### Oil Pan #2 Leaks- Under Investigation Section

2021-2022 TMMK A25A-FKS/FXS Engines

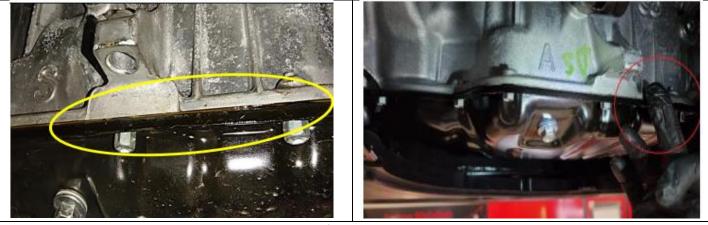
Some 2021-2022 TMMK built vehicles with A25A-FKS/FXS engines may exhibit an oil leak from the No.2 Oil Pan. This issue is currently under investigation.

Examples of leak origin photos

- 1. Take clear pictures of the origin of the leak and the identifier information on the outside of the crankcase as shown in below figures.
- 2. Please create a TAS case and contact TAS for instruction prior to diagnosing or repairing of the vehicle. If it is a weekend or holiday, continue with diagnosis and repair and do not create a TAS case.
