**FORD:**

2015-2016 Transit

Some 2015-2016 Transit vehicles built on or before 1/4/2016 may experience a broken interior sliding door handle due to the sliding door lower roller assembly.

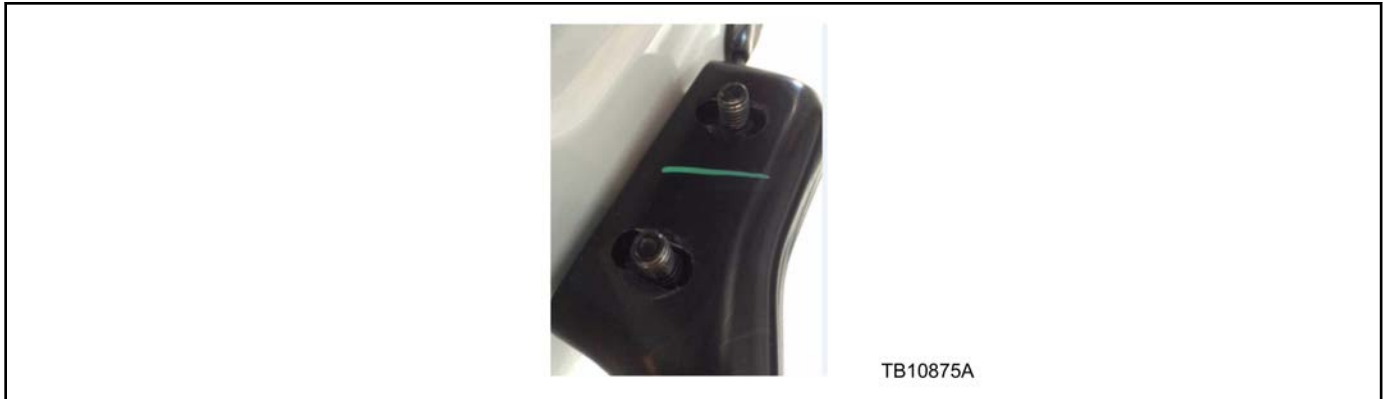
Figure 1 - Article 16-0051

- a. To help maintain original door adjustment, do not remove the angle bracket from the sliding door. (Figures 1 and 2)

- b. Tighten the sliding door lower roller assembly to angle bracket nuts to 30 N•m (24 lb-ft).
4. With the sliding door latched in the fully open position, check the latch in the lower roller for binding on the striker; the latch should have some free play. Adjust the striker as required.
