## Headlamps fogged

Topic number	LI82.10-P-064404
Version	2
Design group	82.10 Exterior lights
Date	08-26-2016
Validity	Model series 205 Halogen
Reason for change	Part designation changed
Reason for block

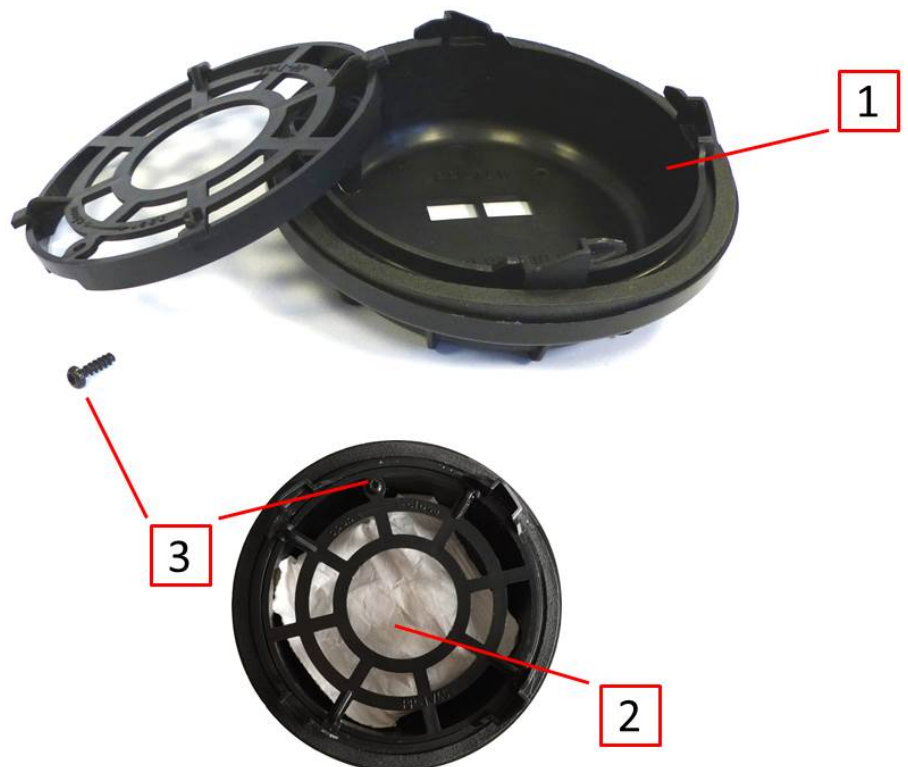
Bild\_02.jpg:

Attachments	
File	Description
Bild_02.jpg	1) Service cover for desiccant pack 2) Desiccant pack 3) Threaded connection
Bild_1.jpg	1) Service cover without membrane
Bild_3.jpg	Vent openings [1] and [2] on side of headlamp [3] and [4] on bottom of headlamp

1.2 Place desiccant packs in new service covers and bolt down (Figure 02).

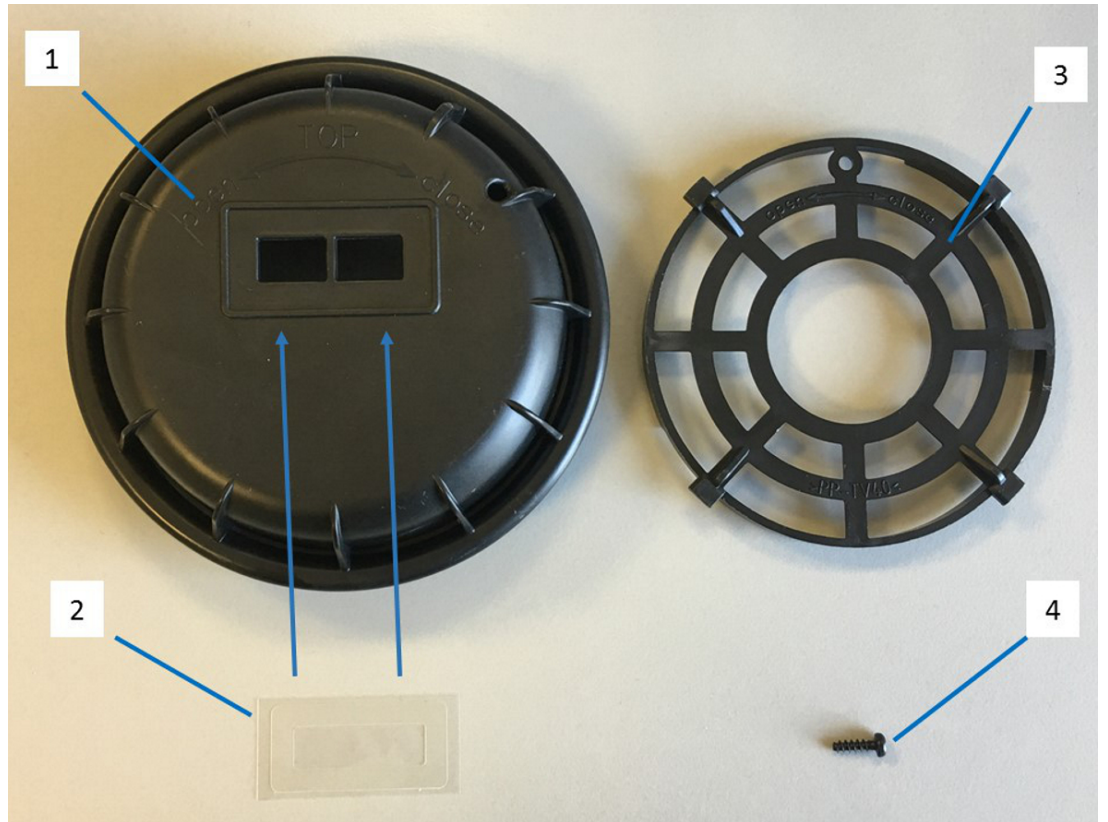
Servicedeckel.jpg:

File	Description
Servicedeckel.jpg	1) Service cover 2) Diaphragm 3) Grille 4) Bolt

1.3 Stick new membrane onto surface provided on service cover.

1.4 Attach service cover with desiccant pack to headlamp.
