87-18-08 - Air Conditioning, Cleaning of the R1234yf Refrigerant Circuit (U.S. Only)

Release date: 12/13/2021

Debris can be dispersed throughout the refrigerant circuit after A/C component damage. In order to maintain A/C operating efficiency, it is important to flush the refrigerant circuit after A/C component repairs.

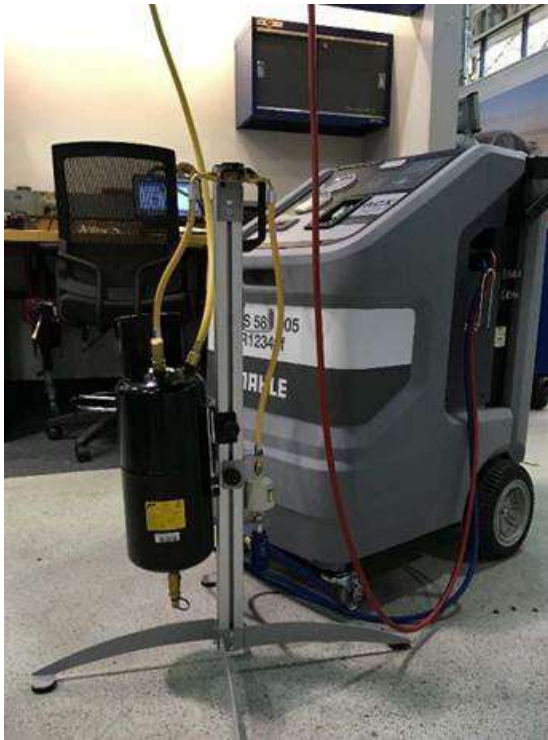
Use an approved R1234yf servicing machine and the R1234yf Flush Kit RTI360831840 (Figure 1).

Used for effective refrigerant handling and air conditioning circuit flushing after air conditioning component failure.

Figure 1. The VAS581005 Air Conditioning Service System with Flushing Device.

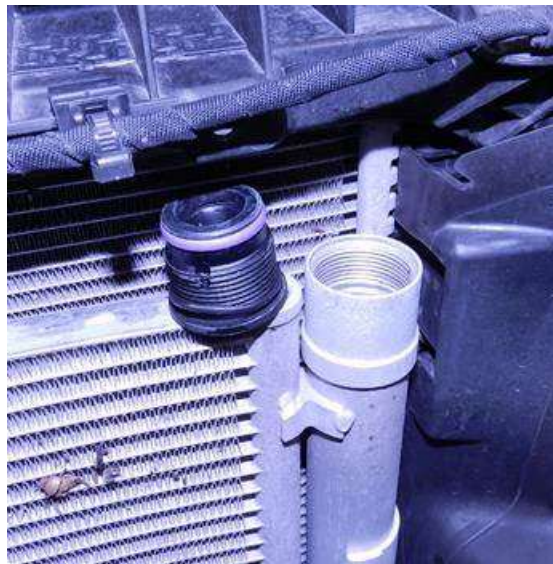
Figure 2. Location of the Receiver Drier

- 6. Remove receiver drier cartridge.
Reinstall cartridge cap with O-ring. (Figure 2)

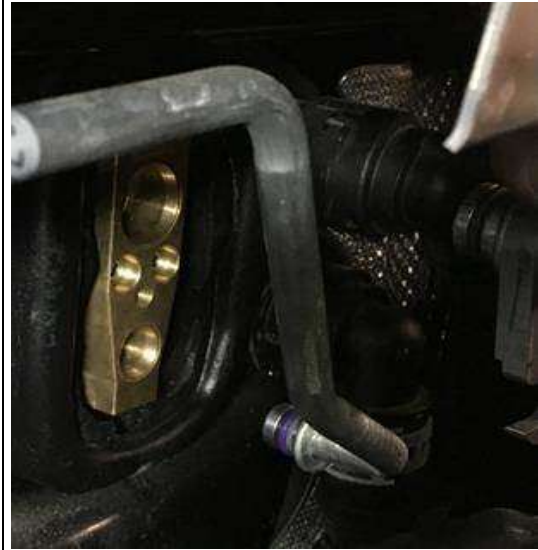
<p>Figure 3. Installation of front expansion valve bypass adaptor VAS 6338/38.</p>	<p>7. Remove expansion valve and install flush plate VAS 6338/38. (Figure 3)</p>
---	--

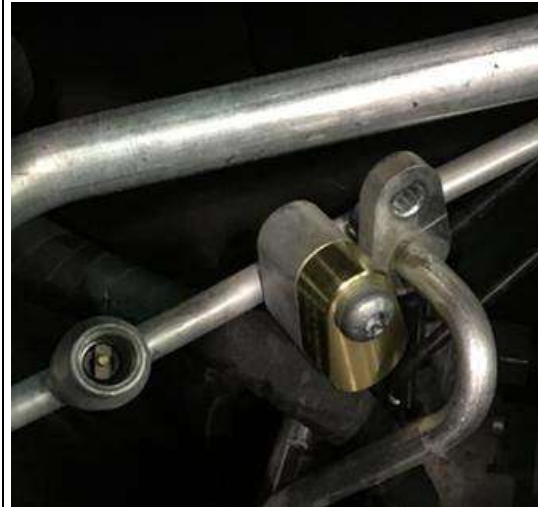
<p>Figure 4a. Installation of high side rear A/C Line connection block adaptor VAS 6338/63.</p>	<p>

Note: (Atlas Only) The rear A/C unit refrigerant lines must be disconnected and replaced with block off adaptors VAS 6338/5 and VAS 6338/63 before performing the front A/C unit flush procedure.</p> <p>8. (Atlas Only) Disconnect rear refrigerant lines and install adaptors VAS 6338/5 and VAS 6338/63 as shown. (Figure 4a, 4b)</p>
--	--

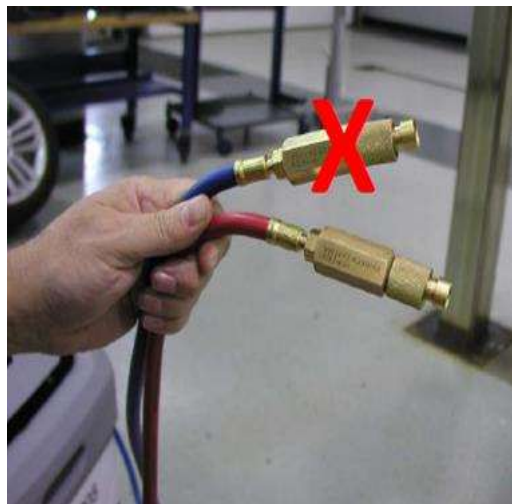
Figure 5. A.C hose adaptor 6338/44.

9. Remove A/C Recovery machine high side coupler from hose.

Install flush adaptor VAS 6338/48 to high side A/C recovery machine hose. (Figure 5)
