Front door collides with fender

Topic number	LI72.10-N-071190
Version	5
Function group	72.10 - Front door
Date	12/7/21
Validity	Model 907
Reason for change	update to part number

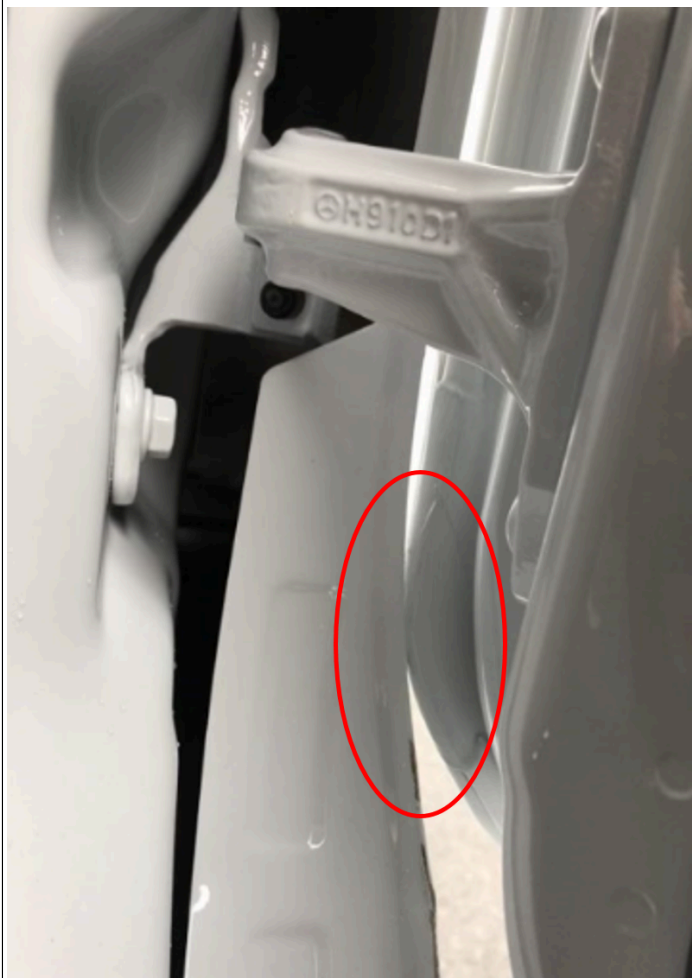
Attachments	
File	Description
01.jpg	Front door collides with fender in area of lower hinge.

Excessive dynamic stress results in permanent deformation of the lower hinge and causes the front door to collide with the fender.

1. Repair damaged component parts correctly.
2. Replace lower hinge of front door on affected side of vehicle.
3. Conduct visual check for cracks on threaded connection of door holder in front door. In the event of damage, please take descriptive pictures to be added to remedy 5.
4. Replace door holder (on both sides) with modified, shortened door holder.
5. Please open FYI PTSS case as we need to track these vehicles to ensure proper resolution

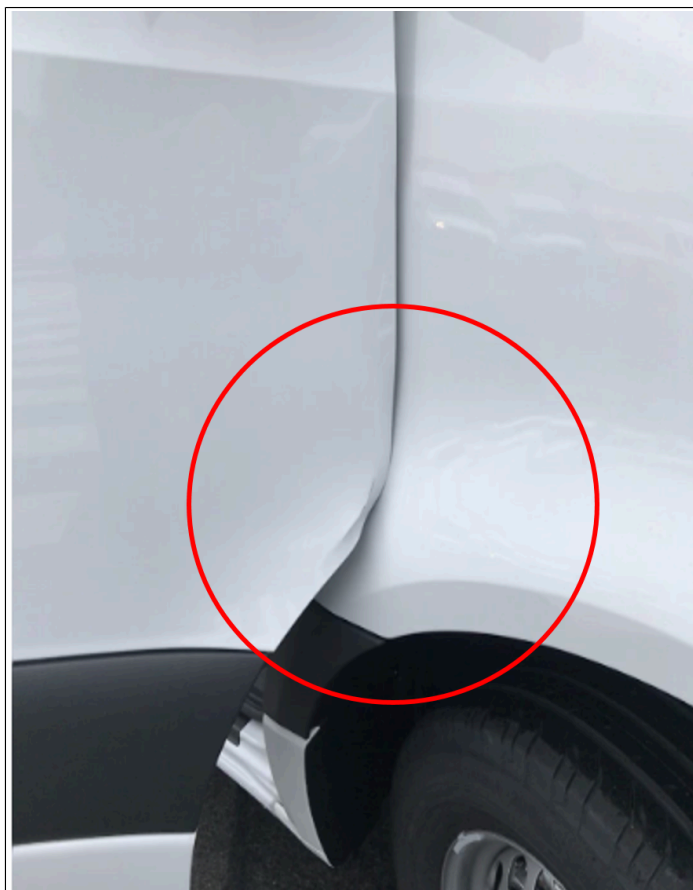
02.jpg	Body damage on the front door and fender.

This can result in damage to the door holder and the front door at the threaded connection of the door holder.

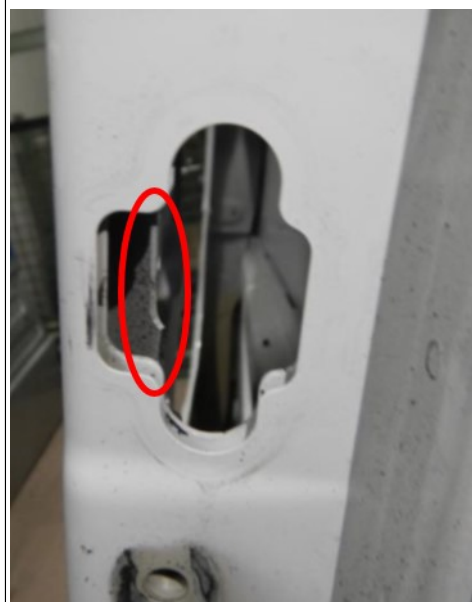
03.jpg

Crack on threaded connection in door

Note: The modified, shortened door holder reduces the opening angle of the door by approx. 6°.
