Technical product information

Topic	Night vision camera - Washer jet leaking
Market area	Bentley: worldwide (2WBE),Hongkong-Macau (5HK)
Brand	Bentley
Transaction No.	2051045/4
Level	EH
Status	Approval
Release date

Washer fluid dripping/leaking from the night vision camera washer jet

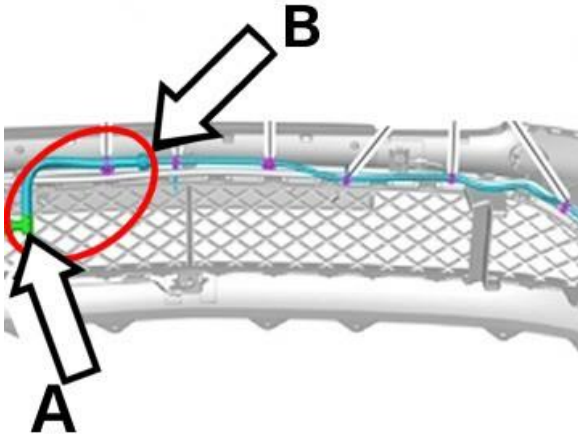
Referring to Figure 1 - In the event the afore mentioned symptom is evident the operative should refer to the Measure section of this TPI to replace the night vision washer jet (short link hose - Circled) which connects the night vision camera washer jet (A) to the washer jet supply hose connector (B)

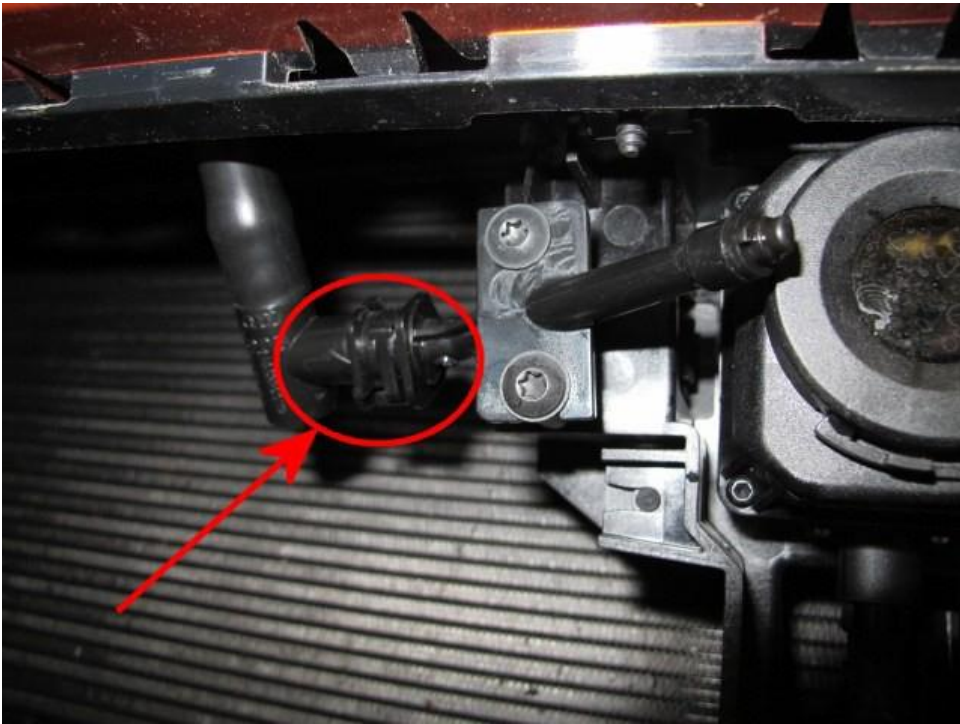
Figure 2

- 1) Referring to Rep.Gr 63 Remove the front bumper lower inner grilles
- 2) Disconnect the hose from the night vision camera as shown in Figures 2 and 3

Please note: Washer fluid may leak once the hose is disconnected - Ensure a suitable container is used to collect the fluid, all fluid MUST be discarded as per all local environmental guidelines)

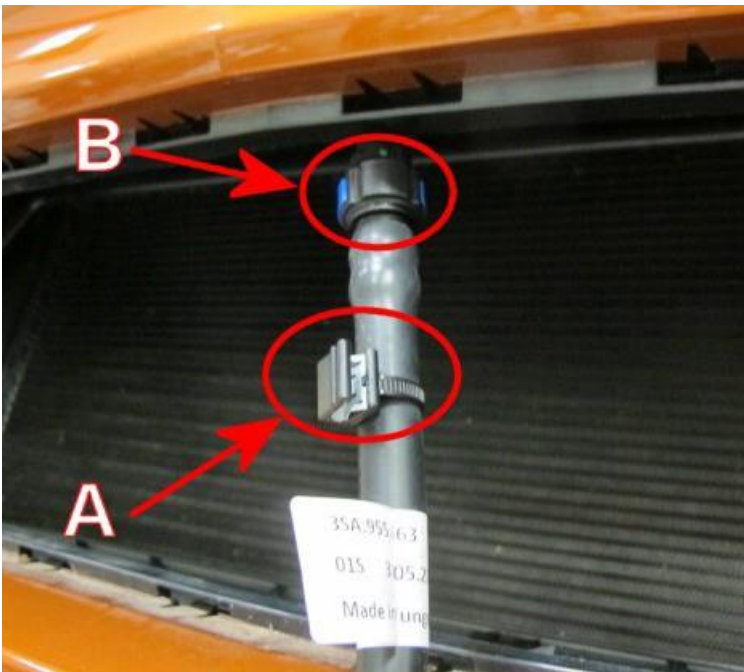
3) Referring to Figure 4

- Disconnect the hose from all applicable clipping points see example at (A)
- Disconnect the hose at (B)

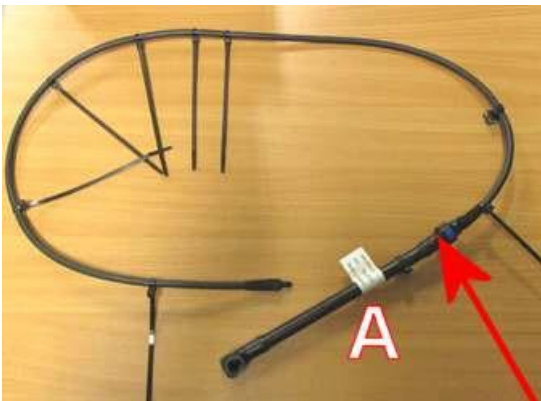
TIP: Referring to Figure 5 - The operative should disconnect the short hose from the hose assembly at the connection shown (Arrow)

The short hose section (A) should be fitted to the vehicle, the remaining part of the hose assembly can be discarded as per all local and environmental guidelines as this is not required to be fitted as part of this TPI unless unserviceable

5) Fit and connect the replacement night vision camera short link hose, ensuring all clips are reattached to all clipping points
