Technical Service Bulletin: TSB210266	Released Date: 10-Dec-2021
Fault Code 7327 Closed Crankcase Ventilation (CCV) Breather Troubleshooting

- ISX12N CM2380 X120B

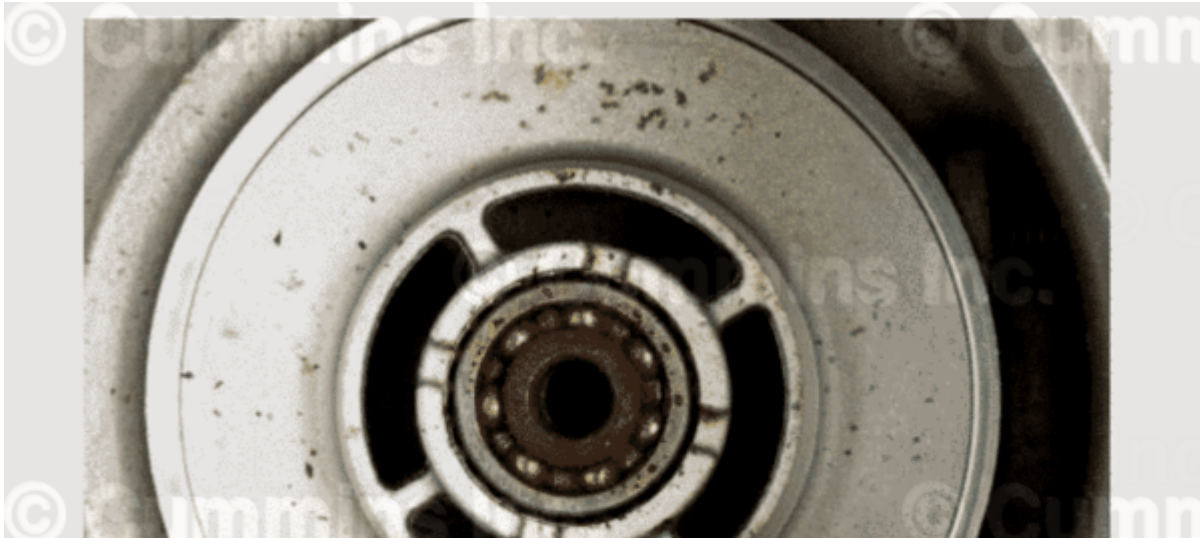
- CCV housing lower bearing corrosion, damage, and/or debris

Figure 2, CCV Housing Lower Bearing Face Heavy Corrosion and Light Debris (Top View).

If visual inspection shows lower bearing corrosion and/or debris, replace crankcase breather, Part Number 5581583. See ISX12N CM2380 X120B Service Manual, Bulletin Number 5504152. Refer to Procedure 003-001 in Section 3 (</qs3/pubsys2/xml/en/procedures/525/525-003-001.html>).
