EPB DTC CODES C2007-11 C2008-11.doc

Reference	SSM66897
Models	LR2 / L359 Range Rover Evoque / L538
Title	RR Evoque and Freelander 2: EPB DTC Codes C2007-11 and C2008-11
Category	Chassis
Last modified	09-Sep-2013 00:00:00
Symptom	302000 Parking Brake System
Content	<p>Issue: Customers have reported warning lamp illumination and Park Brake Activation / De-Activation functionality issues with related DTCs C2007-11 or C2008-11.</p> <p>Cause: JLR Engineering are continuing to investigate root cause of the issue.</p> <p>Action: In order to implement a Right First Time repair, dealers are instructed to follow the attached process for root cause investigation should the above DTCs be observed. Following analysis, dealers are requested to report the causal part for the DTC flag via an EPQR.</p>

DEALER SMM INFO FOR EPB DTC CODES C2007-11 AND C2008-11.

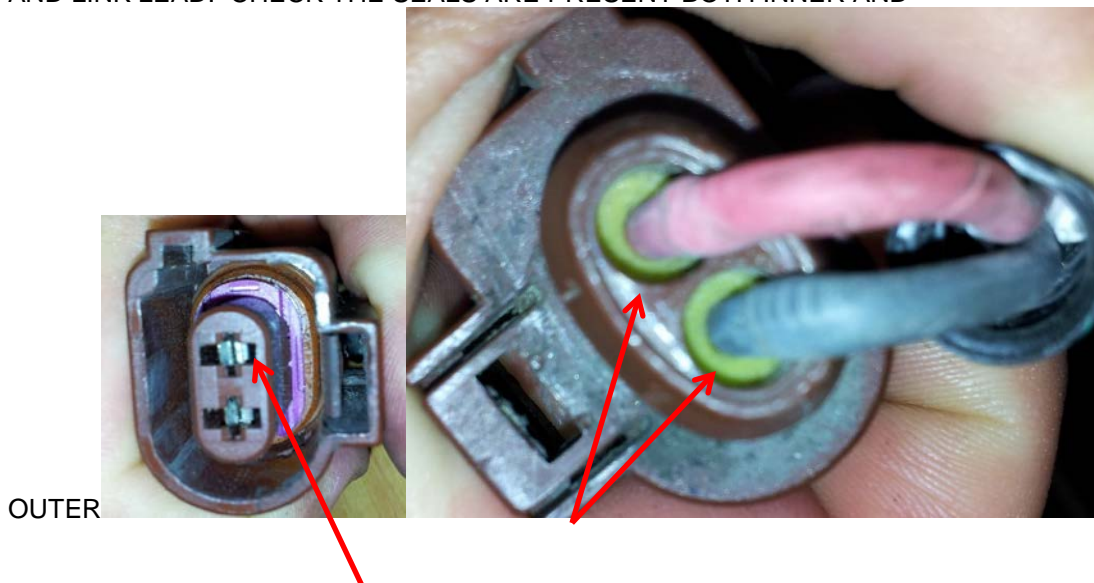
LINK LEAD SEALS – INNER AND OUTER. CHECK FOR PRESENCE AND DAMAGE.

- 1) CHECK FUSE FOR AFFECTED SIDE.
- 2) CHECK ECU GROUND CONNETIONS TO VEHICLE CHASSIS (STUD G4D152-1) (CHECK FOR CORROSION/SCREW TORQUE/LOOSE CONNECTION/PAINT).
- 3) REMOVE THE AFFECTED CALIPER ACTUATOR AND SWAP WITH THE UN AFFECTED CALIPER ACTUATOR (REFER TO TOPIX FOR REMOVAL AND REFITMENT PROCESS), ACTUATE THE EPB VIA SWITCH. CHECK IF THE FAULT FOLLOWS THE ACTUATOR. IF IT DOES THE ACTUATOR IS FAULTY. IF IT DOES NOT THE FAULT IS LIKELY TO BE IN THE LINK LEAD/CONNECTORS ON THE FAULTY SIDE.
- 4) CHECK THE LINK LEAD, CHECK THE PINS FOR CORROSION ON BOTH ACTUATOR AND LINK LEAD. CHECK THE SEALS ARE PRESENT BOTH INNER AND

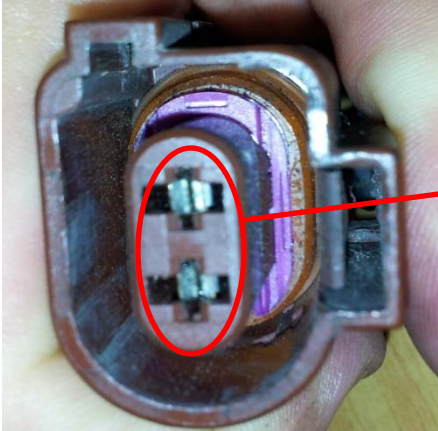
CHECK THAT PINS ARE NOT BACKED OUT. CHECK FOR CORROSION.

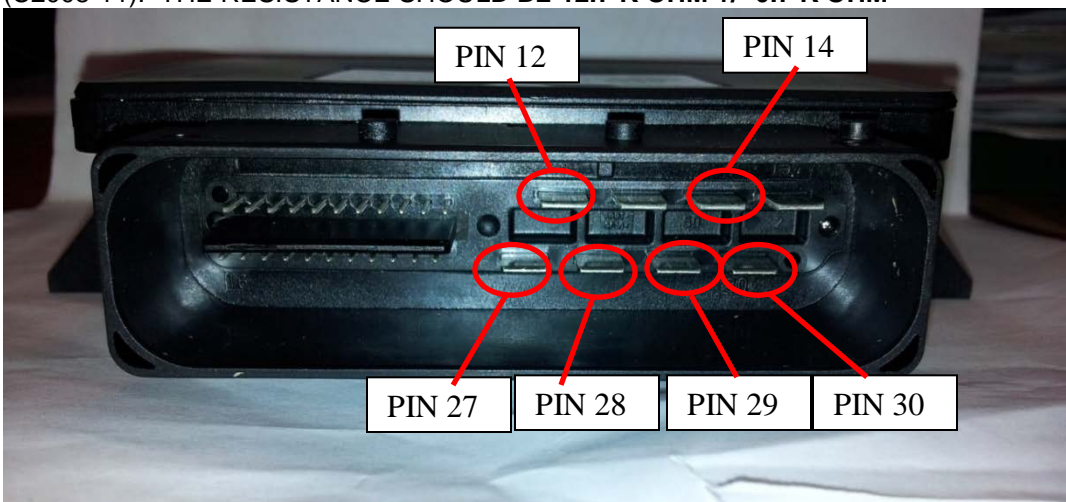
- 5) REMOVE LINK LEAD AND CAREFULLY CHECK FOR ANY VISIBLE SIGNS OF DAMAGE (CHAFING, PINCHING AND STRETCHING).
- 6) REMOVE EPB ECU (REFER TO TOPIX) AND TEST THE RESISTANCE BETWEEN THE MOTOR LINES AND GND ON THE ECU. USING PINS 12 OR 27 (MULTIMETER POSTIVE) TO PIN 28 (GND) FOR THE RIGHT CHANNEL (2007-11). USING PINS 14 OR 29 (MULTIMETER POSTIVE) TO PIN 30 (MULTIMETER G ND) FOR THE LEFT CHANNEL (C2008-11). THE RESISTANCE SHOULD BE **12.7 K OHM +/- 0.7 K OHM**

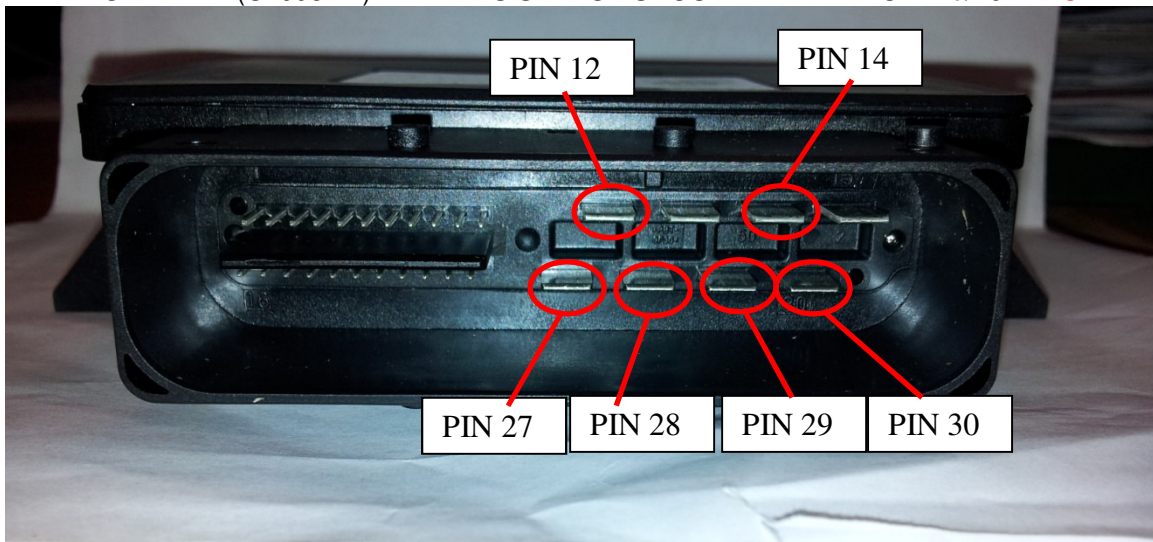
- 1) CHECK FUSE FOR AFFECTED SIDE.
- 2) CHECK ECU GROUND CONNECTIONS TO VEHICLE CHASSIS (STUD G4D152-1) (CHECK FOR CORROSION/SCREW TORQUE/LOOSE CONNECTION/PAINT).
- 5) REMOVE EPB ECU (REFER TO TOPIX) AND TEST THE RESISTANCE BETWEEN THE MOTOR LINES AND GND **ON THE ECU**. USING PINS 12 OR 27 (MULTIMETER POSITIVE) TO PIN 28 (GND) FOR THE RIGHT CHANNEL (2007-11). USING PINS 14 OR 29 (MULTIMETER POSITIVE) TO PIN 30 (MULTIMETER GND) FOR THE LEFT CHANNEL (C2008-11). THE RESISTANCE SHOULD BE **12.7 K OHM +/- 0.7 K OHM**

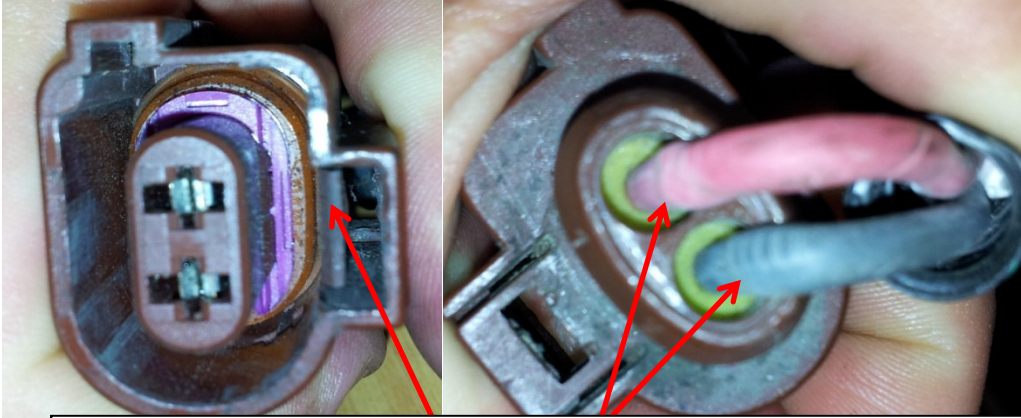
LINK LEAD SEALS – INNER AND OUTER. CHECK FOR PRESENCE AND DAMAGE.

- 4) CHECK THE LINK LEAD, CHECK THE PINS FOR CORROSION ON BOTH ACTUATOR AND LINK LEAD. CHECK THE SEALS ARE PRESENT BOTH INNER AND OUTER

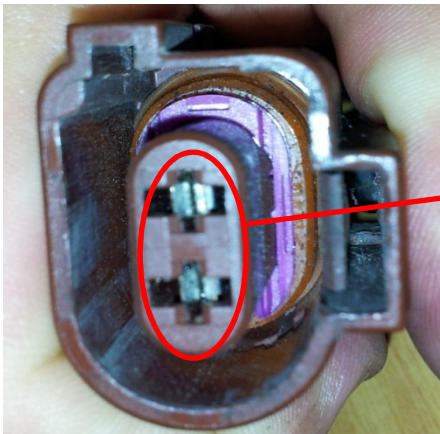
CHECK THAT PINS ARE NOT BACKED OUT. CHECK FOR CORROSION.

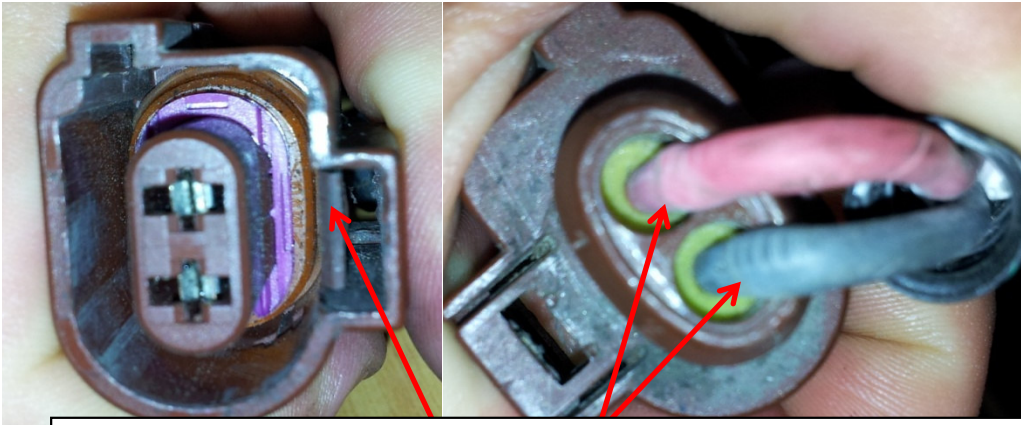
LINK LEAD SEALS – INNER AND OUTER. CHECK FOR PRESENCE AND DAMAGE.

- 1) CHECK FUSE FOR AFFECTED SIDE.
- 2) CHECK ECU GROUND CONNETIONS TO VEHICLE CHASSIS (STUD G4D152-1) (CHECK FOR CORROSION/SCREW TORQUE/LOOSE CONNECTION/PAINT).
- 3) REMOVE THE AFFECTED CALIPER ACTUATOR AND SWAP WITH THE UN AFFECTED CALIPER ACTUATOR (REFER TO TOPIX FOR REMOVAL AND REFITMENT PROCESS), ACTUATE THE EPB VIA SWITCH. CHECK IF THE FAULT FOLLOWS THE ACTUATOR. IF IT DOES THE ACTUATOR IS FAULTY. IF IT DOES NOT THE FAULT IS LIKELY TO BE IN THE LINK LEAD/CONNECTORS ON THE FAULTY SIDE.
- 4) CHECK THE LINK LEAD, CHECK THE PINS FOR CORROSION ON BOTH ACTUATOR AND LINK LEAD. CHECK THE SEALS ARE PRESENT BOTH INNER AND OUTER

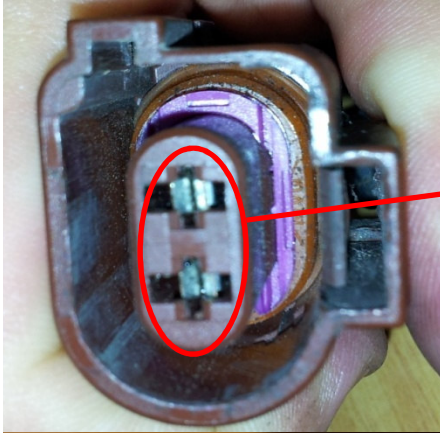
CHECK THAT PINS ARE NOT BACKED OUT. CHECK FOR CORROSION.

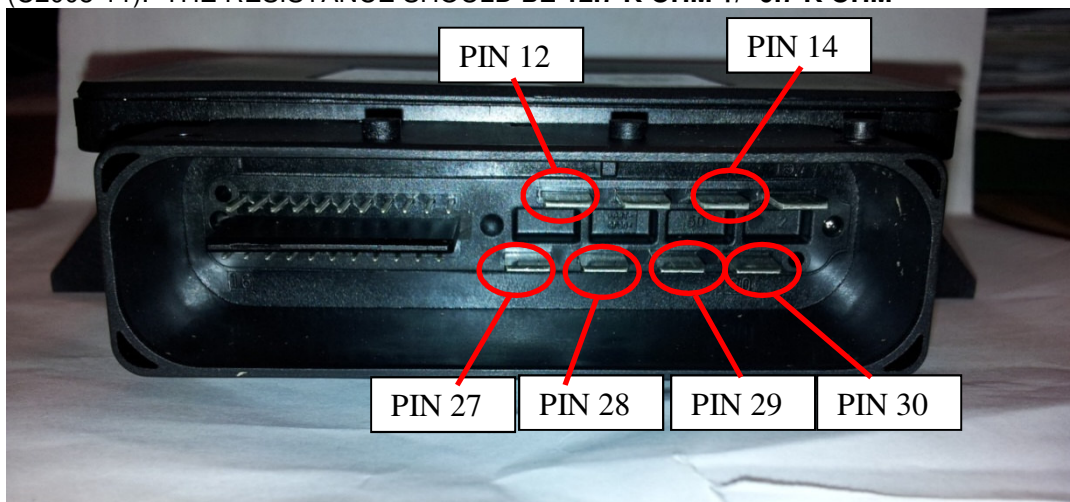
- 5) REMOVE LINK LEAD AND CAREFULLY CHECK FOR ANY VISIBLE SIGNS OF DAMAGE (CHAFING, PINCHING AND STRETCHING).
- 6) REMOVE EPB ECU (REFER TO TOPIX) AND TEST THE RESISTANCE BETWEEN THE MOTOR LINES AND GND ON THE ECU. USING PINS 12 OR 27 (MULTIMETER POSTIVE) TO PIN 28 (GND) FOR THE RIGHT CHANNEL (2007-11). USING PINS 14 OR 29 (MULTIMETER POSTIVE) TO PIN 30 (MULTIMETER G ND) FOR THE LEFT CHANNEL (C2008-11). THE RESISTANCE SHOULD BE **12.7 K OHM +/- 0.7 K OHM**
