Technical Service Bulletin

46 Brake pulsation diagnostic guidelines

46 22 26 2022584/11 January 31, 2022. Supersedes Technical Service Bulletin Group 46 number 21-23 dated February 10, 2021 for reasons listed below.

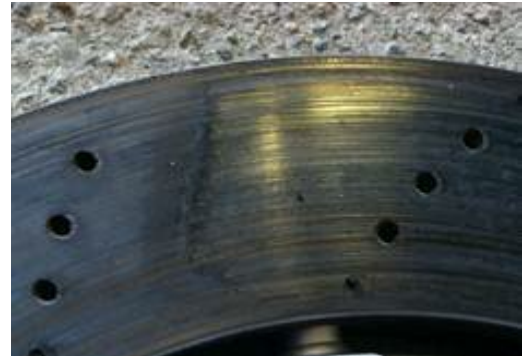
Figure 2. Deposits on the brake disc.

Condition: Brake pad material smeared on the brake disc (Figure 2). This condition can create DTV.

Common cause: An overly-aggressive driving style, which results in frequent sharp braking without proper cooling off periods.

Service: Replace the brake discs and pads.

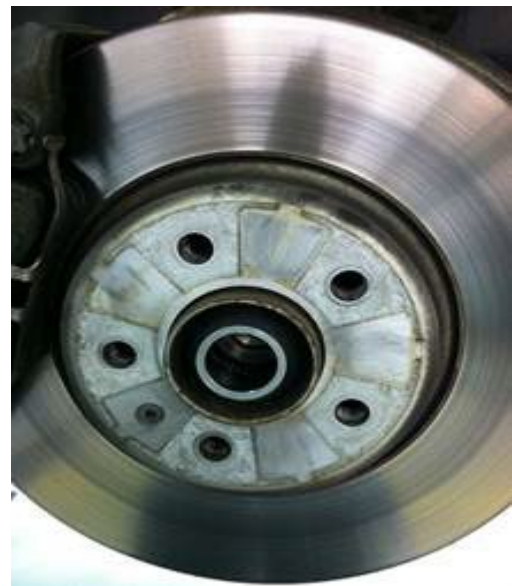
Figure 3. Brake disc with heat marks.

Condition: Blue-tempered or overheated brake discs (Figure 3).

Common cause: Failed component(s) causing constant brake application. This can also be caused by an overly-aggressive driving style, which results in frequent sharp braking without proper cooling off periods.

Service: Replace the brake disc and pads.

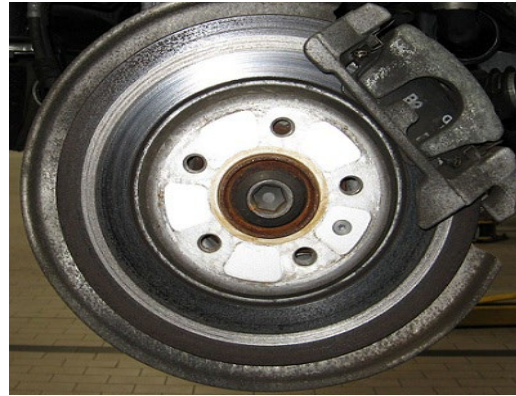
Figure 4. Corrosion/rust build-up.

Condition: Corrosion/rust build-up on the brake discs (Figure 4). This condition can create DTV.

Common causes:

- Exposure to road salt during winter months, high humidity, or moisture.
- Vehicle not being driven for prolonged periods of time.
- A gentle driving style with very light brake application may not be enough to remove build-up (such as rust or corrosion) on the brake discs and pads.

Service: With careful consideration of the traffic situation, perform 2-3 ABS stops from speeds above 50mph. Between each stop, allow the brake components to cool by driving the vehicle for more than one minute at speeds greater than 50mph. Do not perform ABS stops if brand new pads and/or discs are installed. Replace brake disc and pads if the condition is not eliminated.

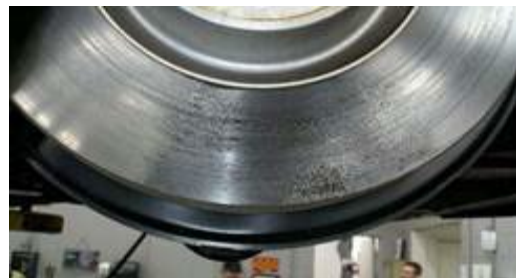
Figure 5. Pad marks on the brake disc.

Condition: Pad material transfer or corrosion marks from brake pads on the brake disc, also known as “pad marks” (Figure 5). This condition can create DTV.

Common cause: These marks can appear if the vehicle has not been driven for a prolonged period of time or if the brakes are exposed to high humidity or moisture.

Service: With careful consideration of the traffic situation, perform 2-3 ABS-stops from speeds above 50mph. Between each stop, allow the brake components to cool by driving the vehicle for more than one minute at speeds greater than 50mph. Do not perform ABS stops if brand new pads and/or discs are installed. Replace brake disc and pads if the condition is not eliminated.

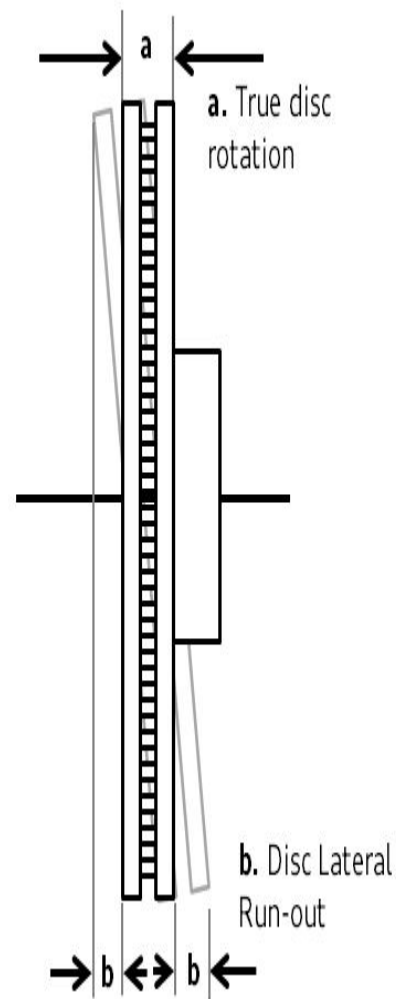
Condition: Excessive brake disc or wheel hub run-out (Figure 6). Measure according to the *Run-out Measurement Instructions* listed below.

- **Over-torqued or improperly-torqued wheels** (torque sticks, impact gun, etc.) can distort the brake disc and hub, causing a run-out condition. Refer to Elsa for proper torque values and procedures for the VIN.
- **Wheels that are not Audi-approved** may not have the same contact surface on the back of the wheel and may not have the correct center bore dimension, which can distort the brake disc and hub, causing a run-out condition.
- **External impact or rust build-up** between brake disc and hub.

6. True disc rotation (a) and disc lateral run-out (b).

Service: Replace brake disc(s) and/or hub(s) if measurements exceed the maximum value listed in the *Run-out Measurement Instructions*.

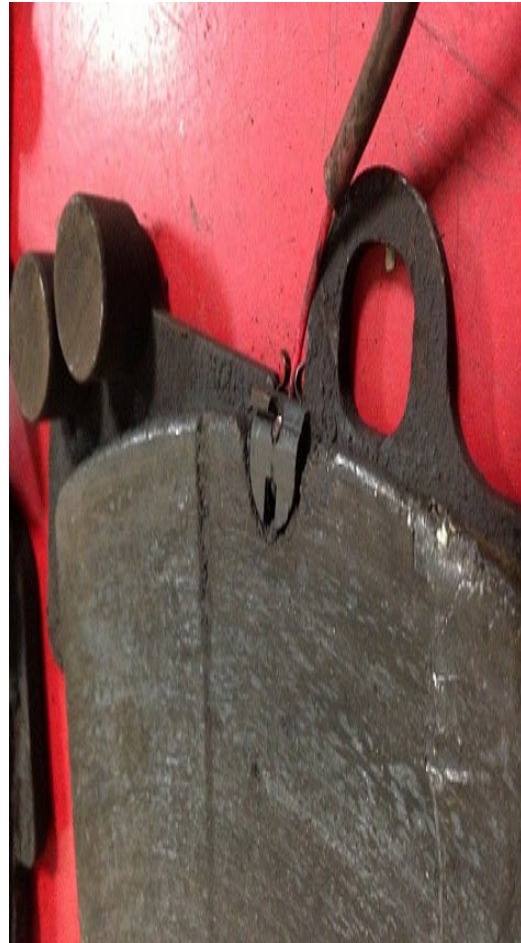
Figure 7. Worn brake pad.

Condition: Worn brake pads (Figure 7).

Common cause: As brake pads and discs reach their wear limit, their dampening characteristics are reduced.

Service: Replace worn brake pads and discs.

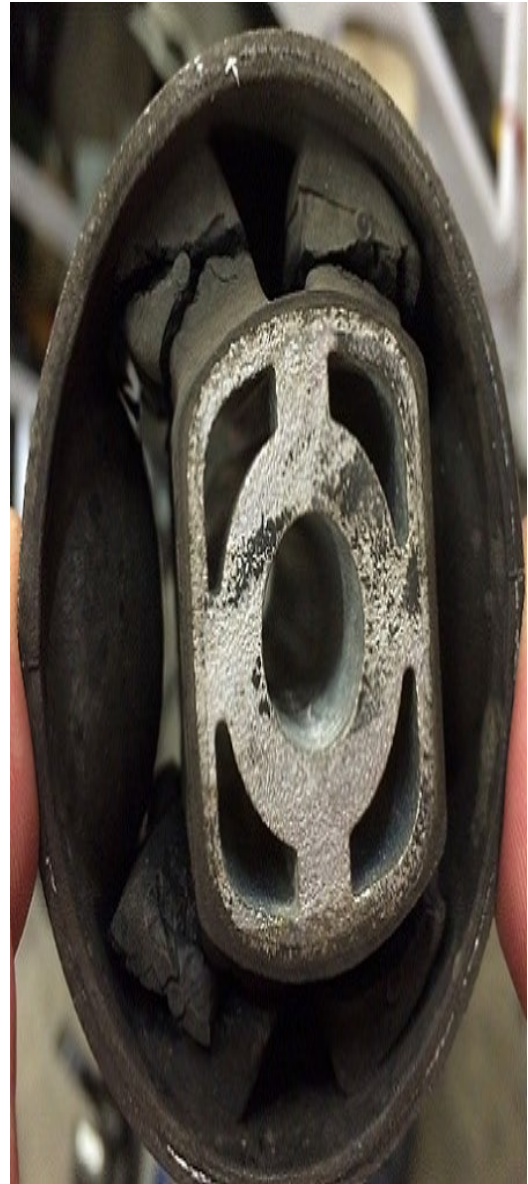
Figure 8. Damaged suspension bushing.

Condition: Faulty, damaged, or aftermarket suspension components (ball joints, links, tie rods, bushing, etc.) can significantly amplify vibration/pulsation or lead to body vibrations which only become noticeable when braking (Figure 8 and Figure 9).

Service: Diagnose these components accordingly.

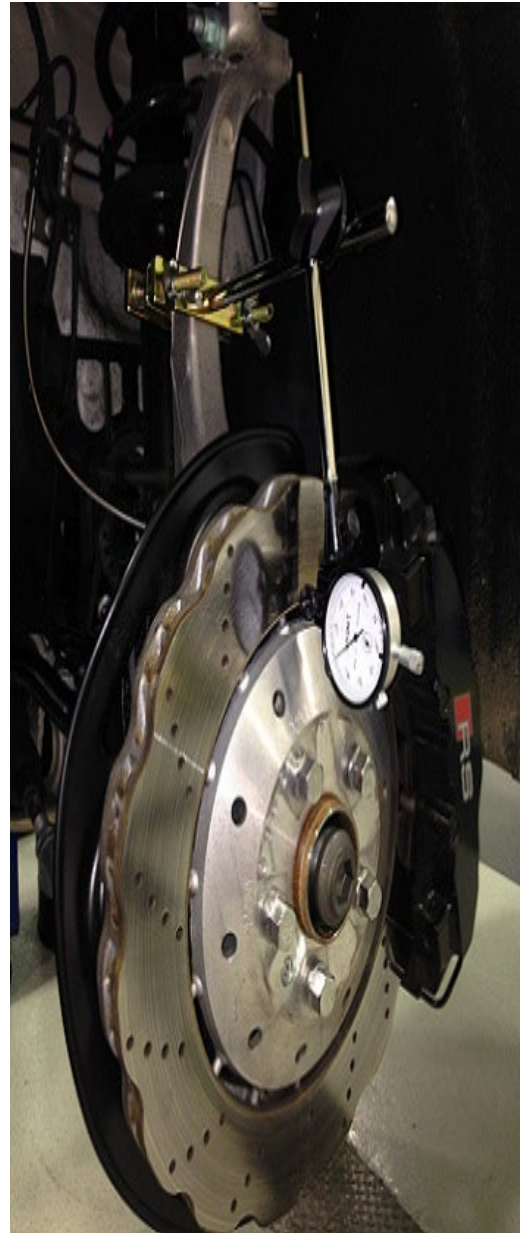
- All surfaces that will be measured must be free of rust/corrosion build-up or pad material transfer.
- VAS6079/1 (or similar measurement tool) is securely attached to the vehicle (Figure 11).
- The brake disc is secured to the hub with 5 bolts.
- Axle bolt/nut is installed and properly torqued.
- Run-out measurements should be taken with all parts installed on the vehicle.

Figure 11. Example of the run-out measurement tool VAS6079/1 properly secured to a solid suspension component.

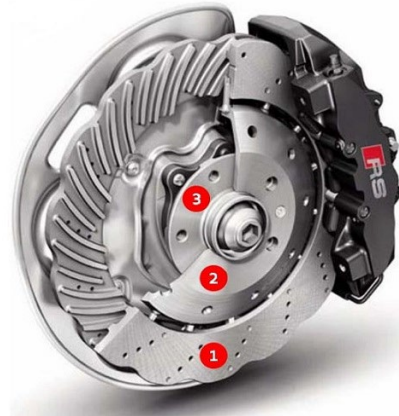
Disc braking surface (Figure 12, point 1):

- Disc hub and wheel hub run-out impact this value.
- Maximum run-out: **0.06 mm / 0.002"**.

Disc hub (center of the brake disc) (Figure 12, point 2):

- Wheel hub run-out impacts this value.
- Disc hub run-out impacts the disc braking surface run-out.
- Maximum run-out: **0.03 mm / 0.0012"**.

Wheel hub (without the disc installed) (Figure 12, point 3):

- This value impacts the disc hub and disc braking surface run-out. High run-out can distort the brake disc.
- Maximum run-out: **0.02 mm / 0.0008"**.

Figure 12. Run-out measurement locations: disc braking surface (1), disc hub (2), wheel hub (3).
