Volvo Chassis - Diesel Exhaust Fluid (DEF) Contamination In Fuel System, Inspection And Repair - US10 to US14 (Non-Common Rail Fuel System)

Overview

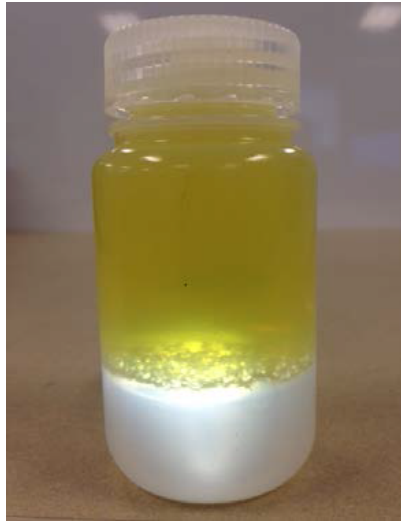
Diesel fuel is less dense than DEF. When allowed to separate, diesel will float on top of DEF.

1. Using an appropriate clear container (a beaker is a good example), obtain a fuel sample from the bottom of the fuel tank.
2. Let the fuel sample sit for 10-15 minutes.
3. Visually inspect the fuel sample to see if separation is observed as shown in the picture below:
 - Putting a light behind the sample container can help highlight a separation line in the sample

If DEF Is Confirmed To Be Present In The Fuel

- The fuel tanks need to be completely drained and thoroughly flushed with water. The presence of pitting on the inside of the tank may require tank replacement. The tank will need to be inspected following cleaning.
- The complete fuel system will need to be thoroughly flushed.
- The system should be dried as thoroughly as possible prior to reassembly.

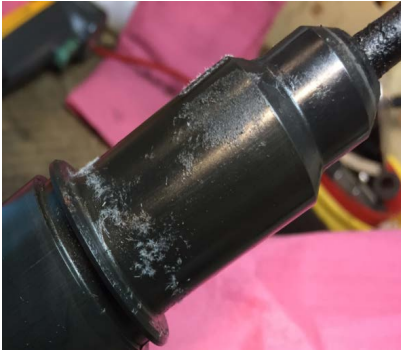
Crystallization in Normal Light

Live UI k for the presence of DEF crystal or residue on the injector using a flashlight. DEF will fluoresce (glow) under blacklight as shown below.

- Fuel Injectors and sleeves
- Fuel pump
- Aftertreatment Hydrocarbon Injector (AHI) Module
- AHI nozzle
- AHI fuel/air supply line (line between AHI module and nozzle)
- Overflow valve in the cylinder head
- Fuel Filter base
