Subject: N192208720 - Service Update
Clean Air Idle Label Missing

Models: 2019 Chevrolet Silverado 4500HD, 5500HD, 6500HD

N192208720 – Clean Air Idle Label Missing

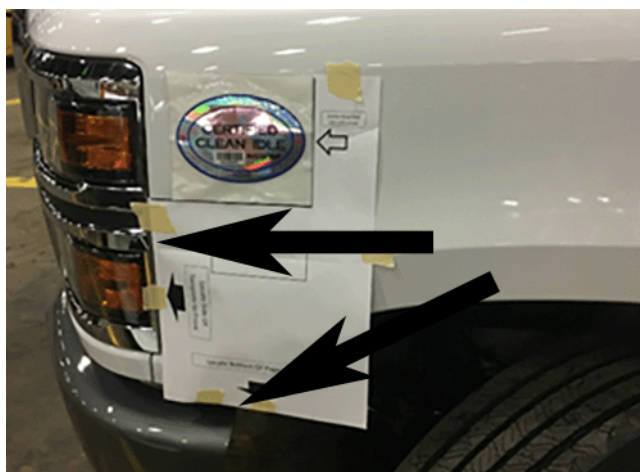
5208537

- Install the template with the left edge aligned with the end of the fender and the bottom level with the bottom edge of the fender. Secure the template with masking tape.

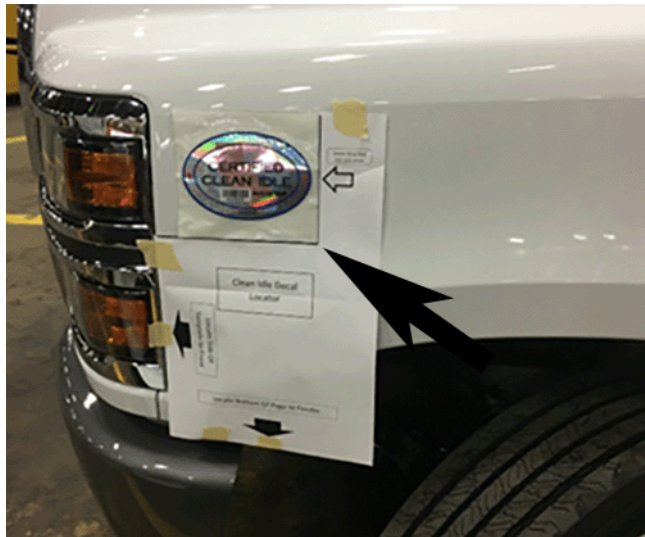
5208558

4. Firmly hold the new label and peel protective liner from the back side, being careful not to touch or contaminate the adhesive with dirt or foreign matter.

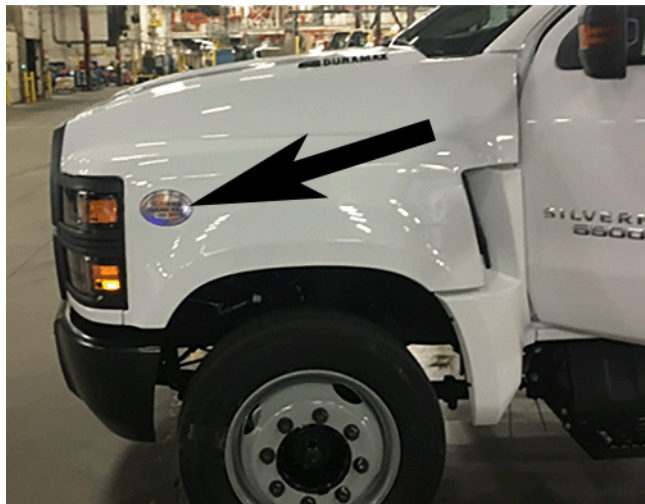
5208424

5. Carefully align new label to the template, align bottom right of decal film with template edges. Press firmly and smooth out entire label ensuring corners are fully adhered. Remove the outer label carrier film.
