Preliminary Information

PIT5479E Diagnostic Tip - Perceived Brake Fluid Leak at Caliper Piston Boot

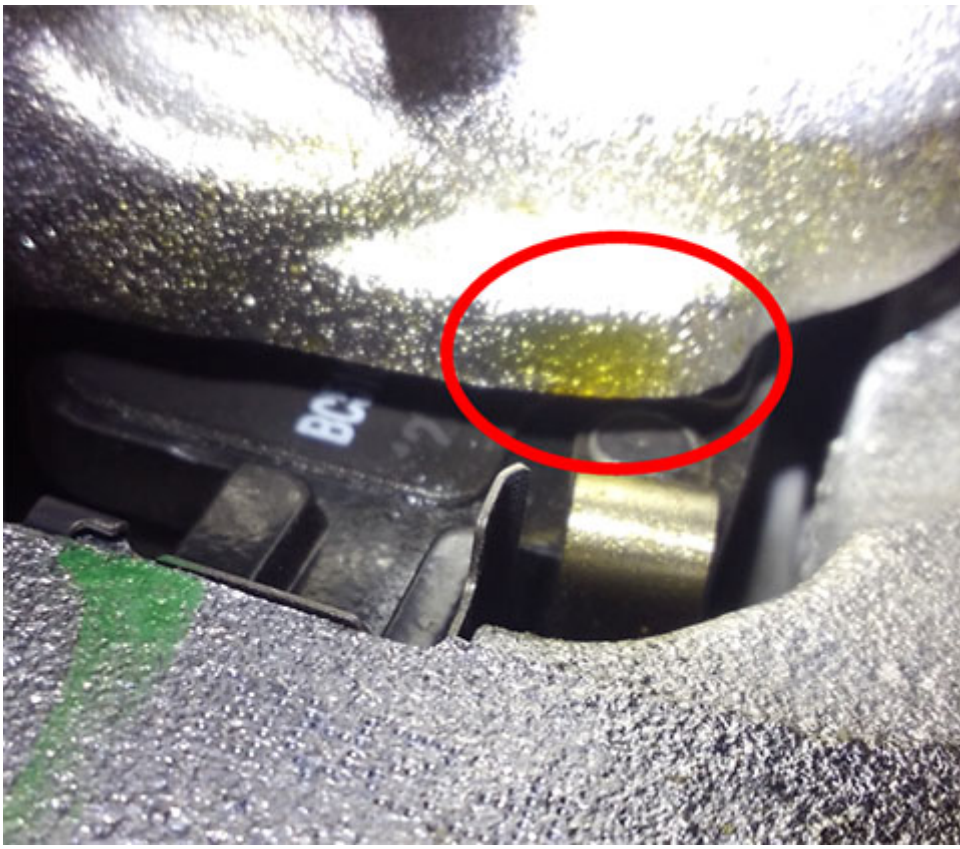
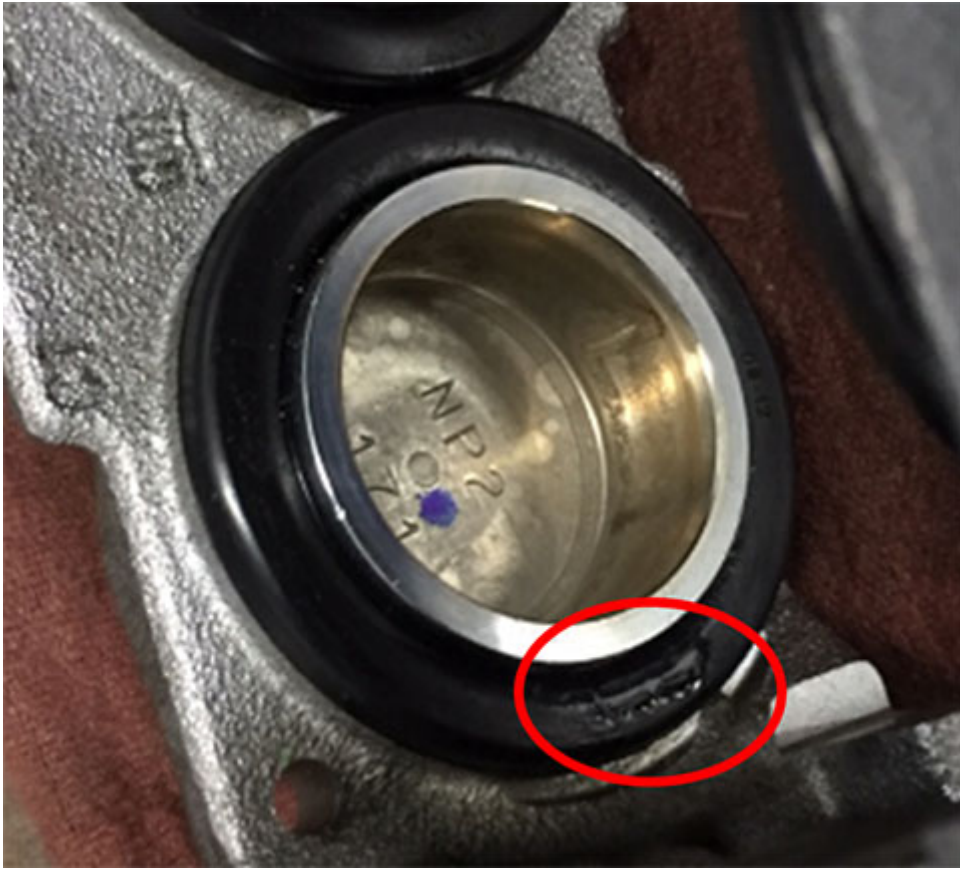
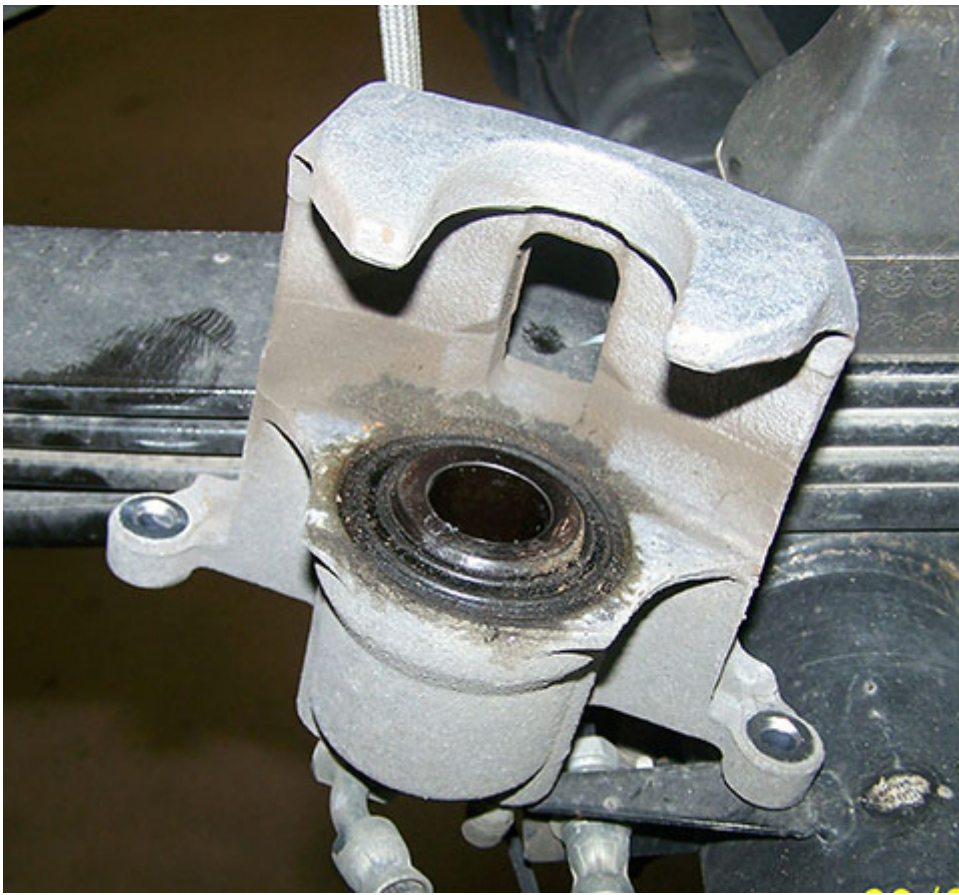
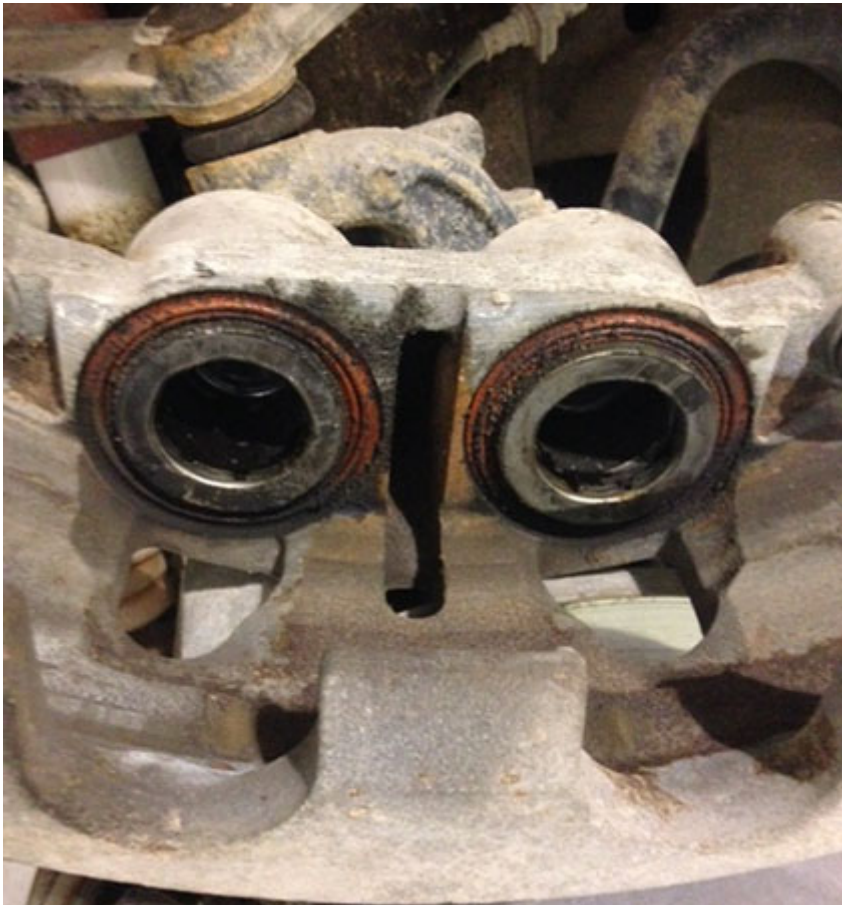
A technician may comment that, during service, it appears there is fluid leaking from the brake caliper piston area. Shown below are examples of newer low mileage vehicles and older higher mileage vehicles.

The substance shown is actually excess assembly grease from the caliper boot and piston installation. This grease can be cleaned off and the rest of the service completed.

NOTE: When diagnosing a brake fluid leak or certain DTC's for hydraulic brake circuit leaks, such as C05B0, do not confuse excessive assembly grease as a brake fluid leak. If it is uncertain what is seen is assembly grease, then clean off the excessive grease and apply the brake pedal 20 times and re-inspect for a leak.
