Technical product information

Topic	V8 Kovomo - Bentayga - Water pump drive gear cover (Deletion)
Market area	Russische Föderation (5RU),Australia E04 Bentley rest Asia and Australia (6E04),China 796 VW Import Comp. Ltd (Vico), Beijing (6796),Germany E02 Bentley rest Europe (6E02),Japan E03 Bentley Japan (6E03),Korea, (South) E08 Bentley South Korea (6E08),United Arab Emirates E06 Bentley Middle East and Africa (6E06),United Kingdom E01 Bentley UK (6E01),United States E05 Bentley USA and rest America (6E05)
Brand	Bentley
Transaction No.	2065918/1
Level	EH
Status	Approval
Release date

V8 Kovomo engine

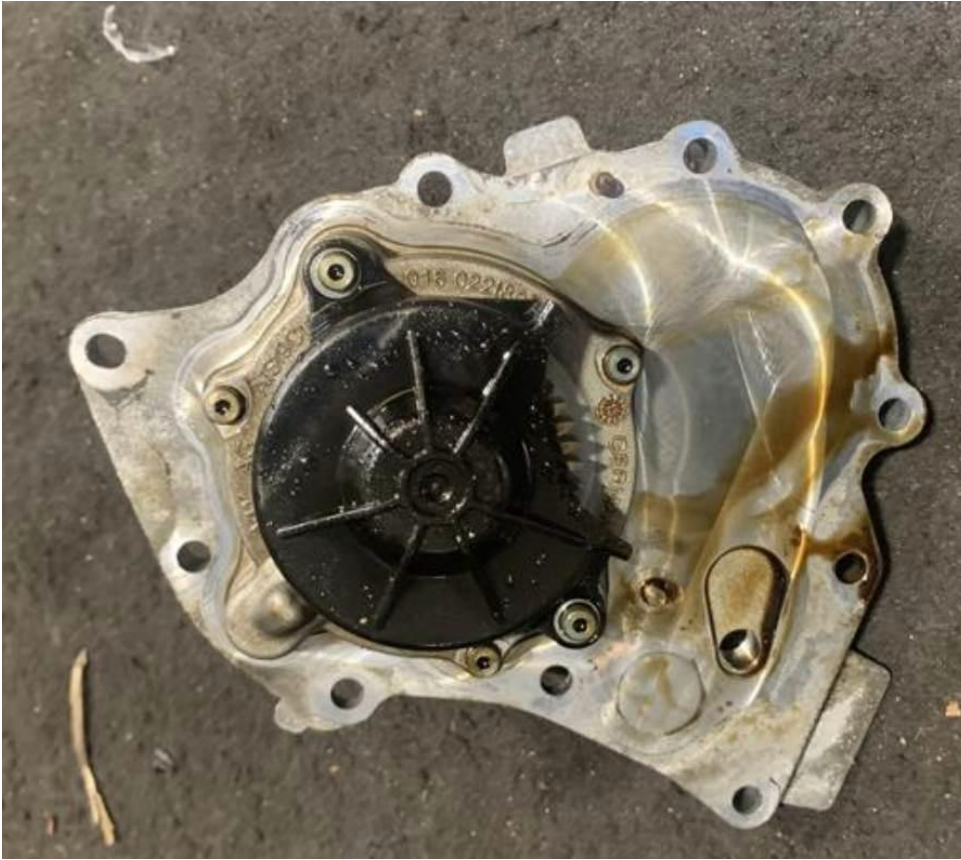
Figure 1

The original water pump has a cover fitted directly over the top of the water pump drive gear (Figure 1)

The cover is no longer fitted on replacement water pumps, the cover is not required and MUST not be transferred to the new water pump

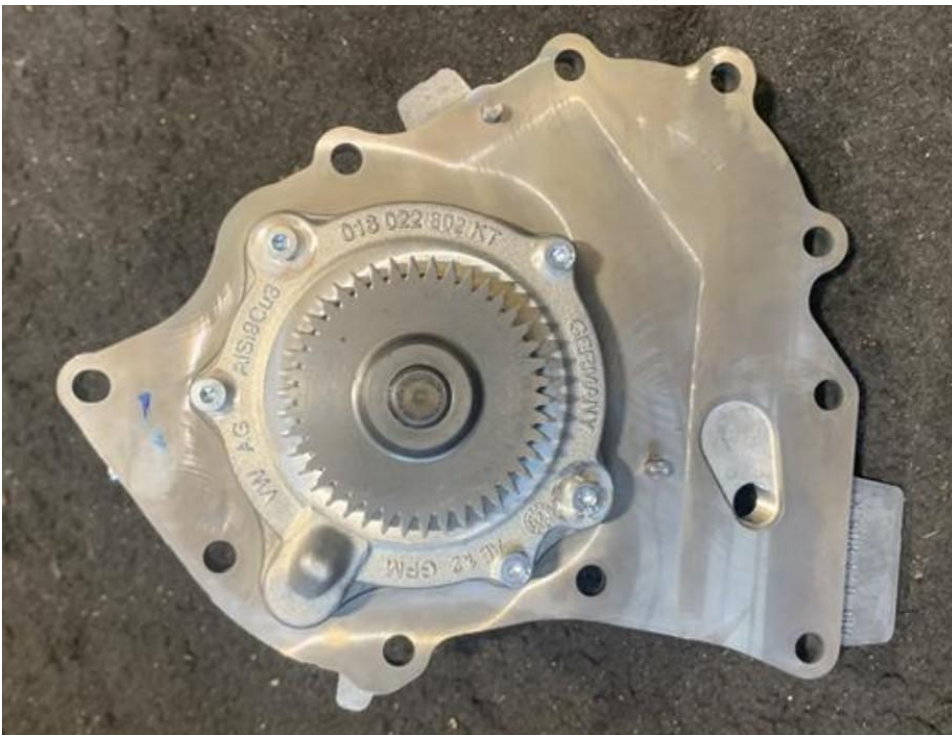
However the replacement water pump does not have a cover fitted (Figure 2)

The operative should fit the new water pump without the cover as shown in Figure 2
