PIT5893 Power Liftgate Actuator Removal Procedure

Brand:	Model:	Model Years:	VIN:		Engine:	Transmissions:
			from	to		
Cadillac	XT5	2018 - 2022	All	All	All	All
Cadillac	XT6	2018 - 2022	All	All	All	All
GMC	Acadia	2018 - 2022	All	All	All	All

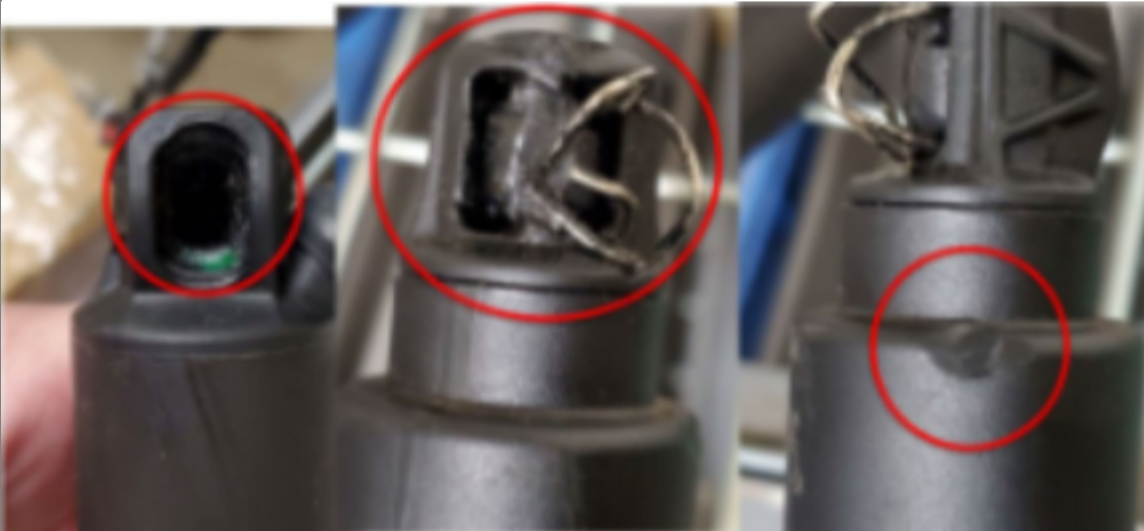
Involved Region or Country	North America
Condition	Power liftgate actuators are being returned for warranty that have damage caused by improper removal.
Cause	<p>Not following the proper procedure to remove the power liftgate actuator. Damage from prying actuators off shown in photos below.</p>

To properly remove the actuator follow the procedure below.

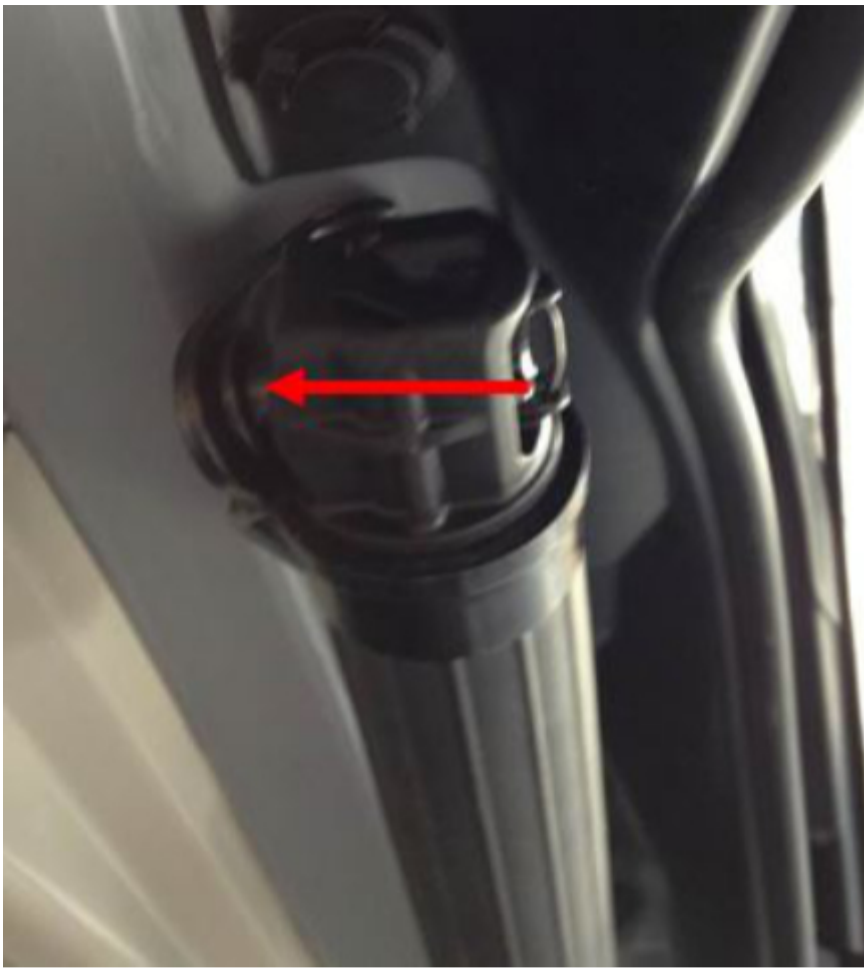
With the liftgate fully open push the actuator ball socket onto the ball in the direction of the arrow as shown below.

Make sure that the spring clip is snapped into the closed position, otherwise push the spring in by hand.

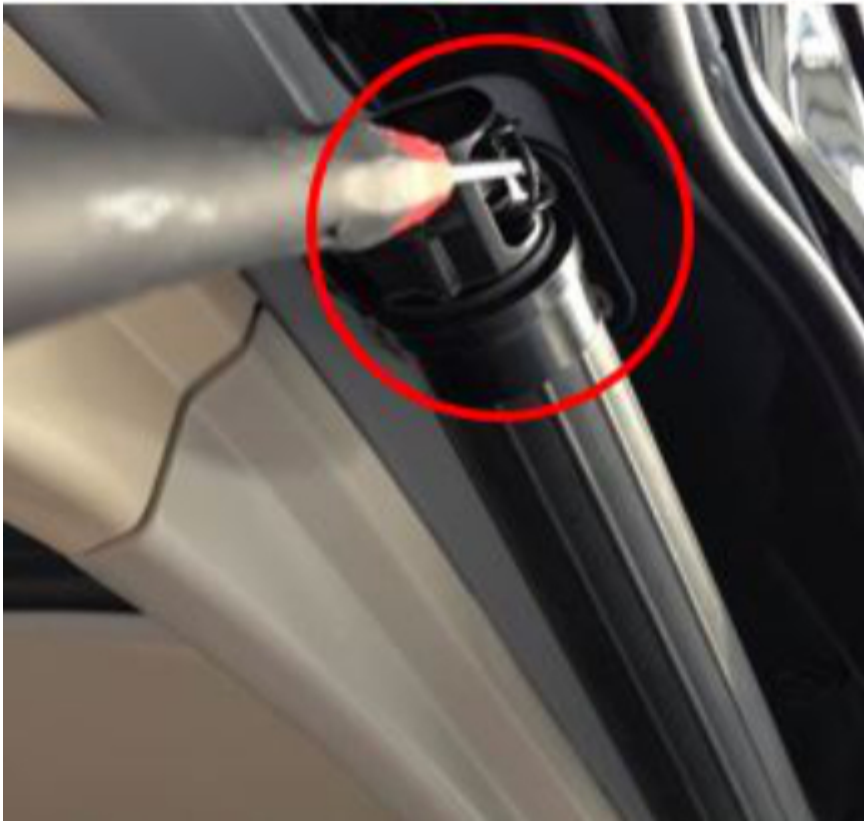
Insert flat pocket screwdriver behind the clip.

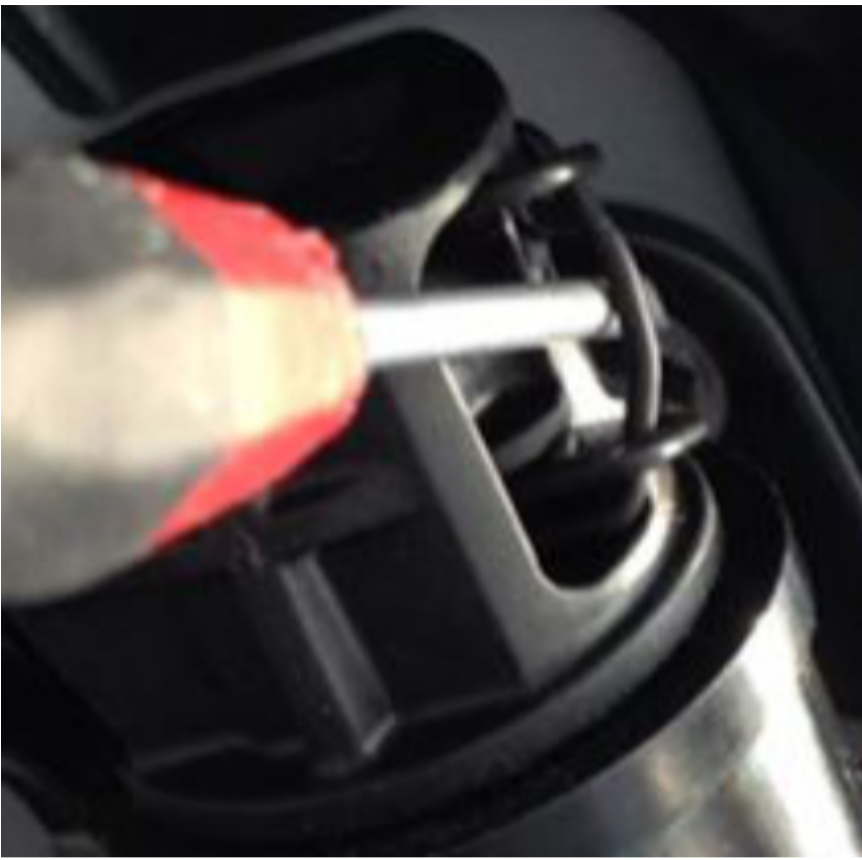
There is no need to remove the clip.

Pull the ball socket off the ball completely.
