Technical Service Bulletin

42 Rattle noise from the rear suspension

42 22 48 2038689/6 March 16, 2022. Supersedes Technical Service Bulletin Group 42 number 21-46 dated August 2, 2021 for reasons listed below.

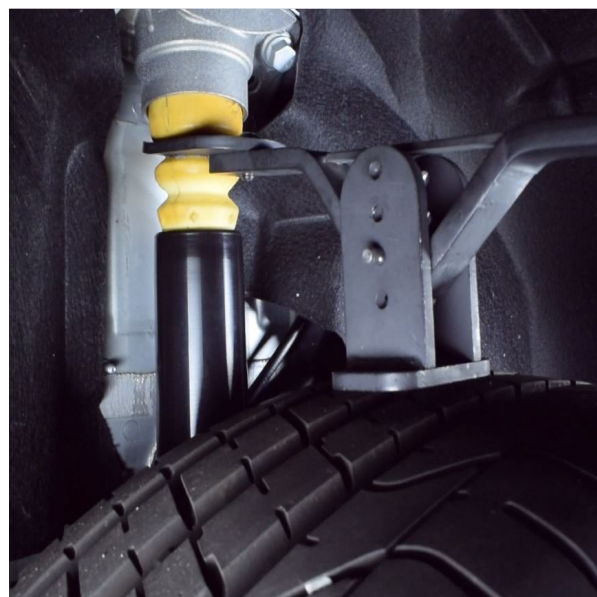
Figure 2. The SET900 tool being used to install a rear bump stop.

1. Clean the top of the rear bump stops and coat with tire mounting paste.
2. Use the SET900 special tool to fully press the rear bump stops into the upper shock mounts (Figure 2).
3. The purpose of the tool is to properly seat the rear bump stops in the rear shock mounts (Figure 3), which will prevent them from dropping out of the rear upper shock mounts and causing the noise.

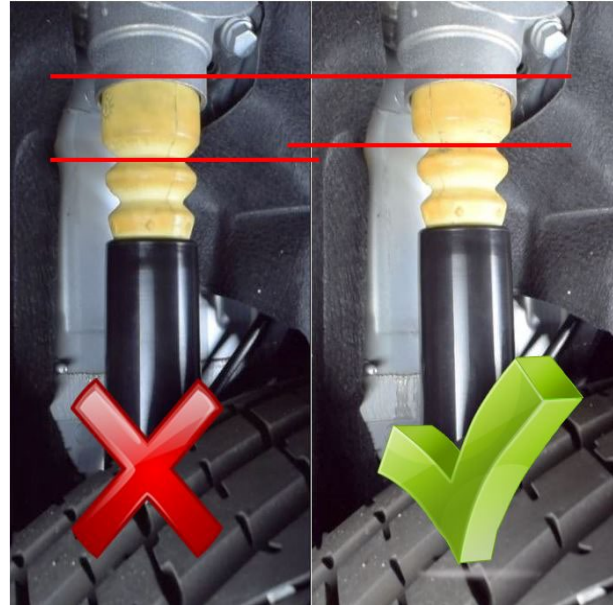
Figure 3. Comparison between rear bump stop installation without and with the SET900 tool.

Always ensure that the dust boot does not get caught on the top of the shock once the vehicle is lowered.
