Thor Motor Coach Technical Service Bulletin

TSB #	TSB 22-04		
Description/Title:	Ford Transit USB dash delete		
Affected Product Line(s):	Certain model year 2022 Gemini/Compass		
Service Campaign # :	RC000259	Released Date:	3/28/2022
Codes:	Inspect Only: TMCTS80273Y Inspect with Repair: TMCTS80273W	Document Date:	3/28/2022
Time Allowed:	Inspect Only: 0.1 Inspect with Repair: 0.2	Document Revision:	A

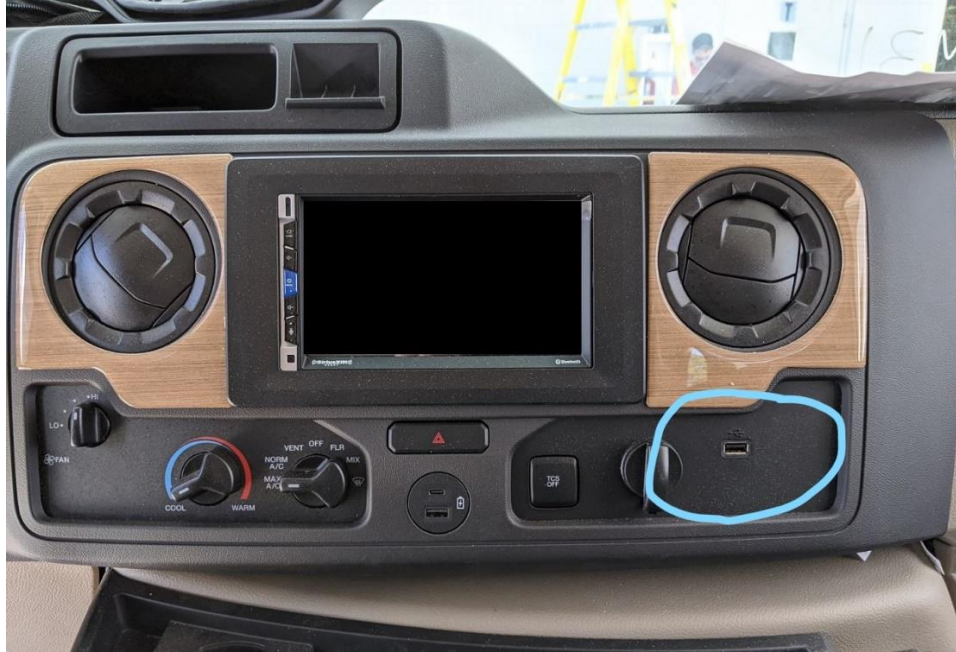
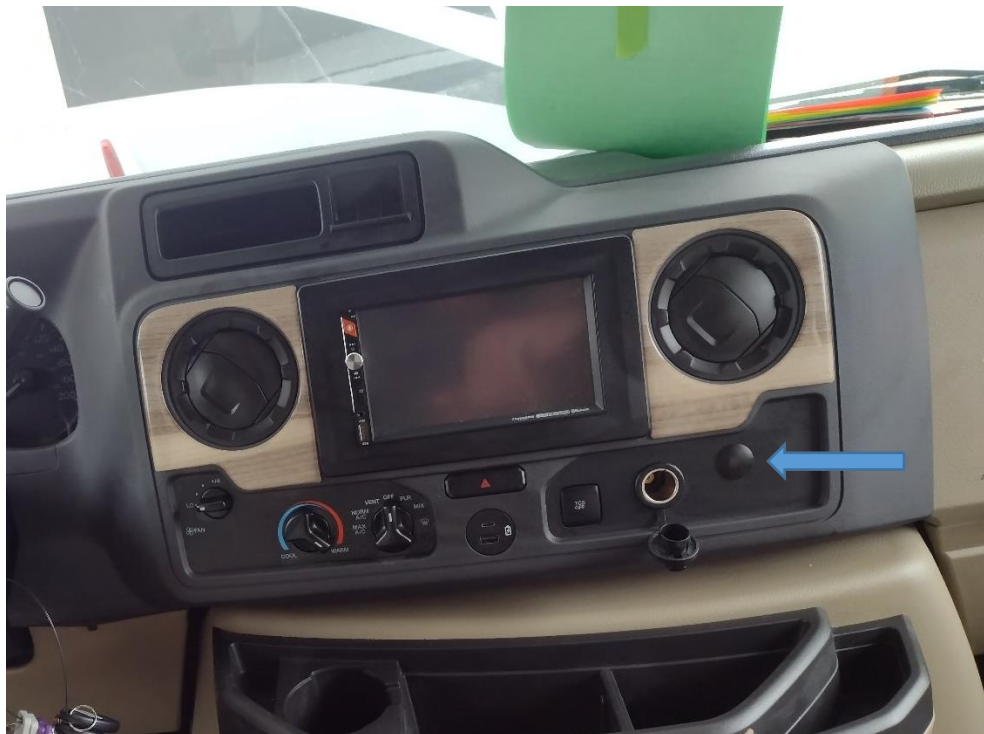
Original Ford USB in dash is non-functioning. TMC uses an upgraded radio in place of the Ford OEM radio, and this USB is no longer supported.

Use a flat head screw driver to push the USB outlet straight in towards the dash until the USB disconnects from the dash. Insert panel fastener in place where USB was in the dash.
