GROUP	MODEL
BOD	2015-2018MY Sedona (YP)
NUMBER	DATE
304	March 2022

## TECHNICAL SERVICE BULLETIN

### 3<sup>RD</sup> ROW CENTER SEAT BELT RETRACTOR WEBBING GUIDE REPLACEMENT

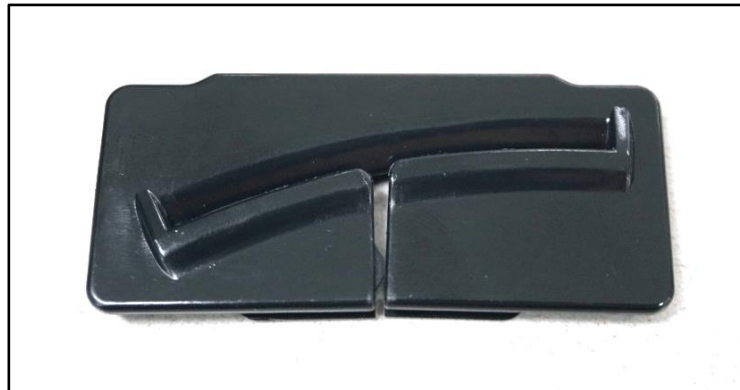
New 3<sup>rd</sup> Row Center Seat Belt Webbing Guide

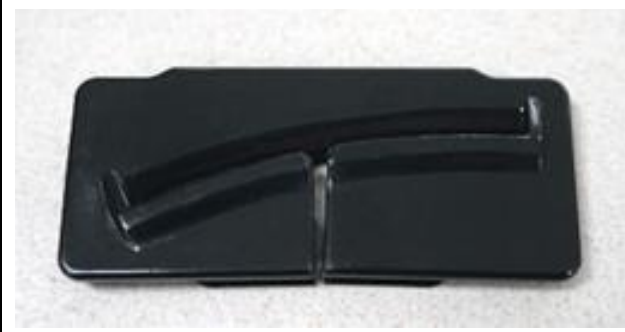
Outside (facing down when installed)

Always install the new guide in the correct position, with the inside facing up, when reassembling it to the vehicle.

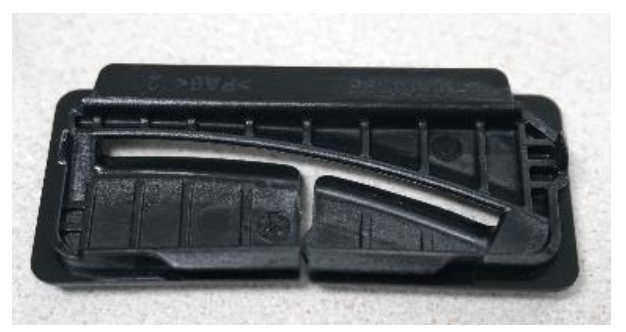
Inside (facing up when installed)
