# Volvo Chassis - Crankcase Ventilation ( CCV ) Oil Leaks - Technical Service Bulletin M-257 - 004, Technical Service Bulletin M-257 - 006 - US14 And US15 Emissions

## CCV Housing Inlet Tube, Replacement

M-257-004

# Crankcase Ventilation Separator Housing, Overhaul

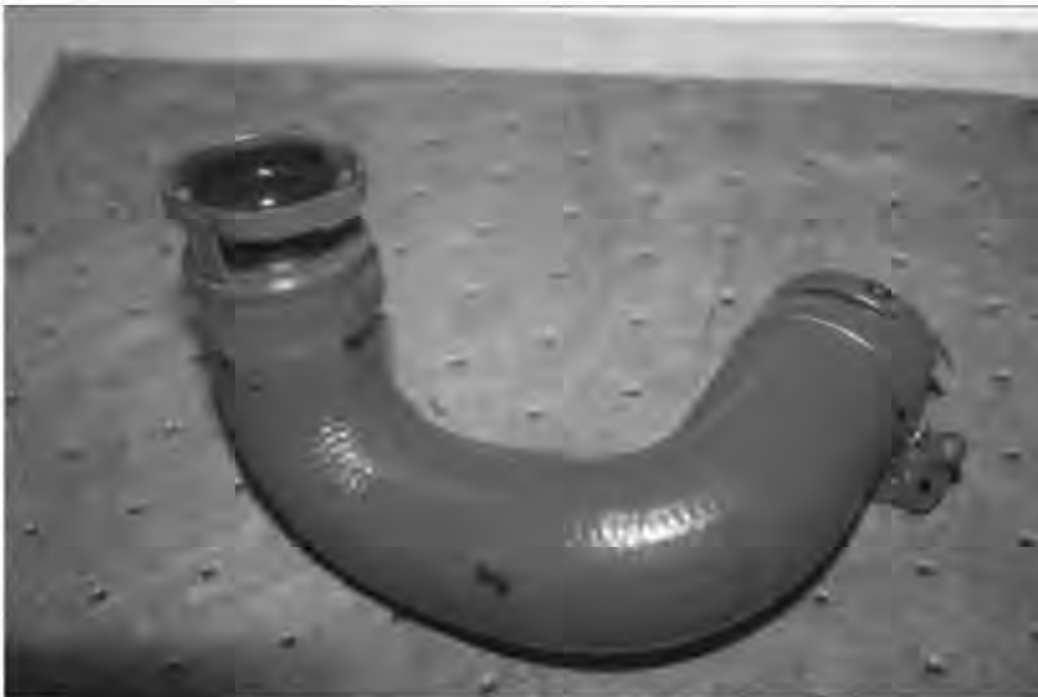
Some trucks may experience oil leaks at the CCV housing inlet tube or at the split line between the upper and lower housings. The cause of this leak is the O-ring installed on the inlet tube. Follow the instruction in this document to properly fix this leak.

To correct this issue, do not disassemble the CCV, replace the inlet tube. Clean the surrounding area to complete the repair. If it is determined that there is a leak at the housing other than the inlet O-ring, the complete CCV assembly will need to be replaced as this is a non-serviceable part. Do not attempt to tighten the split line screws on the housing or disassemble the assembly as seals and repair parts are no longer available for this component as they were on the older version of this component. If the collar on the CCV inlet is worn or broken at the locking lip, replace the complete CCV assembly. Additionally, Replace the CCV to cylinder block gasket any time the CCV assembly is removed.

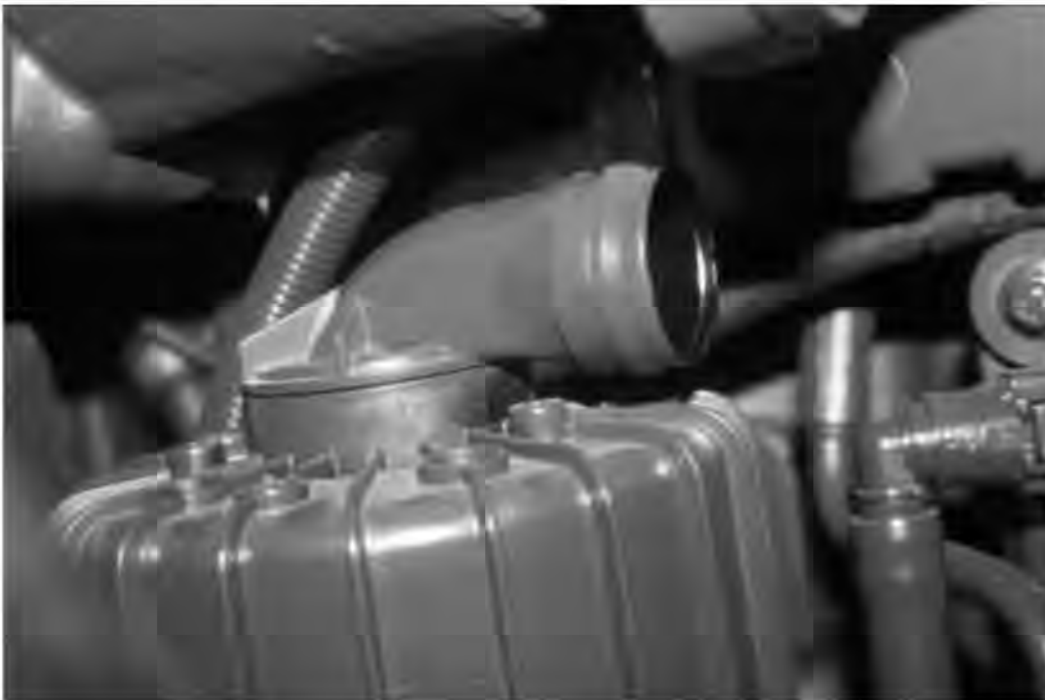
1. Secure the vehicle for service by parking it on a flat level surface, applying the parking brake, chocking the rear wheels, and placing the transmission in neutral or park.
2. Remove the quick connect fitting at the CCV.

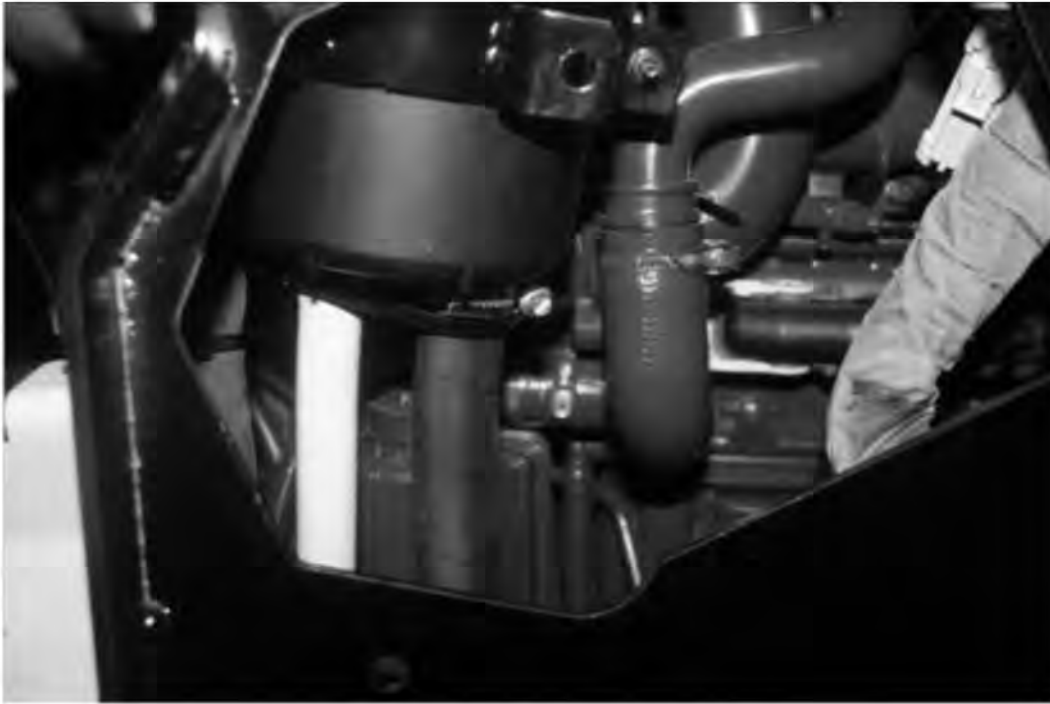
3. Remove the formed rubber hose from the metal ventilation pipe coming from the valve cover.

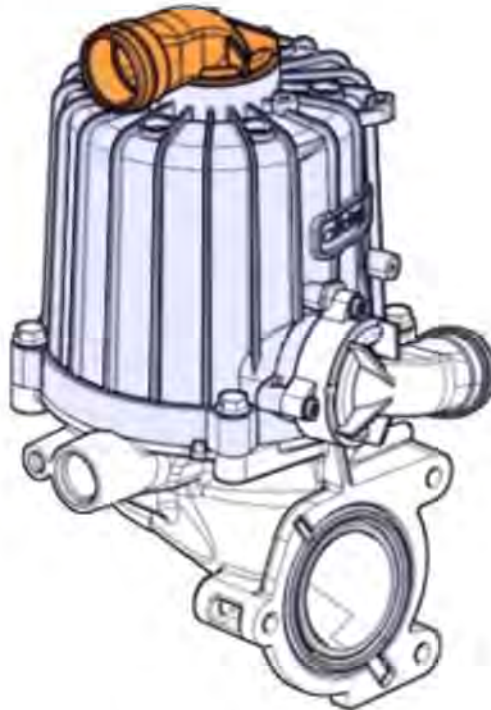
1. Remove the CCV assembly according to Impact instructions.
2. Inspect the inlet quick connect nipple for any signs of damage or wear that would contribute to any leaks in this area. If any damage is noted, replace the complete CCV assembly.

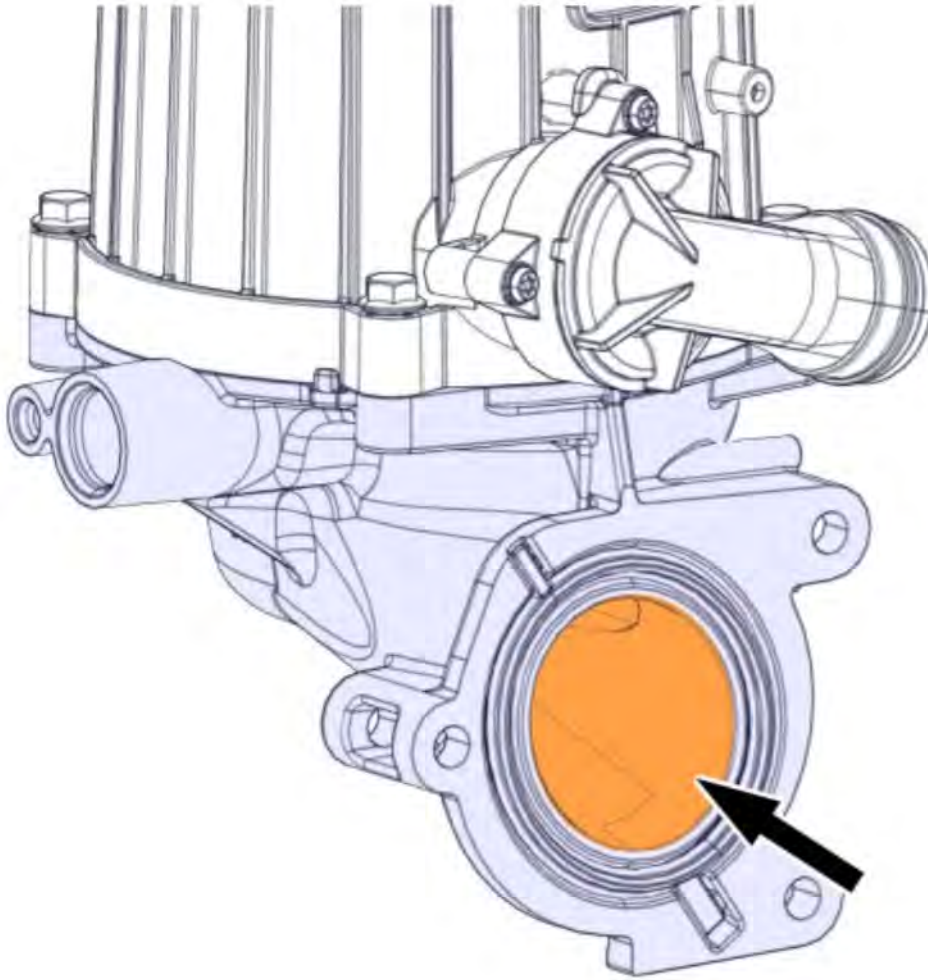
3. Replace the O-ring in the inlet quick coupler hose with a new one.
4. Reach into the flange opening and try spinning the turbine to see if it is free with no hard spots or bearing noise. It should spin freely. If not, replace the complete assembly.

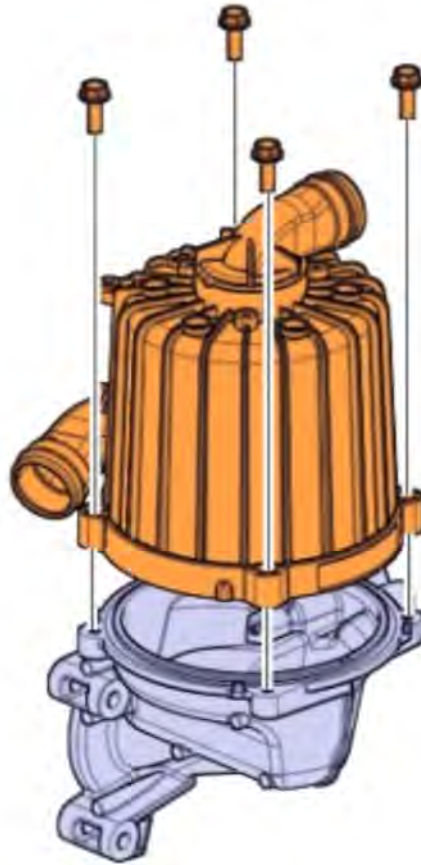
5. Remove the four screws and separate the lower housing from the separator housing.

Note: Discard the screws

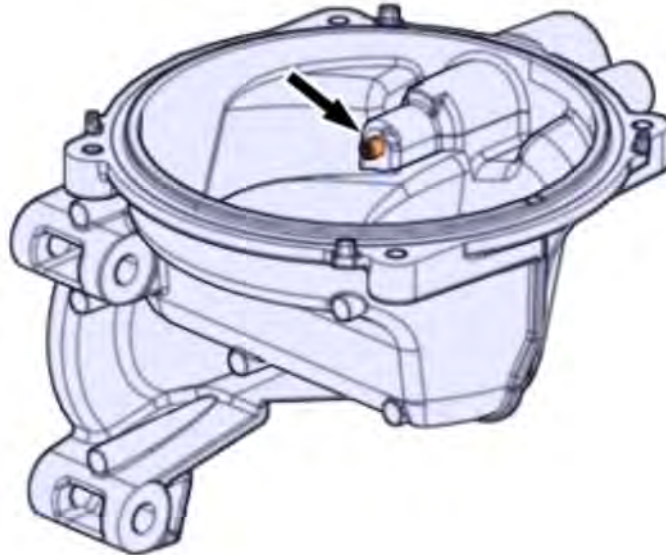
6. Inspect the oil jet for being loose in the lower housing and for any signs of debris or foreign objects that could restrict oil flow. Do not press on the oil jet.

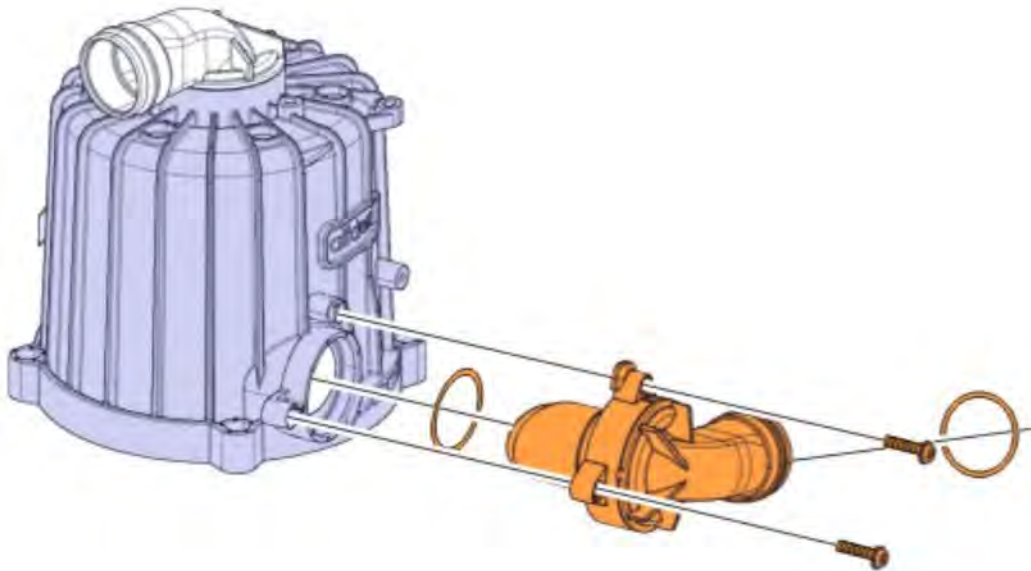
7. Remove the two screws and remove the valve/outlet nipple from the separator housing.

Note: Discard the O-rings.

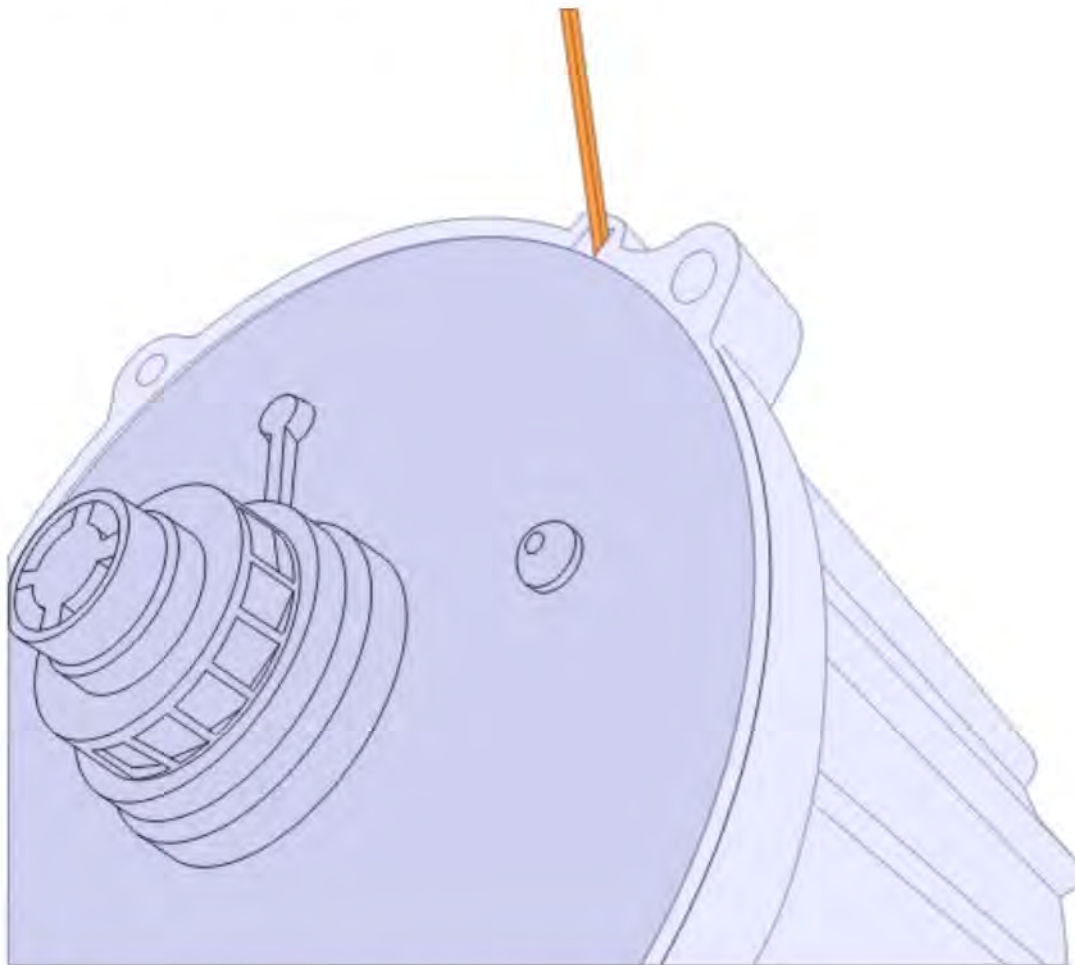
8. Use a small, stiff rod or similar tool [A small allen key used here] in the housing slot to gently pop out the rotor pack from the separator housing.

**Note:** Be careful to not damage the rotor assembly.

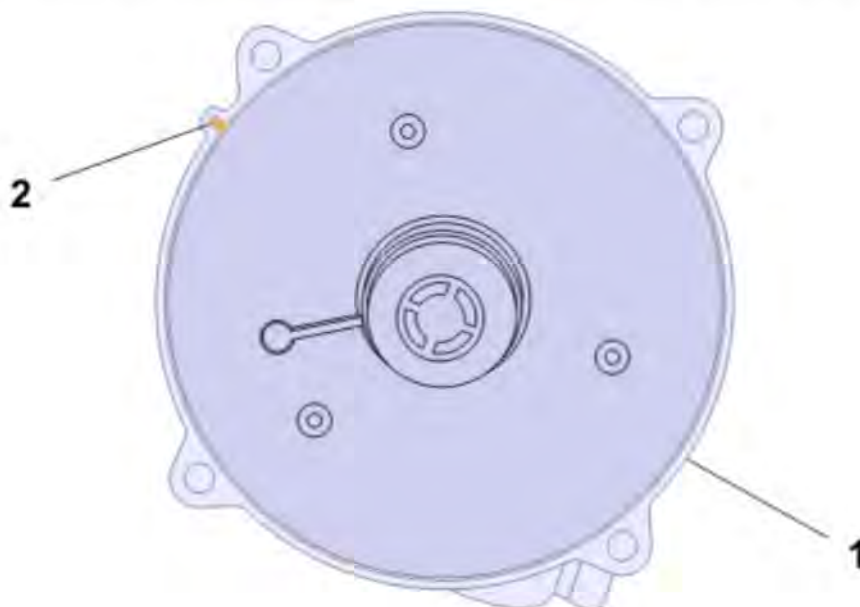
9. Inspect the upper bearing for smooth operation. If the bearing is not smooth, replace the complete assembly.
10. Clean off all the parts with a soft cloth in preparation for assembly. Do not use chemicals on the rotor unit.
11. Install a new O-Ring in the separator housing. Note the cut-away in the inner housing flange. This aligns the rotor pack to the housing.
12. Carefully align and install the rotor pack evenly into the separator housing making sure there is no binding in the upper bearing on assembly. Push in the lower plate starting at the opposite side of the housing slot and work the plate towards the slot. It should pop when completely installed. Test the impeller to make sure it spins freely.

1. Start here
2. Housing slot

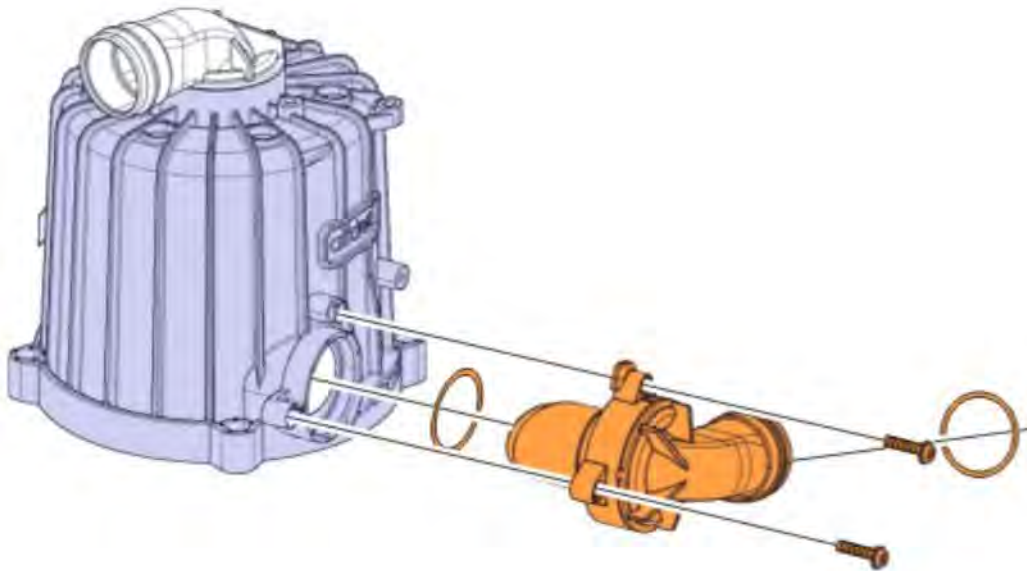
13. Install two O-rings on the valve/outlet nipple, carefully install the nipple into the separator housing and tighten the two retaining screws to 3.2 +/- 0.5 Nm.

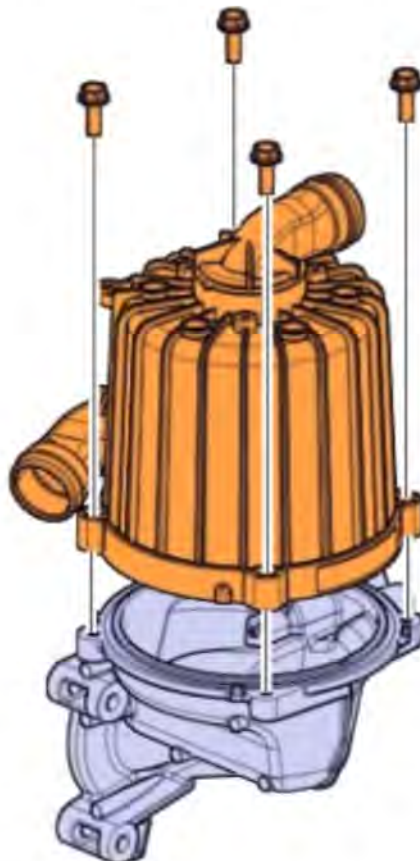
14. Install the second O-ring in the lower housing, align and install the separator housing the lower housing taking care to align it correctly.
15. Install the four new separator housing screws and torque them to 12 +/- 2 Nm.
