Technical Service Bulletin

Topic	Brake noise identification	
Market area	Bentley: worldwide (2WBE)	
Brand	Bentley 2052785/7 EH	
Transaction No.		
Level		
Status	Released for publishing	
Release date	Mar 2, 2022

Brake noise identification

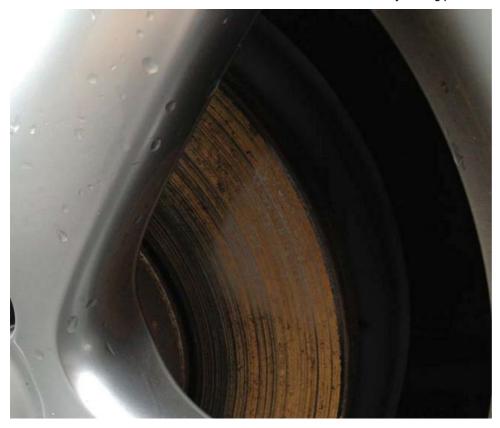
Figure 1

- 1. Brake discs or pads are close to their wear limit.
- 2. New brake pads and/or discs have not been properly bedded in after installation.
- 3. Aftermarket pads or discs are installed.
- 4. There is debris such as small stones, grit, road salt or sand between the brake disc and pad.
- 5. Discs are covered in rust. Rust can form when the vehicle has been stationary for long periods of time (Figure 1).

- 1. Check the overall condition of the brakes to determine if the brake noise can be attributed to one of the causes listed in the *Technical Background* section of this TPI. If the noise is not a result of one these causes, proceed with point 2.
- 2. Record the noise and frequency

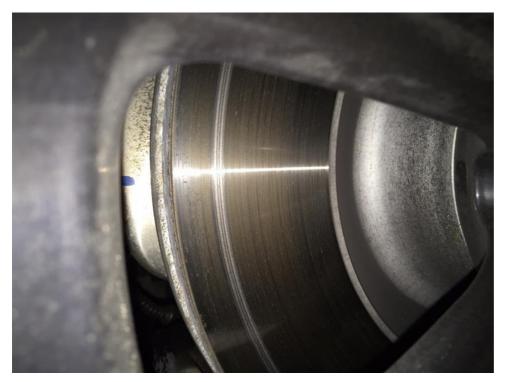
Figure 2

6. Discs have a groove in them (Figure 2)

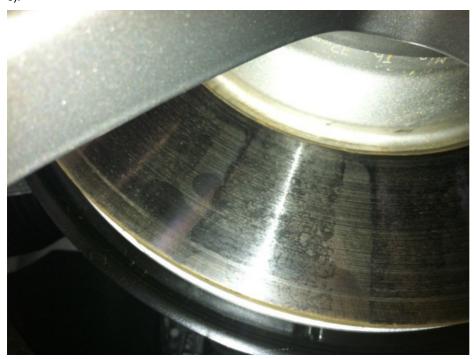
7. There is chemical contamination on the braking surface of the disc due to a wheel or tyre cleaner being sprayed directly onto the disc (Figure 3).

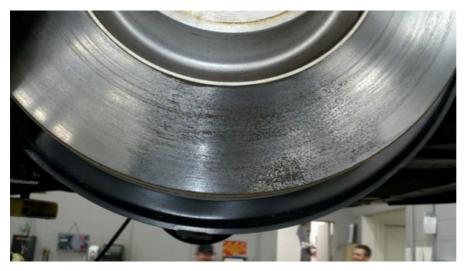
Figure 4

Figure 3
8. There are 'pad marks' on the brake disc as a result of the brake pad material transferring to the discs. This can occur when a vehicle has been stood for long periods of time in a wet or snowy environment (Figure 4).

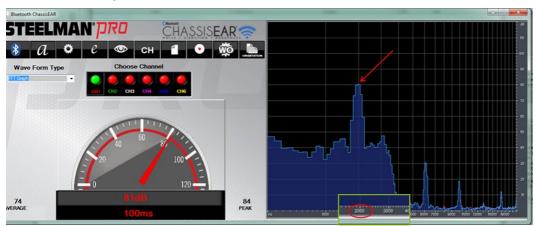
Refer to 'File recording' in the WT 10437 user instructions.

Select 'FFT Graph' as **Wave Form Type** and read the peak achieved during the recording as highlighted in the example above (in this case brake squeal peak frequency is 2000Hz).
