94-22-02 - Parking Assist Sensors Providing False Warnings

Release date: 4/12/2022

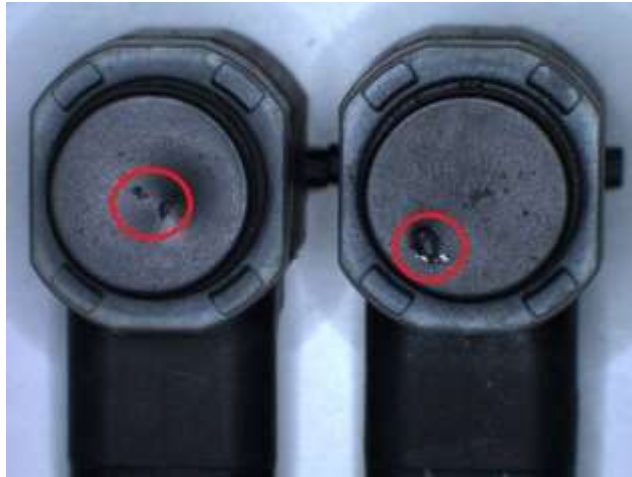
Figure 1. Damage by force (example accident/collision).

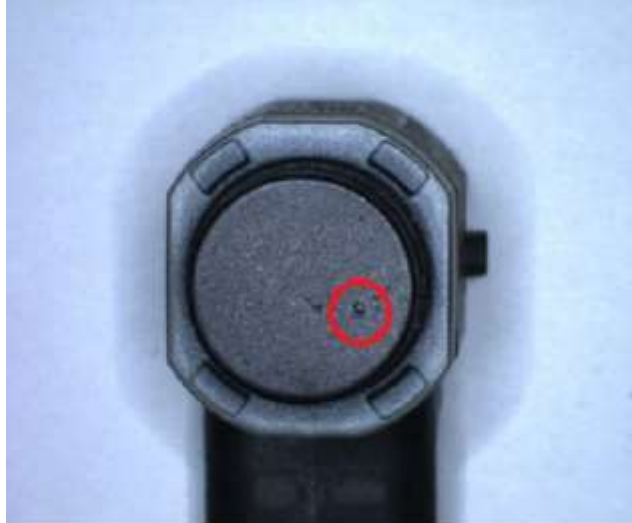
Figure 2. Stone chips causing sensor failure.

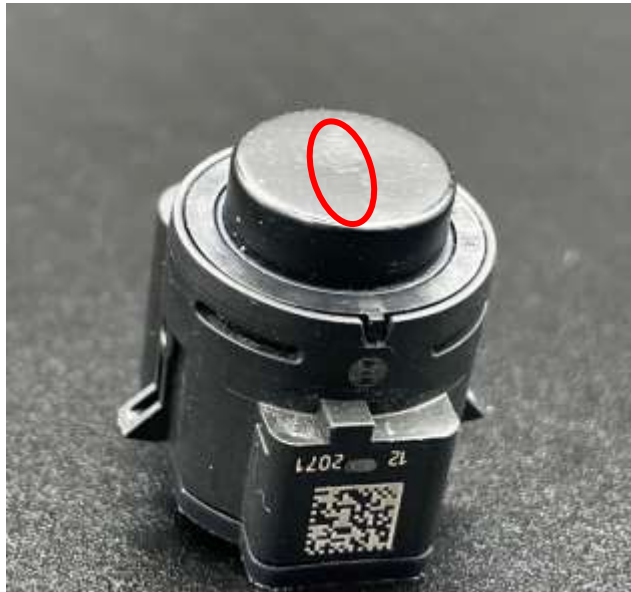
Figure 3

Figure 3. Stone impact (surface deformation-dent).

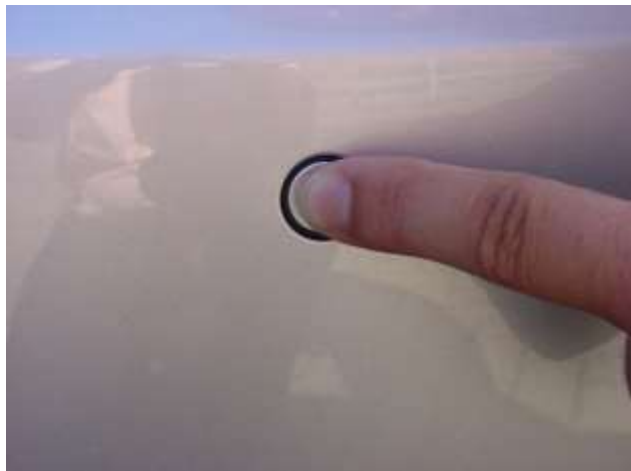
Figure 4. Pressure check for a tight fit and correct attachment of the parking sensors. If the sensor is not snug or feels loose, remove the bumper and reinstall the sensor.

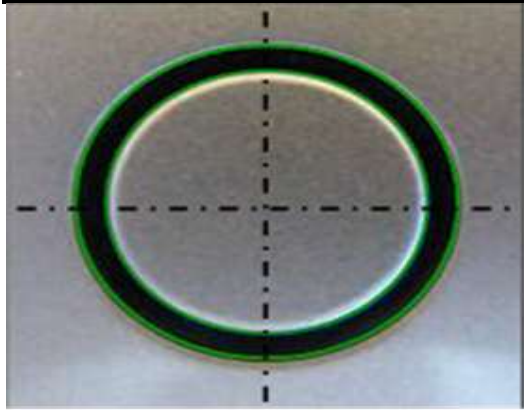
Figure 5. Verify that the sensor is centered inside of the mounting hole (Figure 5). If the sensor is mounted off-center, remove the bumper and reinstall the sensor.

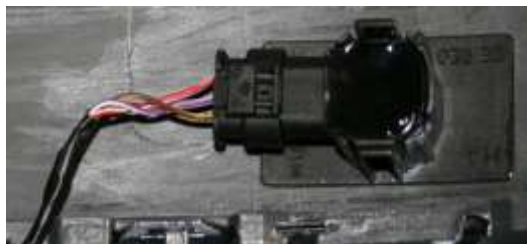
Figure 6. A correctly installed cable with sufficient length.

Figure 6. Check the cables in the bumper for damage and sufficient length (Figure 6). Cables that are too short can cause damage to the harness.

- If the cable is too tight, correct the routing by moving the support clip so the cable is no longer under tension.

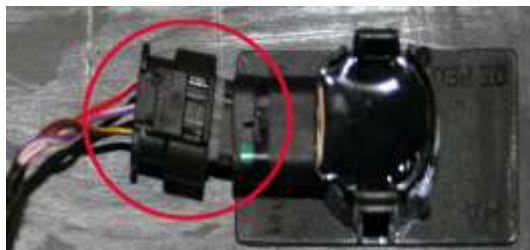
Figure 7. Example of a parking aid sensor connector that is not seated correctly.

Figure 7. Check the connectors on the parking sensors and the socket box for correct installation. If the connectors are not installed properly, secure connection.
