# Technical Service Bulletin

## 64 Frameless window auto-drop function inoperative in freezing weather

64 22 83 2062618/2 April 16, 2022. Supersedes Technical Service Bulletin Group 64 number 21-77 dated March 12, 2021, for reasons listed below.

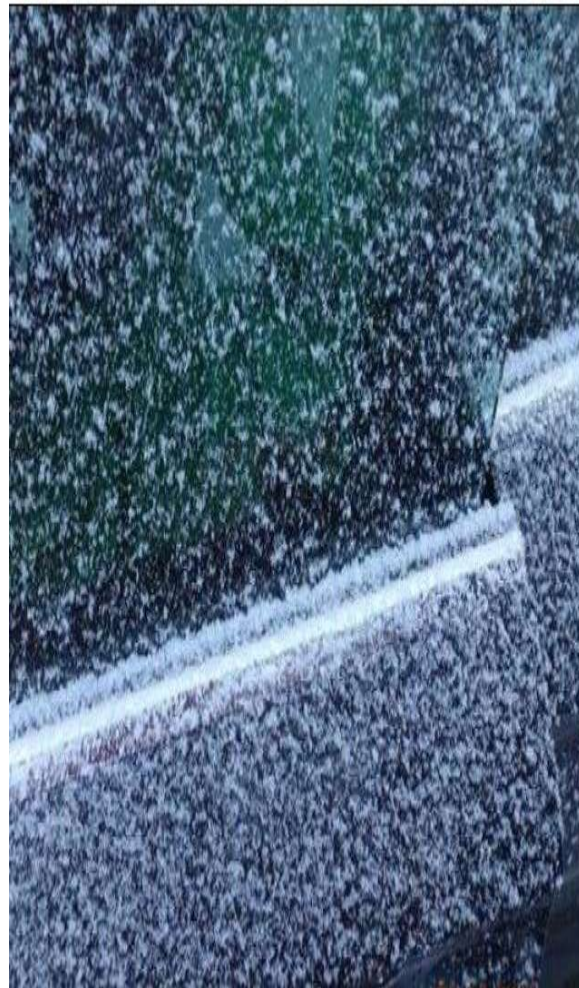
If snow and ice collect on the windows and the outer window slot seals, the function that lowers/raises the windows when opening/closing the doors may not operate, even if the window slot seal is of the latest generation. In freezing weather, the window auto-drop function can be blocked by snow and ice building up between the windows and the outer window slot seals (Figure 1).

*Figure 1. Snow and ice build-up on window and window slot seal surfaces.*

1. With a plastic scraper, remove snow and ice from the windows as described in the owner's manual.

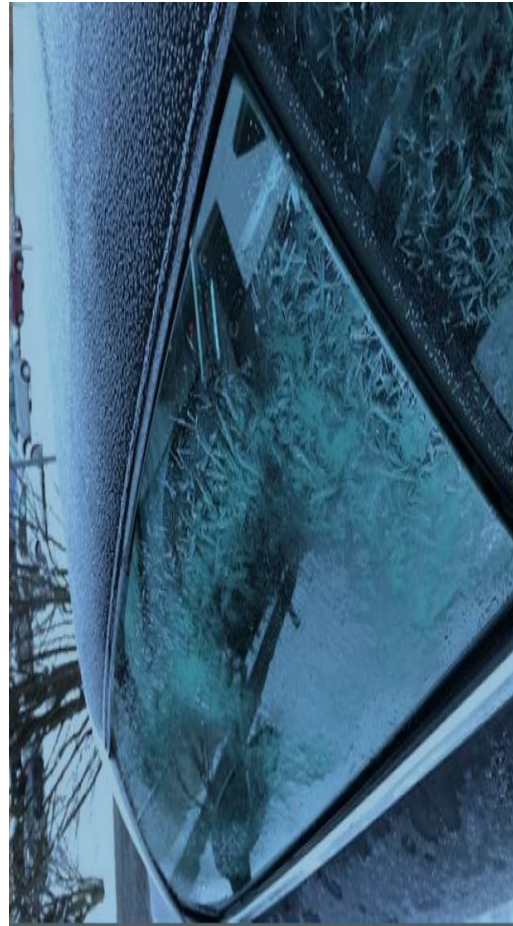
*Figure 3. Solvent-free de-icer spray melts snow and ice and eliminates blockage.*

2. If needed, spray an Audi approved solvent-free de-icer on the windows to remove any snow/ice from the contact area of the outer window slot seal to the window (Figure 3).
