# TECHNICAL SERVICE BULLETIN

## Shifter Not Moving The Transmission To The Proper Gear Position

**22-2066**

**Issue:** Some 2013-2016 Fusion, 2013-2018 C-MAX, 2014-2019 Escape, 2013-2021 Transit Connect, and 2015-2018 Edge vehicles may indicate an incorrect shifter lever position. This may be due to the bushing at the transmission end of the shifter lever cable resulting in a mismatch of cluster and selected gear position. To correct the condition, follow the Service Procedure steps to replace the bushing and on certain vehicles install the protective cap over the selector at the transmission end of the selector lever cable.

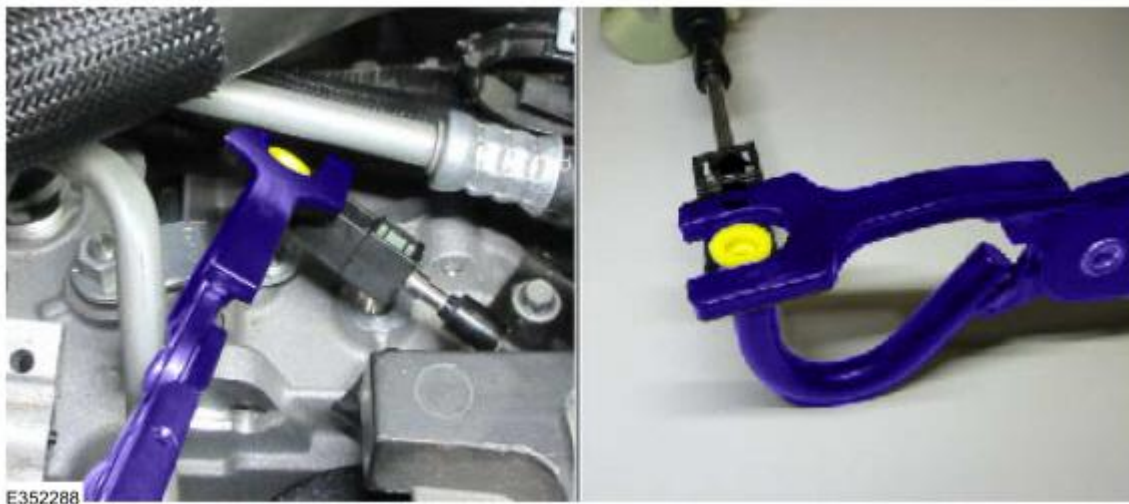
Figure 7

- Using a tool such as a Lisle 38350 - Exhaust Hanger Removal plier to press bushing out. The shoulder of the bushing is positioned upward, small end of plier is pressing the bushing out. (Figure 7)

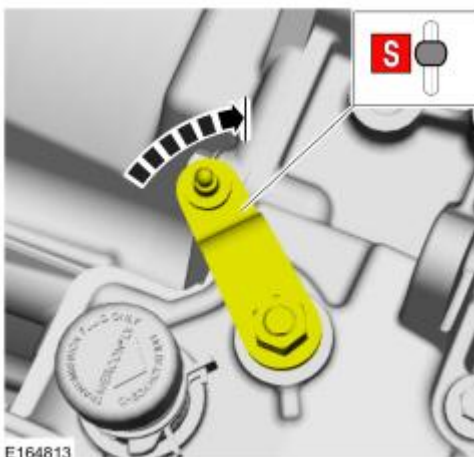
Figure 9

5. Place the vehicle's transmission gear selector in drive (D).
6. Rotate the manual control lever clockwise until it stops. (Figure 9)

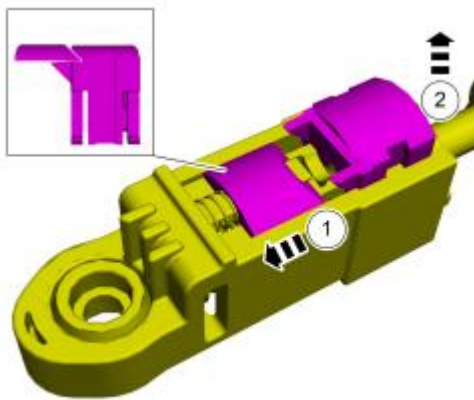
Figure 11

8. Release the selector lever cable adjuster lock. (Figure 11)

(1). Carefully release the adjuster lock tabs outward.

(2). While holding the adjuster lock tabs outward, slide the lock out to unlock the selector lever cable.
