# INSTRUCTION TO SERVICE

ITS60422		March 17, 2022
<b>SECTION:</b>	292-Electrical Harnesses	
<b>WRITTEN BY:</b>	Aditya Gadepalli	
<b>SUBJECT:</b>	MCI Main Distribution Panel Inspection and Cleaning for Harsh/Corrosive Environment	
<b>ISSUE:</b>	<p>This is to inform you that your vehicle may contain a defect that could affect the safety of a person. The Main Distribution Panel (MDP) in the battery compartment has experienced failures that may result in thermal events and/or uncommanded vehicle shutdown.</p> <p>Due to the current global parts shortage, the components required to conduct the related recall repair instructions are not currently available. This is specific to repair instructions ITS60272 (J4500), ITS-60335 (J3500), ITS 60283 (D Coach), and ITS60298 (D45CRT and D4520 coach). In the interim period, prior to these repair instructions being incorporated on the buses identified above, MCI recommends conducting an immediate inspection of the MDP, MCI P/N: 07-08-7940, and regular interval inspections every three months for signs of thermal stress or corrosion following this inspection procedure</p>

<b>SUMMARY:</b>	Due to the Main Distribution Panel failures resulting from sup

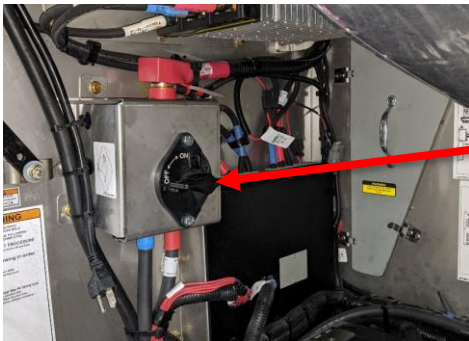
1. Set park brake and chock wheels.
2. Turn the main battery disconnect switch to the "OFF" position.
3. **Follow steps 4 to 8 on J4500, J3500, D45CRTLE, and D4520 coach models.**
4. Locate the Main Battery Disconnect Switch and ensure it is in the off position.

Turn off  
MDS.

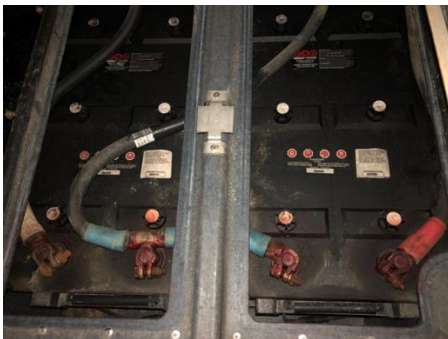
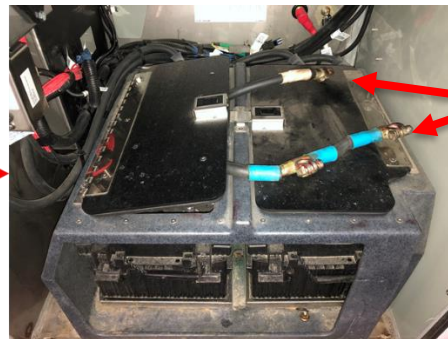
5. Disconnect GND, 12V, and 24V battery cables from the coach batteries. Ensure the battery cables do not come in contact with each other or the coach.

Disconnect all  
battery cables.

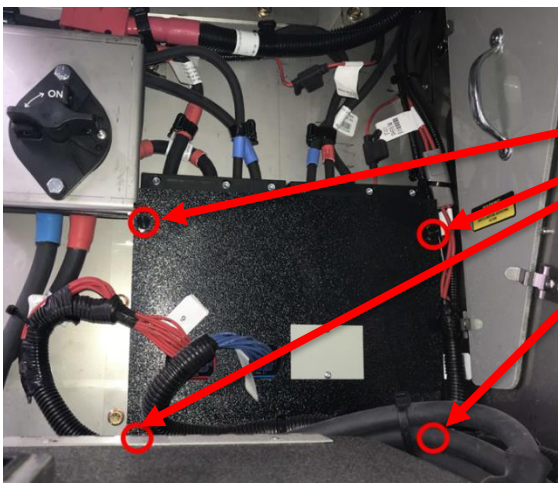
6. Locate the MDP compartment mounted on the rear wall in the battery compartment. Remove and save the 4 thumb screws to release the MDP cover.

Remove and save 4  
thumb screws.

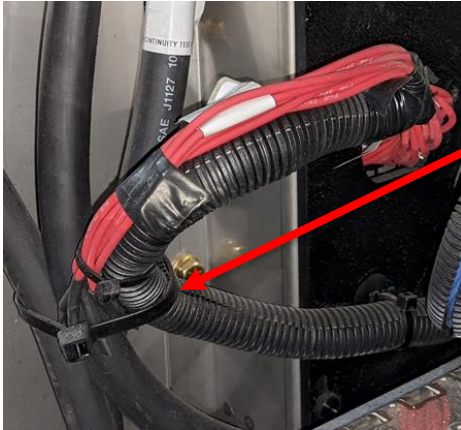
7. Remove tyrap that secure BT-P162 to the Main Disconnect Switch cables.

Remove BT-P162 tyrap on battery cables.

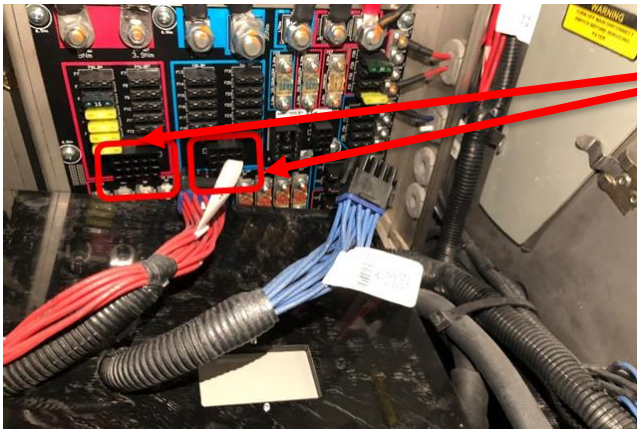
8. Disconnect connectors BT-P161 and BT-P162 from MDP.

Disconnect BT-P161 and BT-P162.

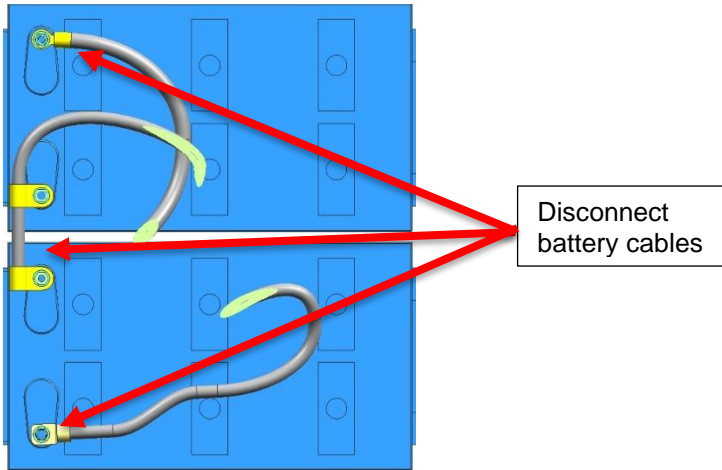
11. Disconnect GND, 12V, and 24V battery cables from the coach batteries. Ensure the battery cables do not come in contact with each other or the coach.

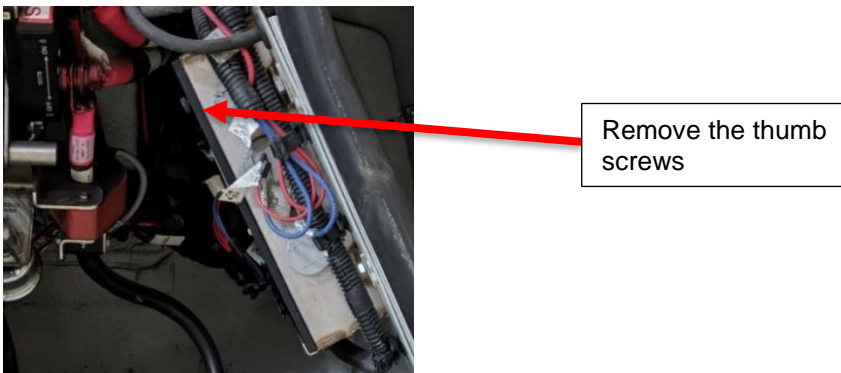
12. Remove and save the two thumbscrews from the MDP cover.

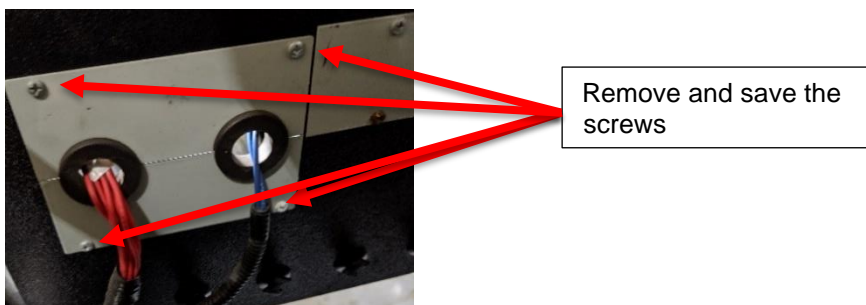
13. Remove and save 4 screws holding the MDP cut-out part to the MDP cover.

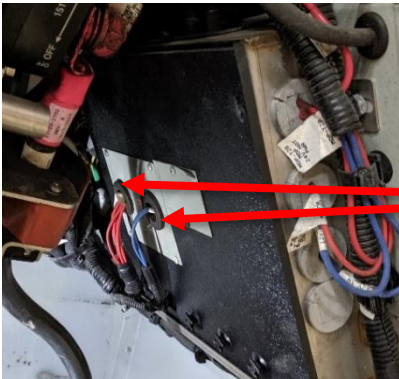
14. Disconnect the two connectors, BT-P162 and BT-P161, from the main distribution panel.

Disconnect the wires

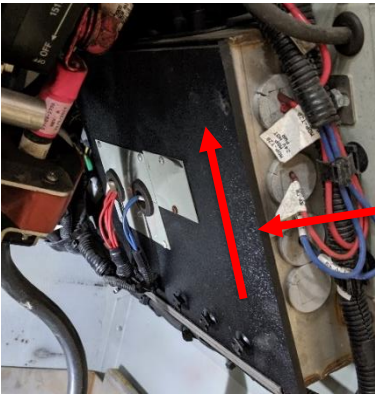
15. Slide out and save the battery compartment cover out of the bracket.

Slide the cover out

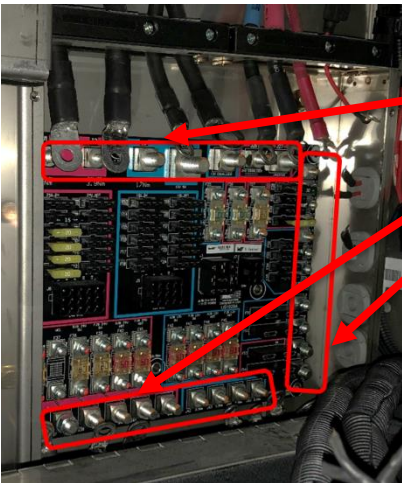
16. Remove all cables from MDP. Make a note of where each cable is connected on the board. Place nuts and lock washers back on studs after the cables are removed.

Remove all cables from MDP.

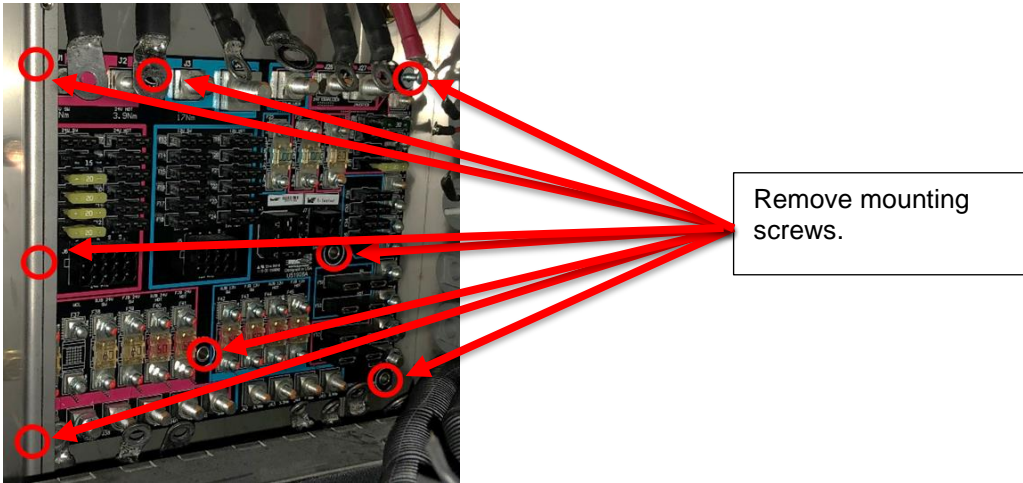
17. Remove & save 8 MDP mounting screws and washers to remove the MDP from the coach.

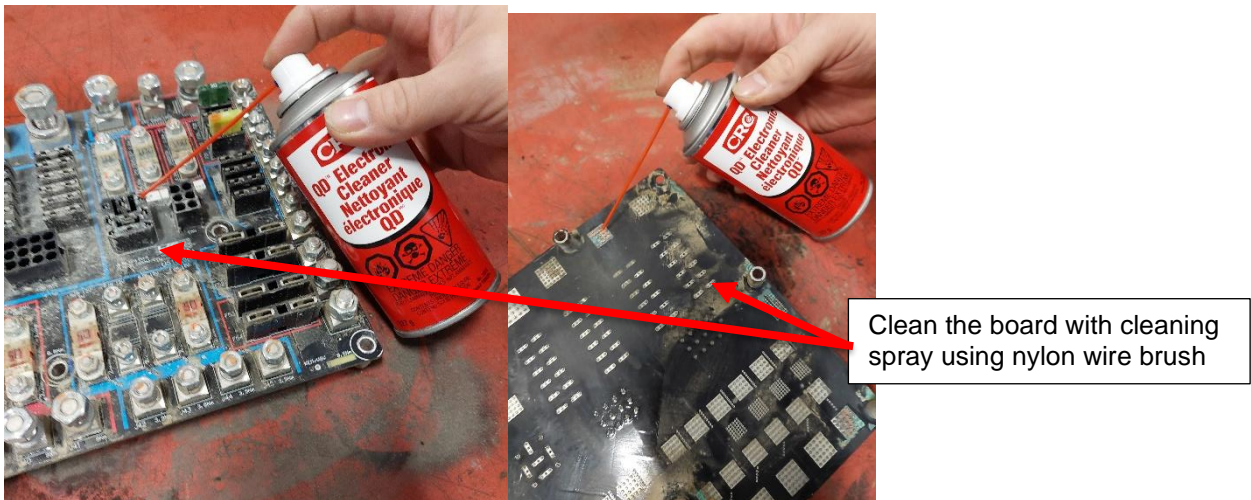
18. Blast the MDP board with air and clean the board with hard nylon wire brush by spraying cleaning spray lightly to eliminate the dirt.

☞ **NOTE:** Maintain caution to spray the cleaner lightly as it could remove the existing conformal coating and also maintain caution not to damage the pins on the MDP.

☞ **NOTE:** If the board is found damaged/corroded beyond repair, please contact your local MCI representative for the replacement board.

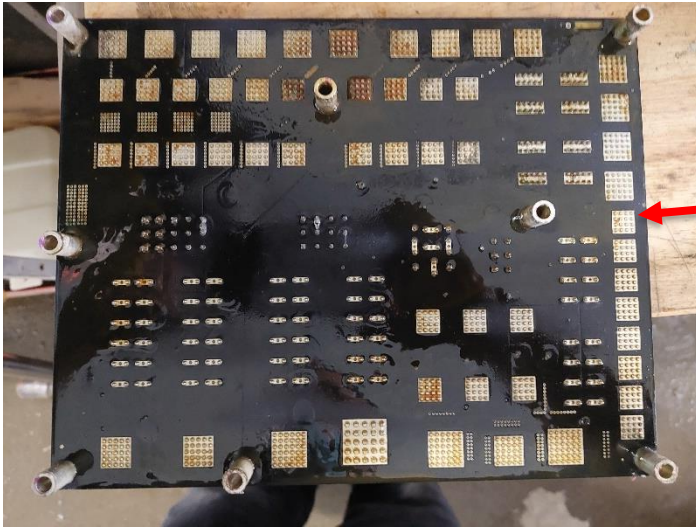
19. Using short sprays, apply the corrosion inhibitor, MCI P/N: 23-02-0119, on back of the board and allow 5-10min for it to dry.

Spray corrosion inhibitor, MCI P/N: 23-02-0119

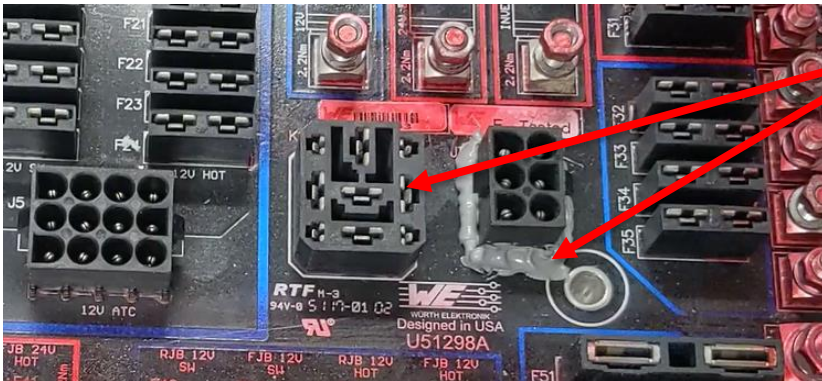
20. Using RTV silicon, place a bead of silicone around fuse checker connectors K1 and J7.

Apply RTV around K1 and J7 connectors.

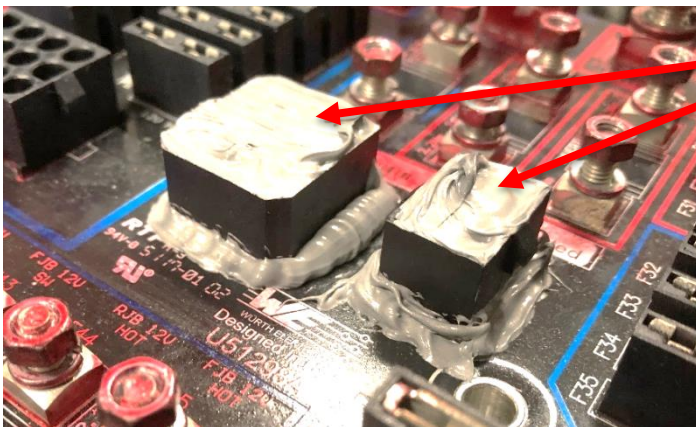
21. Using RTV silicon, seal the top of fuse checker connectors K1 and J7. Let the silicon dry (approximately 30 minutes).

Apply RTV on top of K1 and J7 connectors.

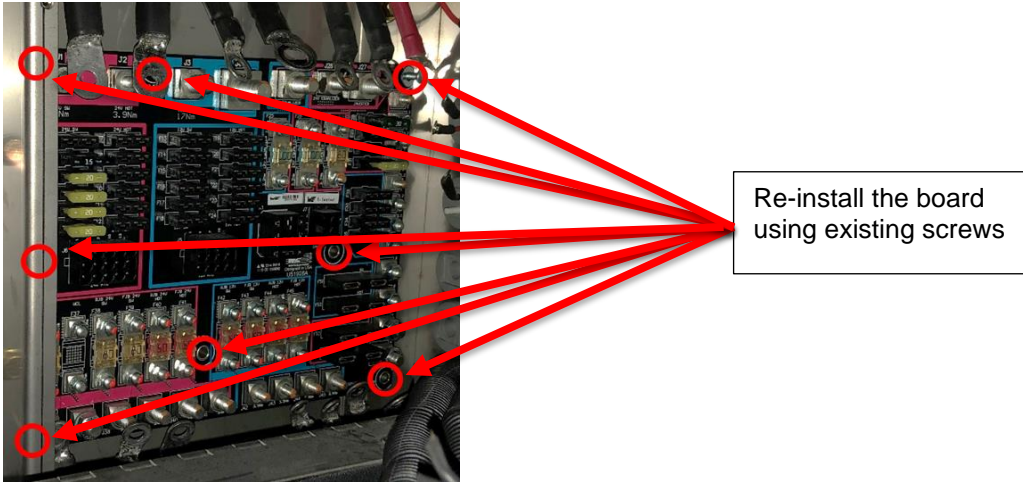
22. Re-install the MDP to the wall using existing screws and torque the screws to 75 In-Lbs. Re-install the cables referencing the torques specified in step 39.

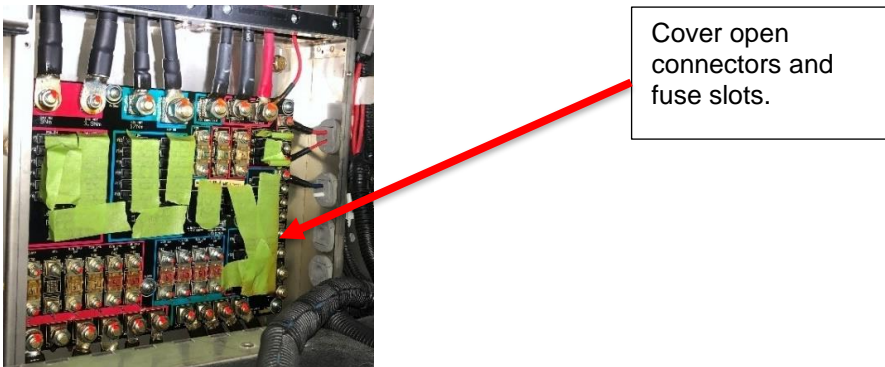
23. Cover all open connectors and fuse slots with masking tape.

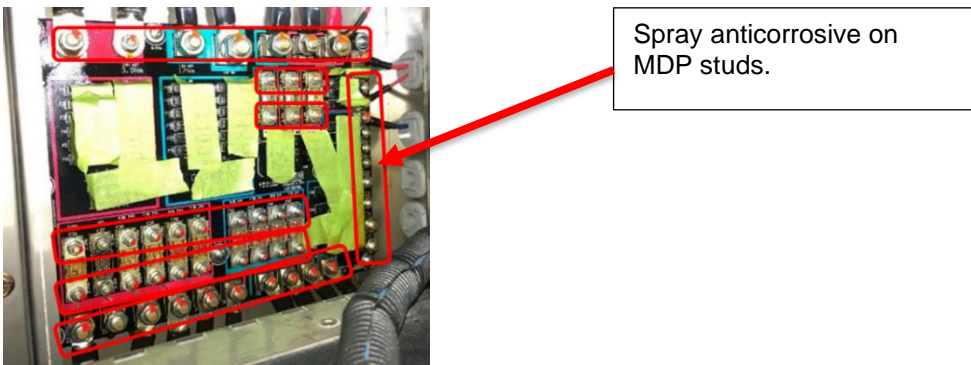
24. Using short sprays, apply the corrosion inhibitor, MCI P/N: 23-02-0119, on all power and fuse studs. Wipe off any excessive corrosion inhibitor from the fuse windows using a dry rag.

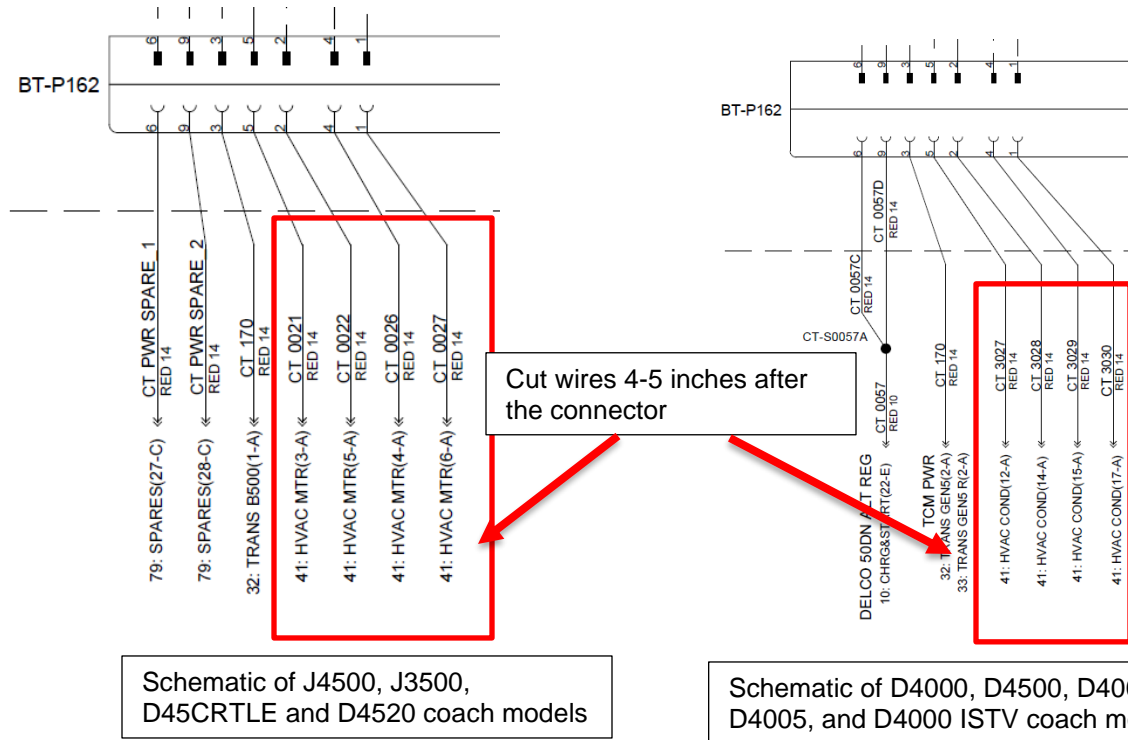
25. Cut HVAC wires CT0021, CT0022, CT0026, and CT0027 4-5 inches from the 24V BT-P162 connector.

**NOTE:** Heatshrink and tie back the wire attached to the pins to avoid corrosion.

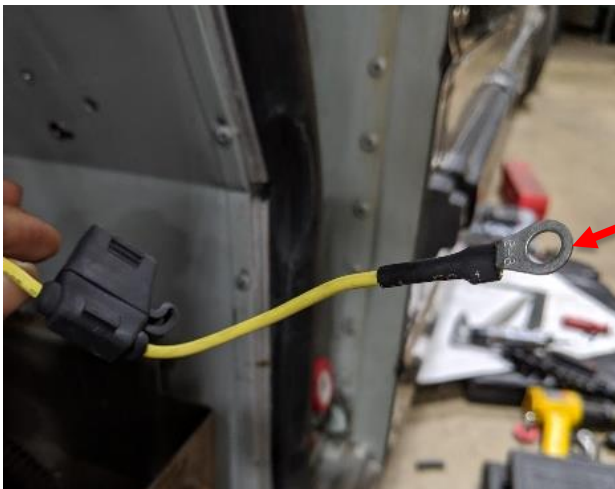
26. Crimp HHG in-line fuse holders, MCI P/N: T19-1168, to the HVAC wires using splice connector, MCI P/N: 19-11-431, black heat shrink, MCI P/N: 19-11-1465, and a 1/2" ring terminal at the end, MCI P/N: 19-11-393.

Crimp inline fuse holder to the HVAC wires

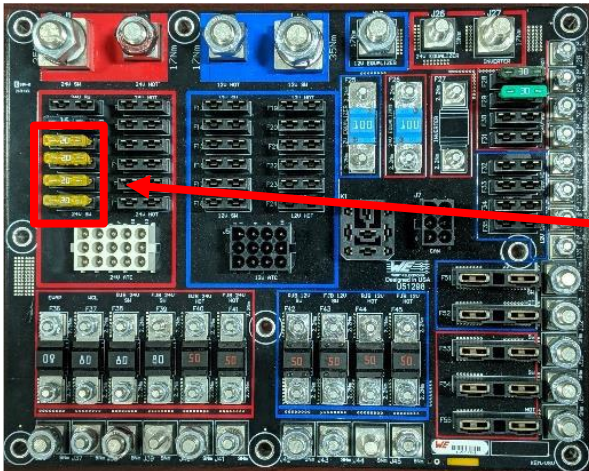
27. Remove 20A fuses from the MDP and install them in the in-line fuse holders.

Remove 20A fuses and install in in-line fuse holders

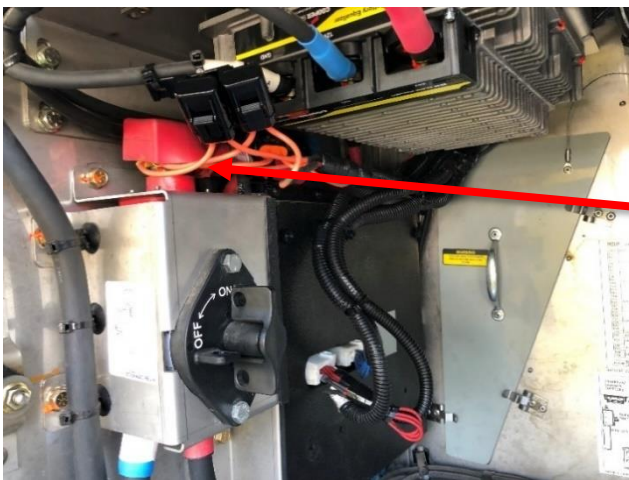
J4500, J3500, D45CRTLE and D4520 coach models

28. Connect the modified HVAC wires to either 24V SW stud on the MDS as shown below for various coach models. Torque the nut to 300 In-lbs.

Connect the modified HVAC wires to 24V SW stud on MDS

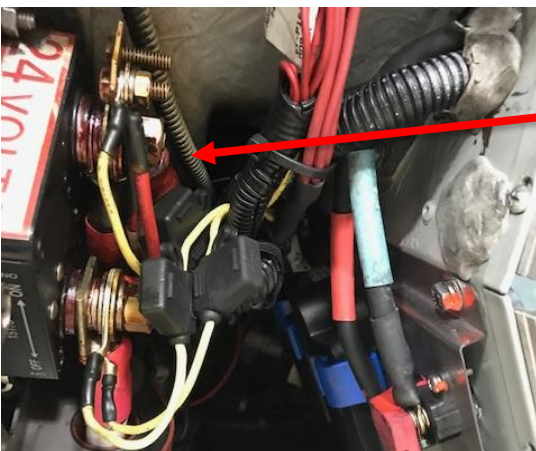
D4000, D4500, D4005, D4005, and D4000 ISTV coach models

Connect the modified HVAC wires to 24V SW stud on MDS

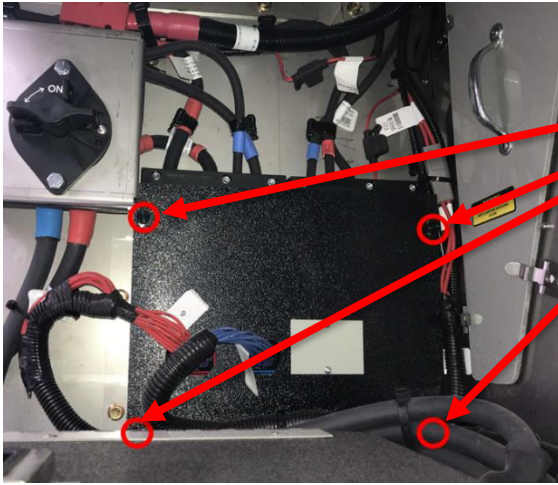
30. Secure the MDP cover using the 4 thumb screws, MCI P/N: 07-08-9231.

Install 4 thumb screws.

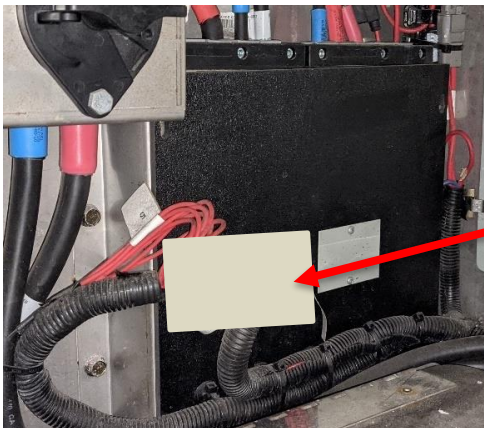
31. Seal the opening on MDP cover for BT-P161 and BT-P162 connectors over the wires with duct tape.

Cover the openings with duct tape

**NOTE:** Ensure smooth routing of cables and ensure no rubbing on the remaining wires.

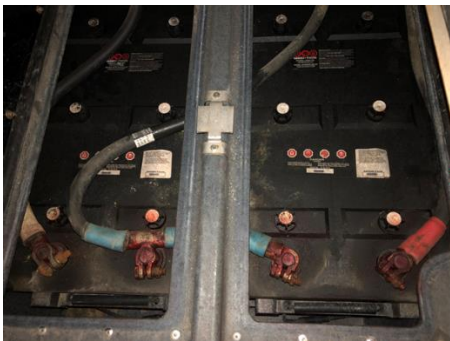
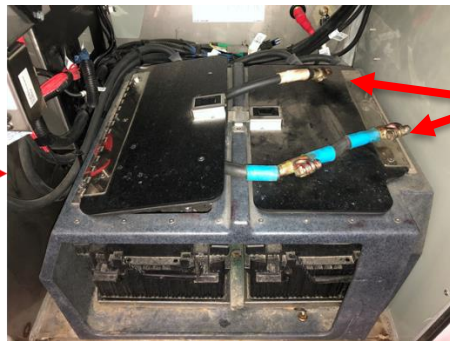
32. Re-install the battery cables and torque the studs following the maintenance manual.

Reconnect all battery cables.

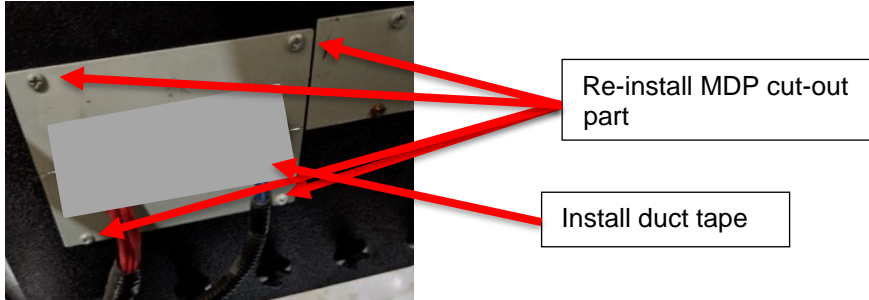
35. Prior to installing the MDP cover, re-install the MDP cut-out part to the MDP cover using existing screws. Duct tape over the BT-P161 and BT-P162 connectors around the wires to seal the area.

**NOTE:** Ensure smooth routing of cables and ensure no rubbing on the remaining wires.

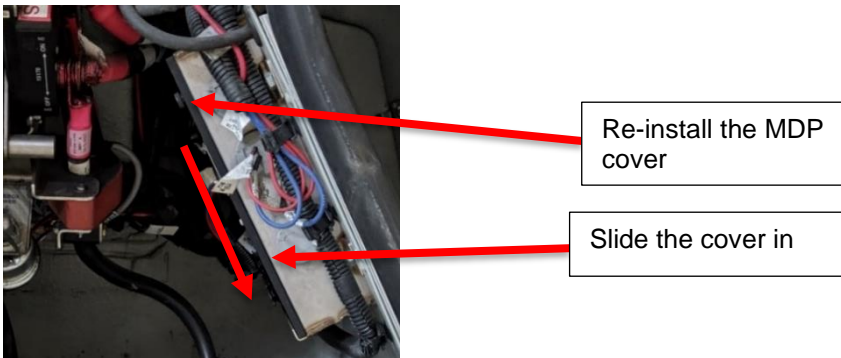
36. Slide in and re-install the MDP cover using the existing two thumbscrews.

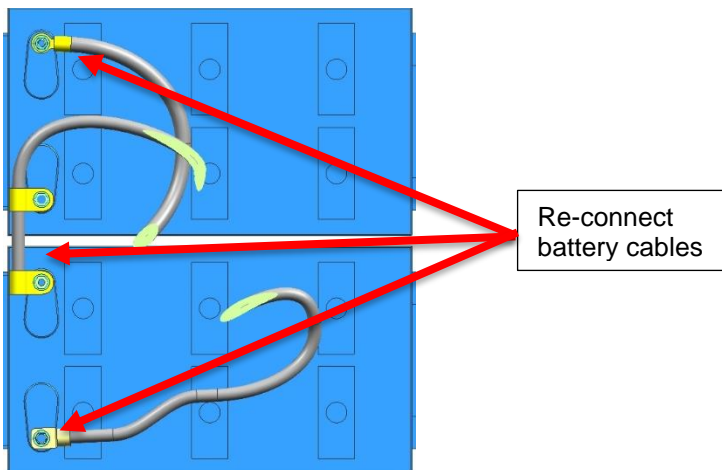
37. Re-install the battery cables and torque the studs following the maintenance manual.

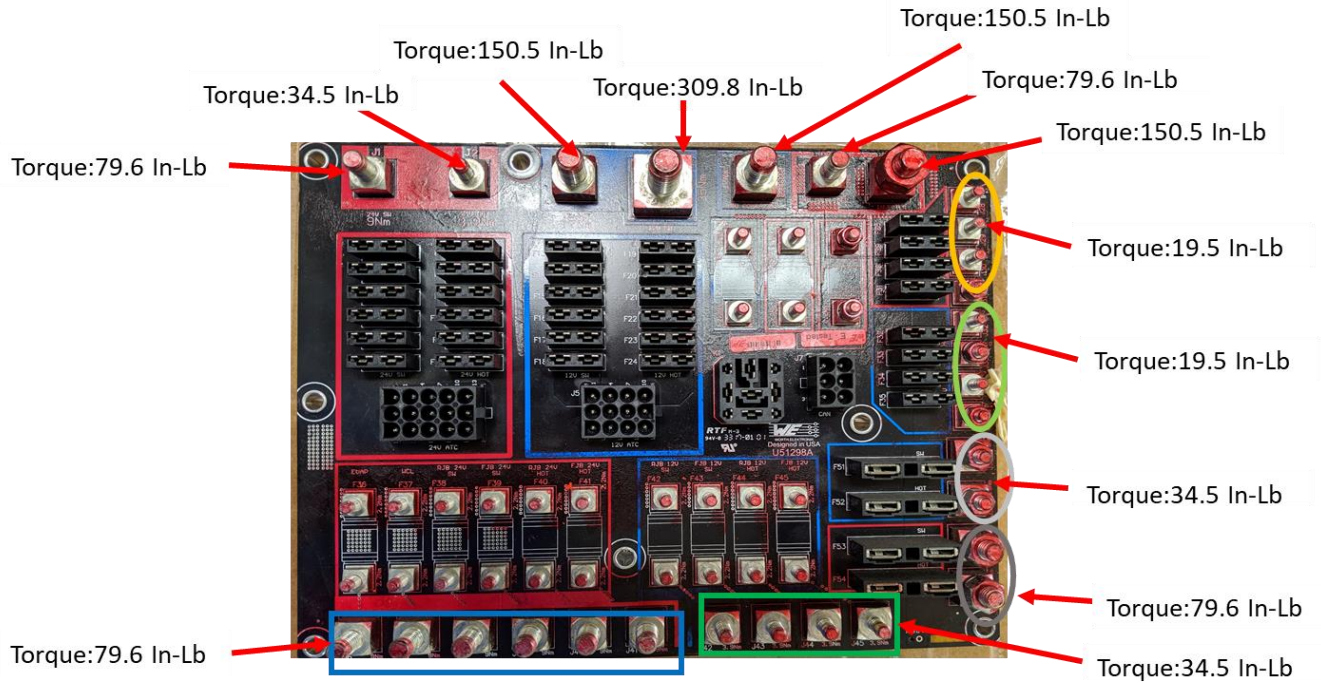
38. Following are the torque values for the MDP studs:
