Subject: CORROSION AT THE CONTACT PART BETWEEN THE ROOF MOLDING CLIPS AND THE ROOF PANEL	Bulletin No.: 09-017/22
	Last Issued : 04/29/2022

2019-2021 Mazda3 (Japan built) vehicles with VINS lower than JM1BP*****507106 (produced before December 4, 2021)

2019-2021 Mazda3 (Mexico built) vehicles with VINS lower than 3MZBP*****219987 (produced before December 2, 2021)

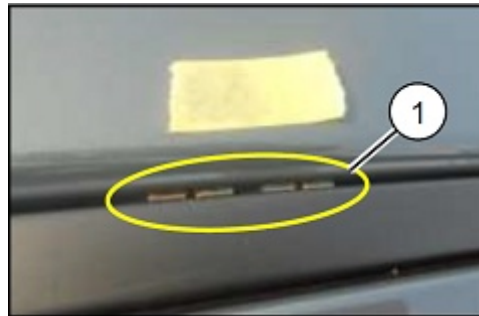
Some vehicles may have rust (1) on the contact parts between the clips (for attaching the roof molding) and the roof panel (ditches of the roof rail).

This is caused by the gap between the roof molding attachment clips and the roof panel not being wide enough to allow paint to be appropriately applied to the roof panel. To eliminate this concern, the shape of the roof molding clip has been changed to enable paint application between the clip's rib and roof during the manufacturing process. Customers having this concern should have their vehicle repaired using the following repair procedure.

1. Verify the customer concern.
2. Remove the roof molding clips, repair the rusted area, and replace the clips with new ones.
 - a. Remove the roof molding according to the procedure on MGSS (ROOF MOLDING REMOVAL).

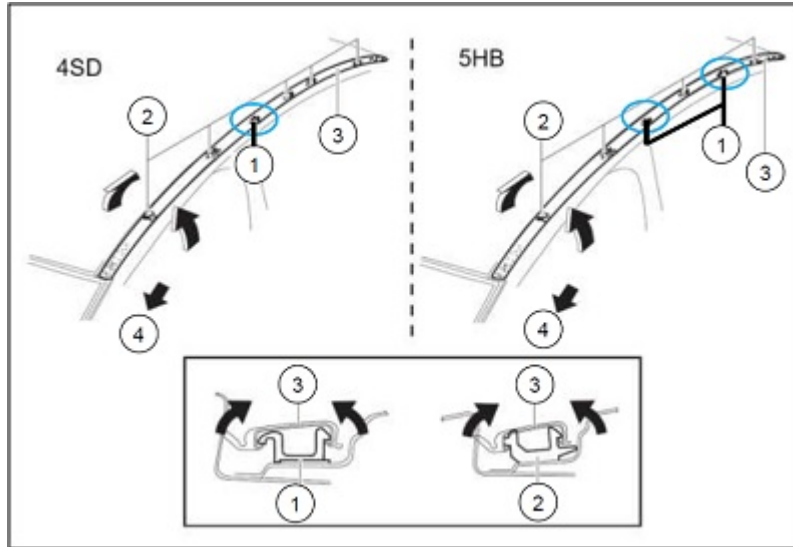
b. Remove all mounted "Clip A's" from the vehicle. (Two clips for 4-door SD and four clips for 5-door HB).

1	Clip A
2	Clip B
3	Roof Molding
4	Vehicle Front

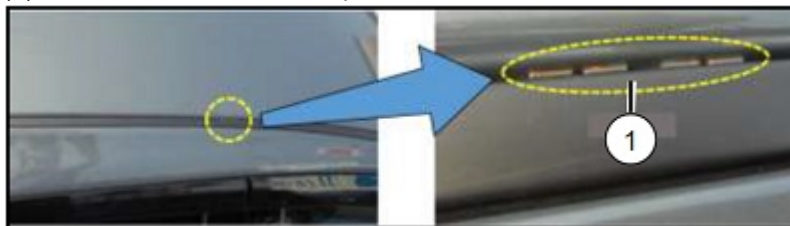
c. Remove the rust (1), clean the surface, and repaint the rusted area.

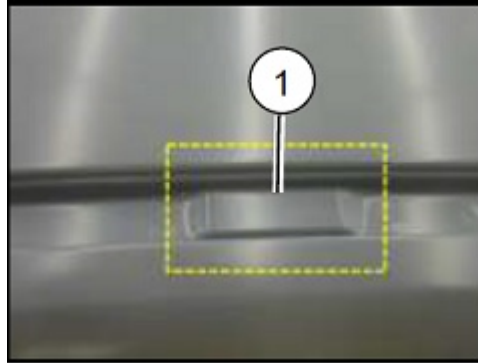
d. Paint the new "Clip A's" with the same paint of the vehicle, and then install "Clip A's" on the rectangular protrusion (1) on the body side.

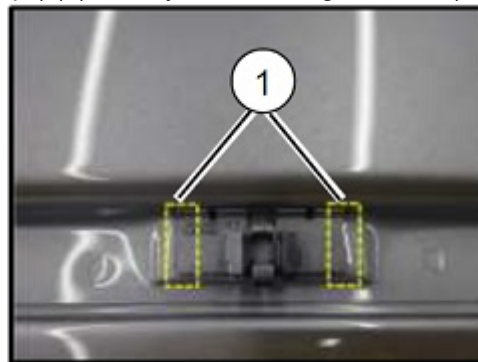
e. Apply adhesive around each clip (1) (on the yellow rectangular areas) after installing "Clip A's" on the vehicle.
