Version 2

Warranty Extension: Engine Does Not Auto Restart After Entering Auto Idle Stop

Year	Model	Trim Level	VIN Range
2015–20	TLX	V6 (SH-AWD)	Check the iN VIN status for eligibility

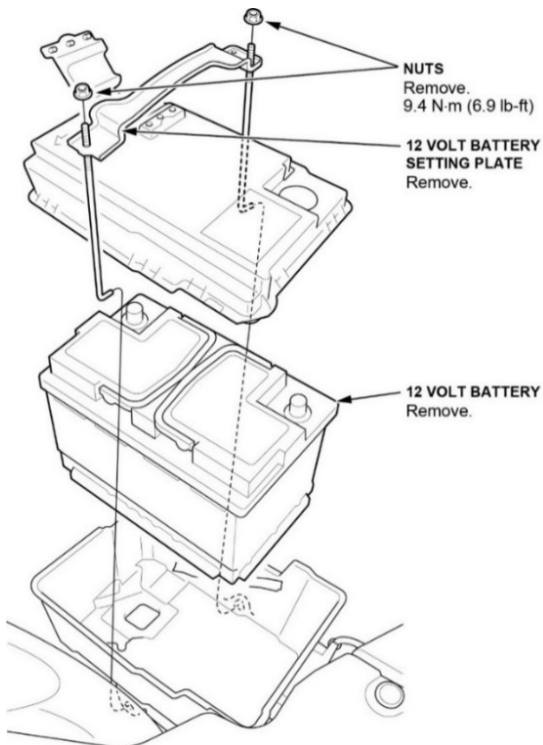
1. Disconnect the 12 volt battery.
2. Remove the 12 volt battery setting plate and the 12 volt battery.

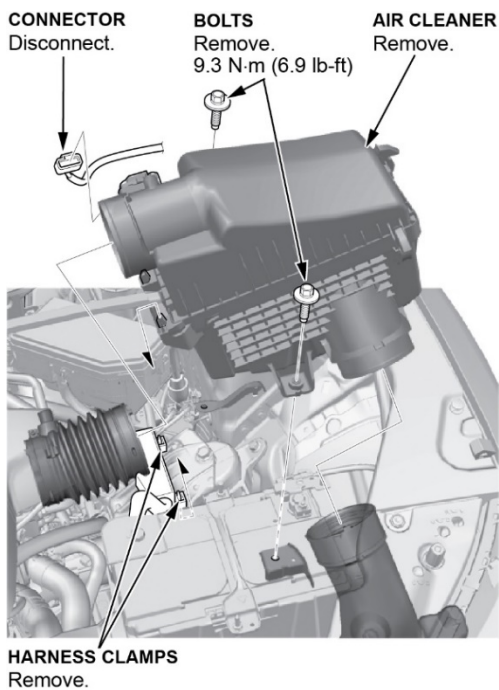
3. Disconnect the connector from the air cleaner, then remove the harness clamps and remove the air cleaner assembly.

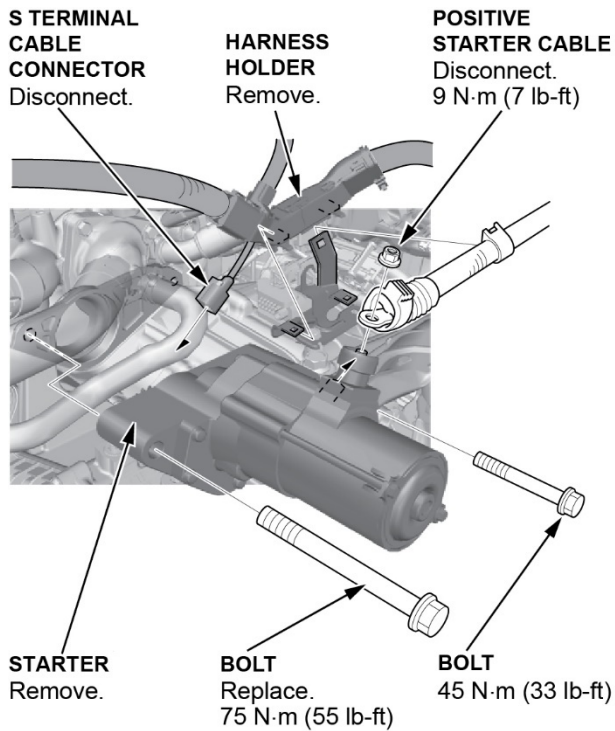
4. Remove the harness holder from the starter.

5. Disconnect the positive starter cable and the connector, then remove the starter.

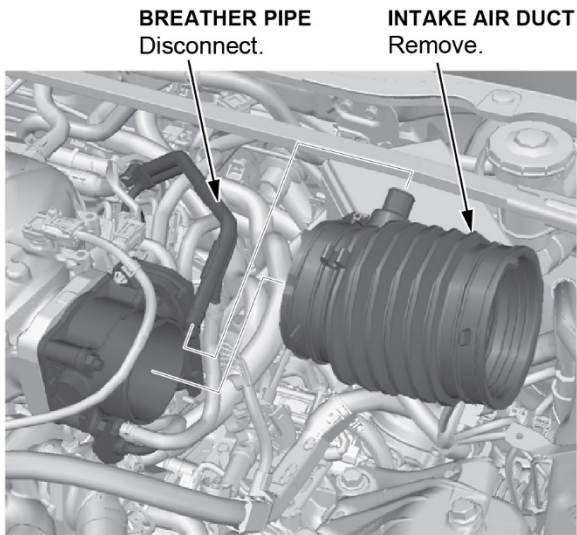
1. Disconnecting the breather pipe and remove the intake air duct.

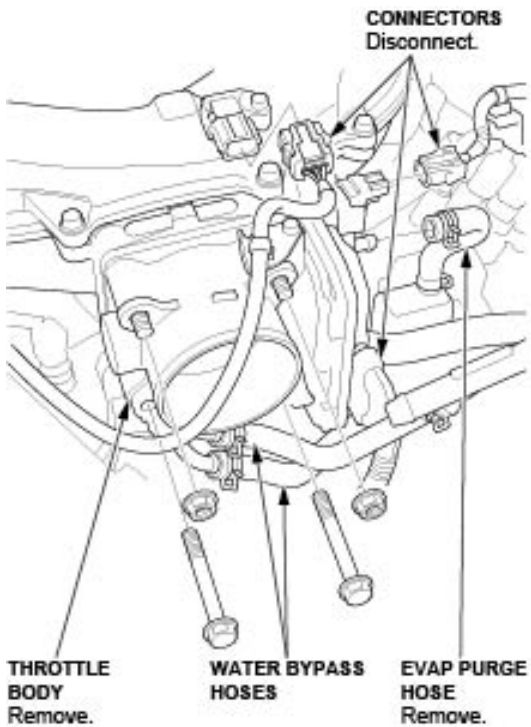
2. Disconnect the connectors and EVAP purge hose. Remove the throttle body without disconnecting the water bypass hoses.

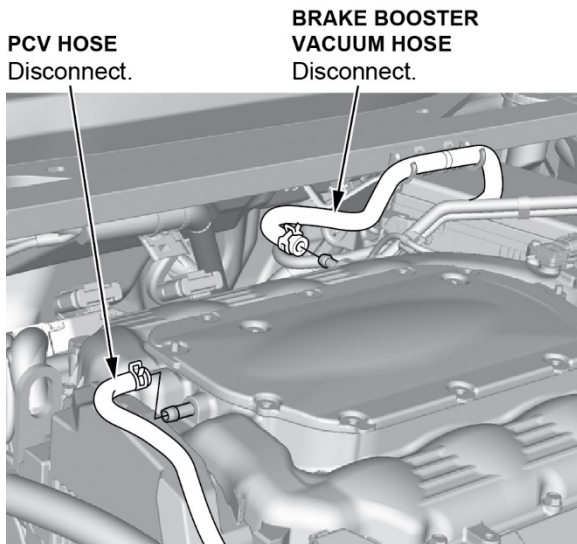
3. Disconnect the PCV hose and the brake booster vacuum hose.

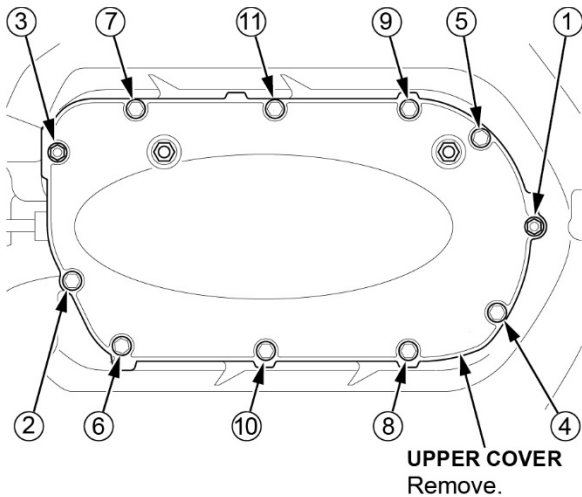
4. Remove the upper cover mounting bolts and nuts sequentially in three steps. Remove the upper cover.

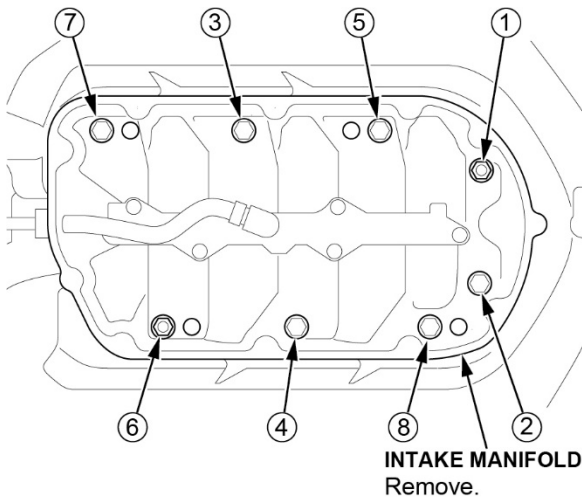
5. Remove the intake manifold mounting bolts and nuts sequentially in three steps. Remove the intake manifold.

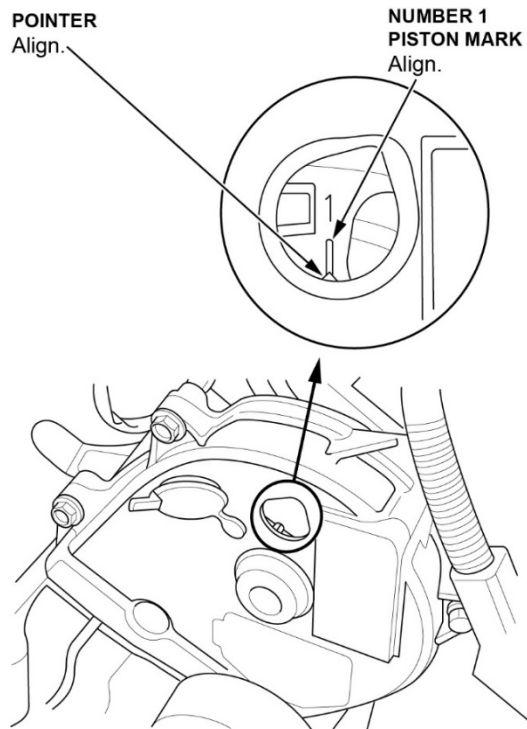
- Set the No. 1 piston at top dead center (TDC). Align the pointer on the front upper cover with the No. 1 piston TDC mark on the front camshaft pulley.

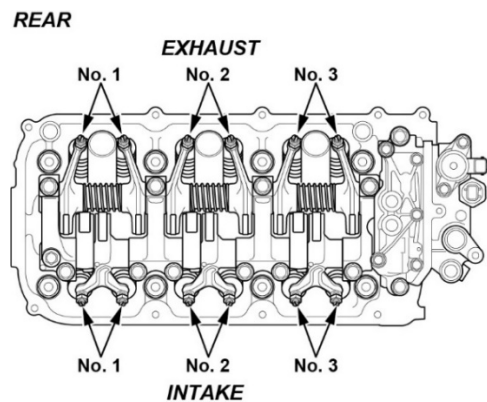
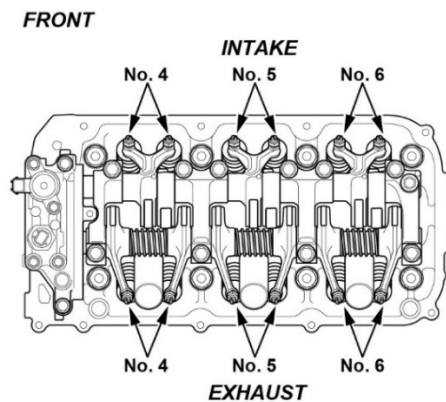
- Select the correct feeler gauge for the valve clearance you are going to check.

Valve Clearance Spec:

- Intake: 0.20–0.24 mm (0.008–0.009 in)
- Exhaust: 0.28–0.32 mm (0.011–0.012 in)

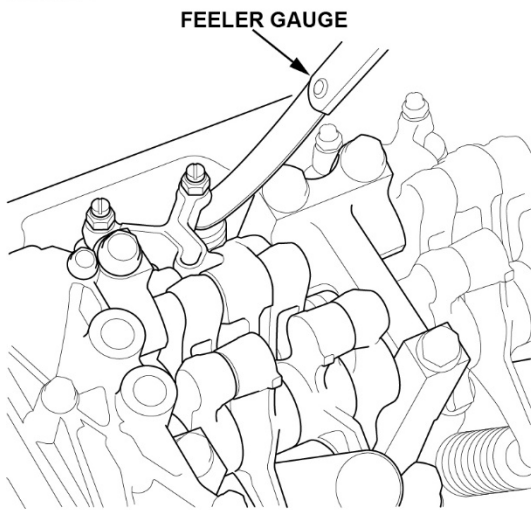
INTAKE

10. Insert the feeler gauge between the adjusting screw and the end of the valve stem on the No. 1 cylinder and slide it back and forth; you should feel a slight amount of drag.

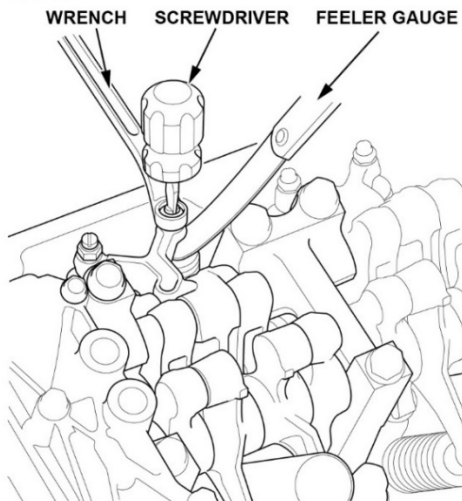
INTAKE

11. If you feel too much or too little drag, loosen the locknut, then turn the adjusting screw until the drag on the feeler gauge is correct.
12. While holding the adjusting screw with the screwdriver, tighten the locknut, then recheck the clearance. Repeat the adjustment, if necessary.

Intake: 20 N·m (15 lbf·ft)

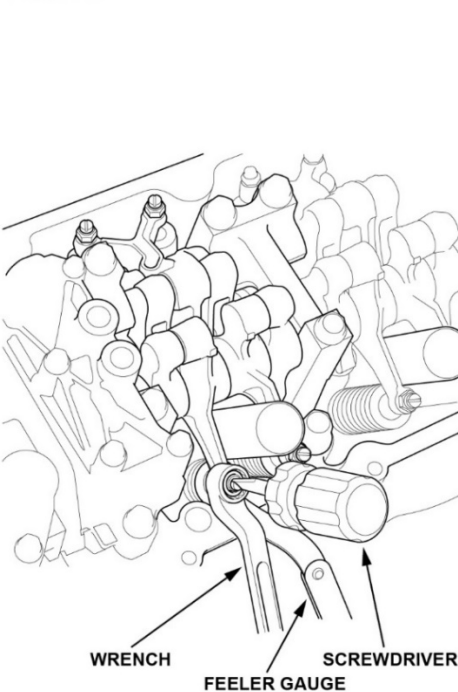
EXHAUST

Exhaust: 20 N·m (15 lbf·ft)

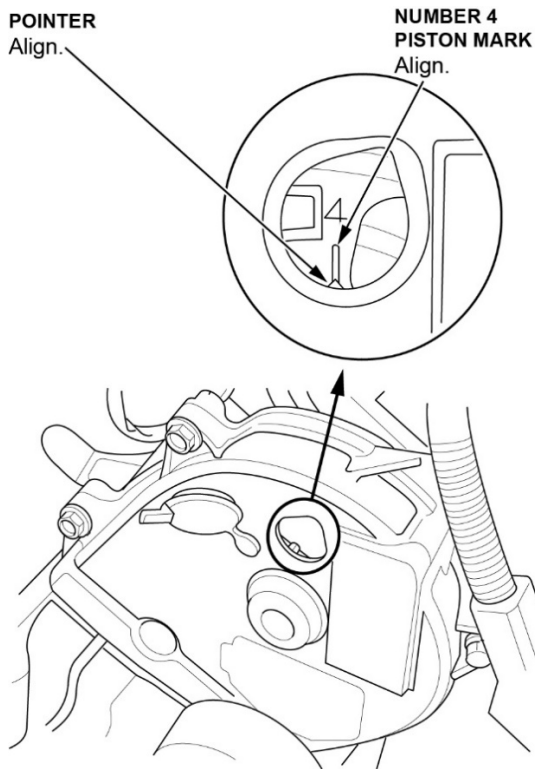
13. Rotate the crankshaft clockwise. Align the pointer on the front upper cover with the No. 4 piston TDC mark on the front camshaft pulley.
14. Check, and if necessary, adjust the valve clearance on the No. 4 cylinder.

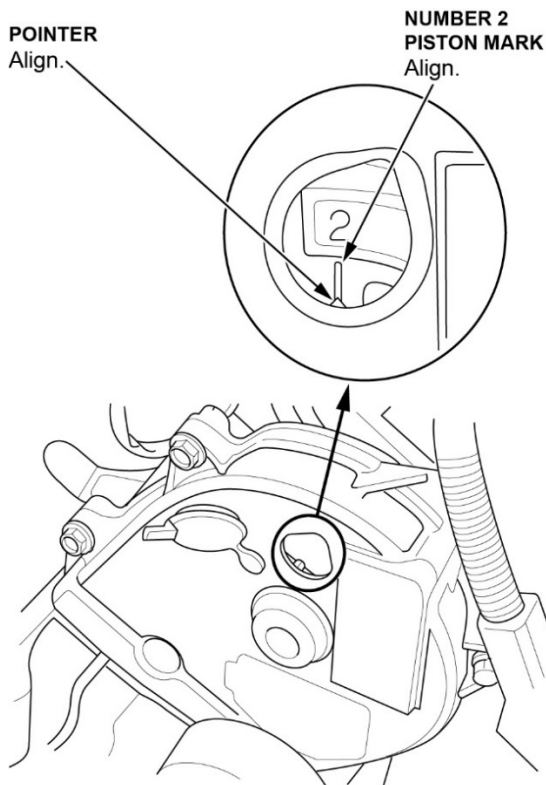
15. Rotate the crankshaft clockwise. Align the pointer on the front upper cover with the No. 2 piston TDC mark on the front camshaft pulley.
16. Check, and if necessary, adjust the valve clearance on the No. 2 cylinder.

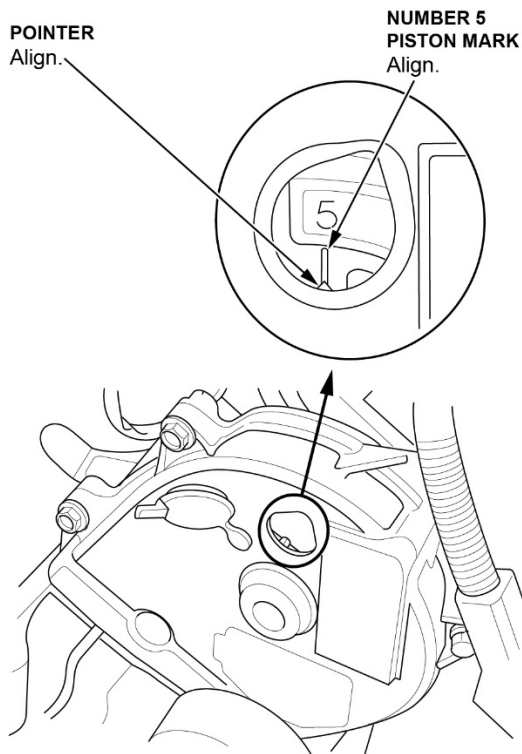
17. Rotate the crankshaft clockwise. Align the pointer on the front upper cover with the No. 5 piston TDC mark on the front camshaft pulley.
18. Check, and if necessary, adjust the valve clearance on the No. 5 cylinder.

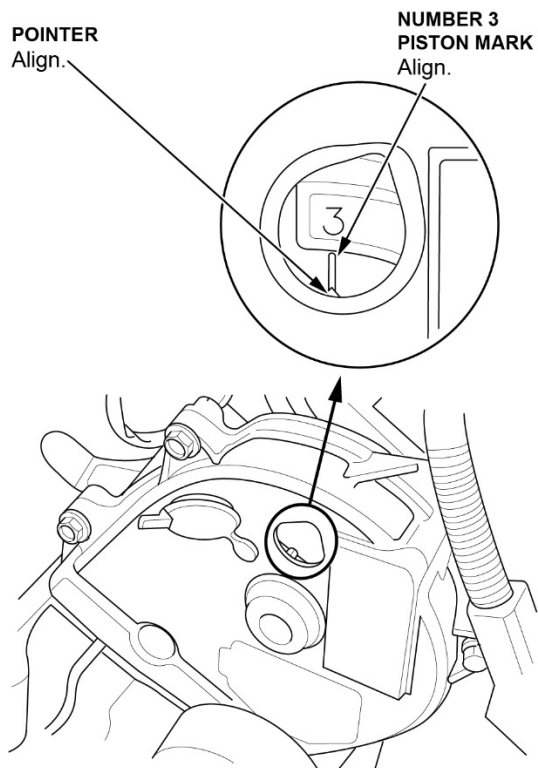
19. Rotate the crankshaft clockwise. Align the pointer on the front upper cover with the No. 3 piston TDC mark on the front camshaft pulley.
20. Check, and if necessary, adjust the valve clearance on the No. 3 cylinder.

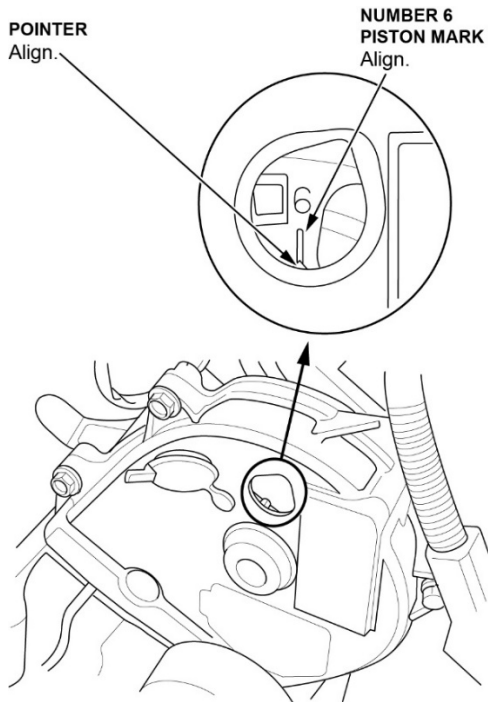
21. Rotate the crankshaft clockwise. Align the pointer on the front upper cover with the No. 6 piston TDC mark on the front camshaft pulley.
22. Check, and if necessary, adjust the valve clearance on the No. 6 cylinder.

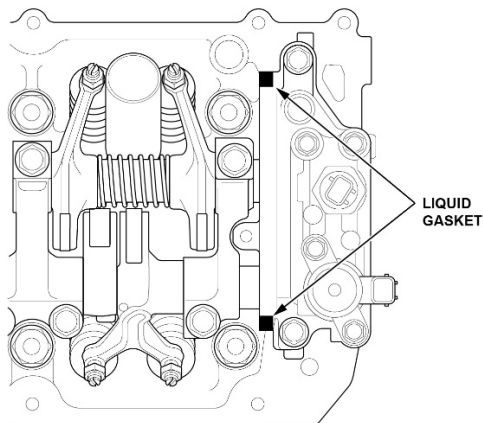
FRONT ROCKER ARM OIL CONTROL VALVE

23. Check the spark plug seals for damage. If any seals are damaged, replace it.
24. Thoroughly clean the head cover gasket and the groove of the cylinder head cover.
NOTE: Check and if necessary, replace the head cover gasket.
25. Install the head cover gasket in the groove of the cylinder head cover. Make sure the head cover gasket is seated securely.
26. Apply liquid gasket to the front and rear rocker arm oil control valve mating surfaces.
